Profile/Photo Observation Report

Date:	03/21/2018	Weather:		Coding:	PACP 6.0
Pipe Length (ft):	335.8	Owner:	NA	Pre Clean:	No Pre-Cleaning
P.O.#:		Surveyor:	Selasie Honu	PSR:	P-308-018-016
Customer:		Clean Date:	01/01/1900	Shape:	C

Street:	EMERALD DR	Flow Control:	Not Controlled
City:	Hobart, IN	Year Renewed:	
Location:	Light Highway	Tape/Media #:	
Purpose:	Routine Assessment	Dia/Height:	8"
Use:	Sanitary	Material:	PVC
Drain Area:	NA	Lining:	
Category:	NA		
Comment:			
Location Details:		Direction of Survey:	Downstream
US MH:	M-308-018	DS MH:	M-308-016
		Total Length Surveyed (ft):	340.6

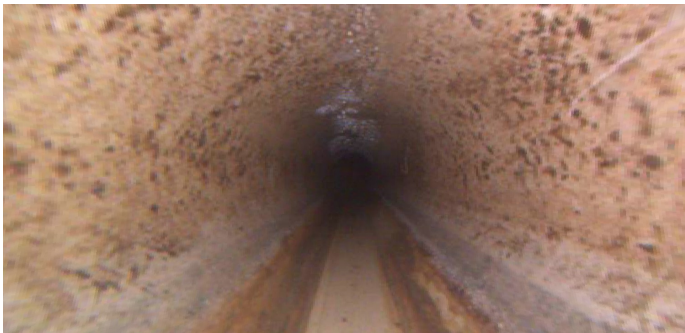
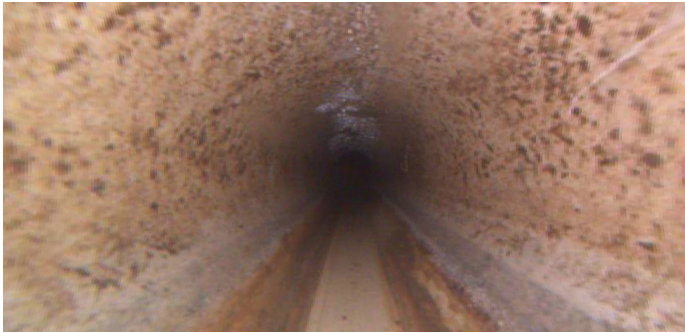
Code:	MWL
Description:	Water Level

Distance (ft):	.0
Structural Grade:	0
O&M Grade:	0
Clock Start/From:	
Clock To:	
1st Value:	
2nd Value:	
Value Percent:	5.000
Continuous Index:	
Within 8" of Joint:	NO
Remarks:

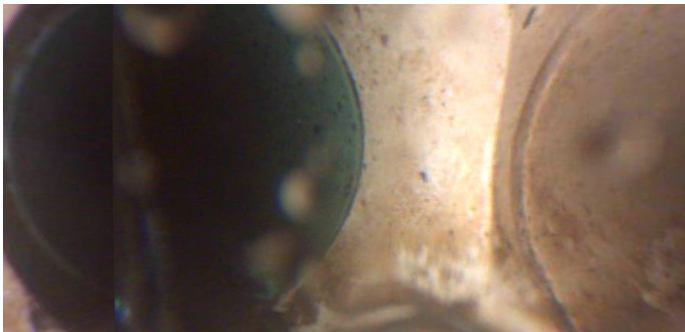
Code:	TF
Description:	Tap Factory

Distance (ft):	94.2
Structural Grade:	0
O&M Grade:	0
Clock Start/From:	9
Clock To:	
1st Value:	4.000
2nd Value:	
Value Percent:	
Continuous Index:	
Within 8" of Joint:	
Remarks:

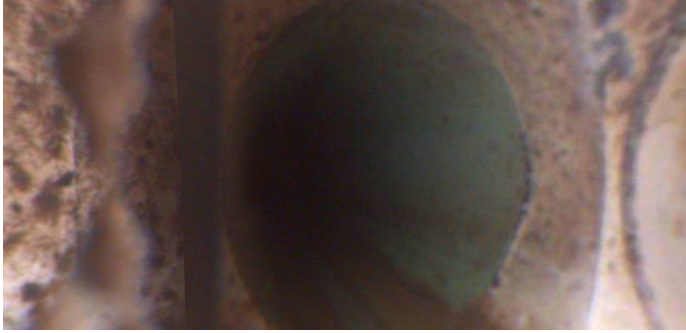
Code: **TF**
Description: **Tap Factory**

Distance (ft): **108.6**
Structural Grade: **0**
O&M Grade: **0**
Clock Start/From: **3**
Clock To:
1st Value: **4.000**
2nd Value:
Value Percent:
Continuous Index:
Within 8" of Joint:
Remarks:

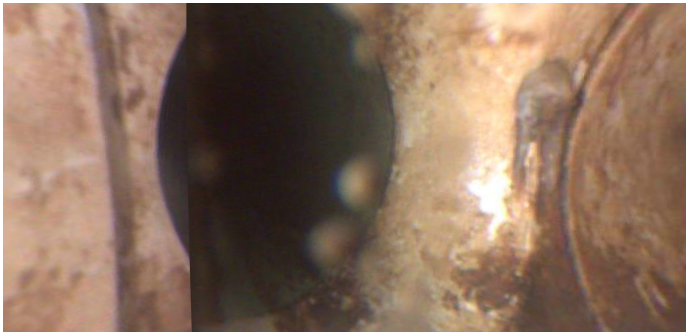
Code: **TF**
Description: **Tap Factory**

Distance (ft): **189.5**
Structural Grade: **0**
O&M Grade: **0**
Clock Start/From: **9**
Clock To:
1st Value: **4.000**
2nd Value:
Value Percent:
Continuous Index:
Within 8" of Joint:
Remarks:

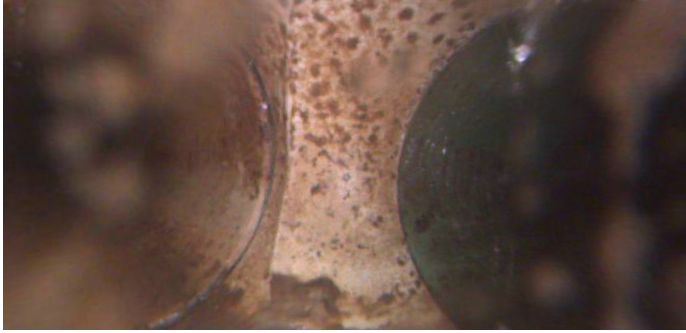
Code: **TF**
Description: **Tap Factory**

Distance (ft): **203.3**
Structural Grade: **0**
O&M Grade: **0**
Clock Start/From: **3**
Clock To:
1st Value: **4.000**
2nd Value:
Value Percent:
Continuous Index:
Within 8" of Joint:
Remarks:

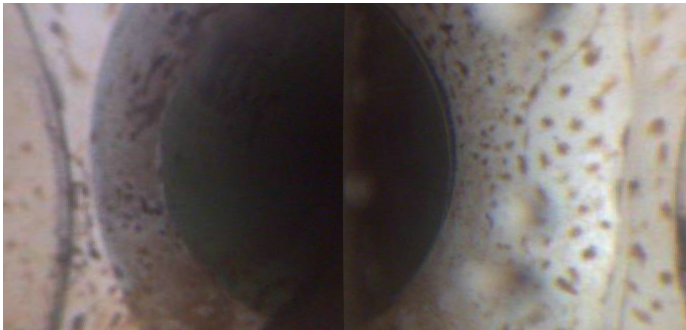
Code: **TF**
Description: **Tap Factory**

Distance (ft): **284.8**
Structural Grade: **0**
O&M Grade: **0**
Clock Start/From: **9**
Clock To:
1st Value: **4.000**
2nd Value:
Value Percent:
Continuous Index:
Within 8" of Joint:
Remarks:

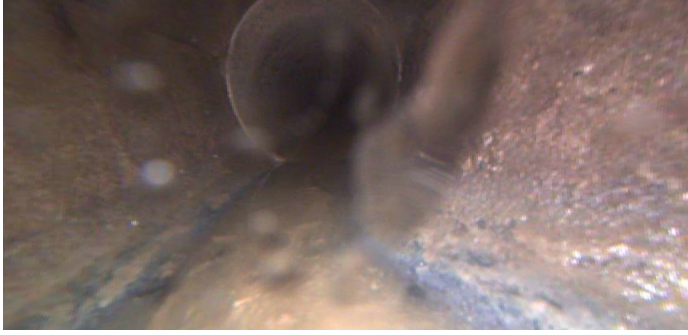
Code:	AMH
Description:	Manhole
Distance (ft):	340.6
Structural Grade:	0
O&M Grade:	0
Clock Start/From:	
Clock To:	
1st Value:	
2nd Value:	
Value Percent:	
Continuous Index:	
Within 8" of Joint:	NO
Remarks:	M-308-016
