Profile/Photo Observation Report

Date:	03/21/2018	Weather:		Coding:	PACP 6.0
Pipe Length (ft):	335.8	Owner:	NA	Pre Clean:	No Pre-Cleaning
P.O.#:		Surveyor:	Selasie Honu	PSR:	P-308-018-016
Customer:		Clean Date:	01/01/1900	Shape:	C

Street:	FOXCROFT STREET	Flow Control:	Not Controlled
City:	Hobart, IN	Year Renewed:	
Location:	Light Highway	Tape/Media #:	
Purpose:	Routine Assessment	Dia/Height:	8"
Use:	Sanitary	Material:	PVC
Drain Area:	NA	Lining:	
Category:	NA		
Comment:			
Location Details:		Direction of Survey:	Downstream
US MH:	M-308-018	DS MH:	M-308-016
		Total Length Surveyed (ft):	340.6

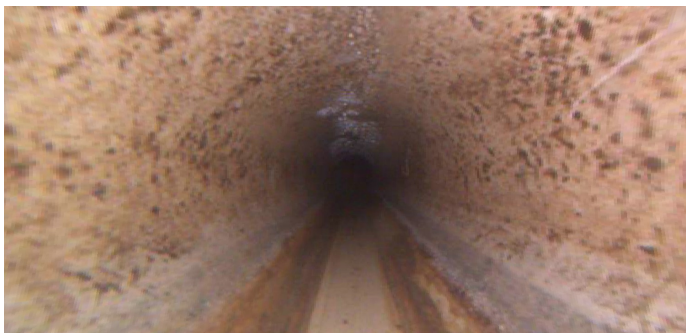
Code: **AMH**
Description: **Manhole**

Distance (ft): **.0**
Structural Grade: **0**
O&M Grade: **0**
Clock Start/From:
Clock To:
1st Value:
2nd Value:
Value Percent:
Continuous Index:
Within 8" of Joint: **NO**
Remarks: **M-308-018**

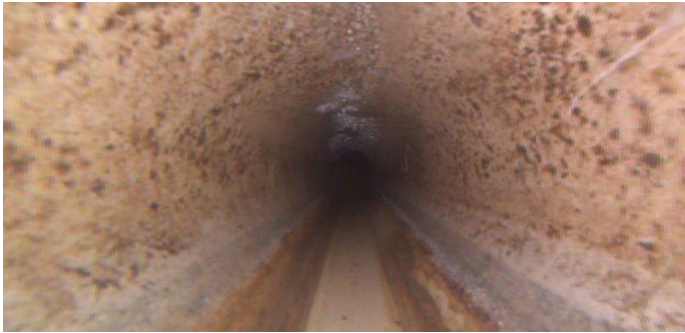
Code:	MWL
Description:	Water Level

Distance (ft):	.0
Structural Grade:	0
O&M Grade:	0
Clock Start/From:	
Clock To:	
1st Value:	
2nd Value:	
Value Percent:	5.000
Continuous Index:	
Within 8" of Joint:	NO
Remarks:

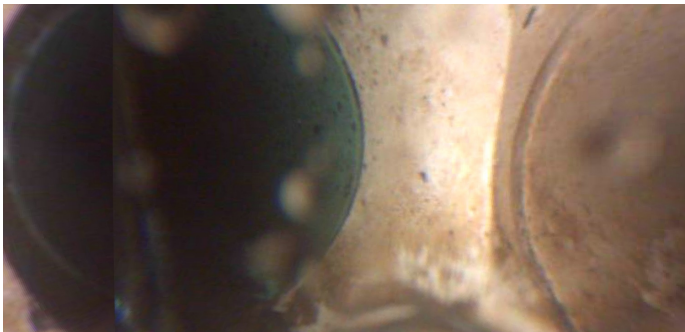
Code:	TF
Description:	Tap Factory

Distance (ft):	94.2
Structural Grade:	0
O&M Grade:	0
Clock Start/From:	9
Clock To:	
1st Value:	4.000
2nd Value:	
Value Percent:	
Continuous Index:	
Within 8" of Joint:	
Remarks:

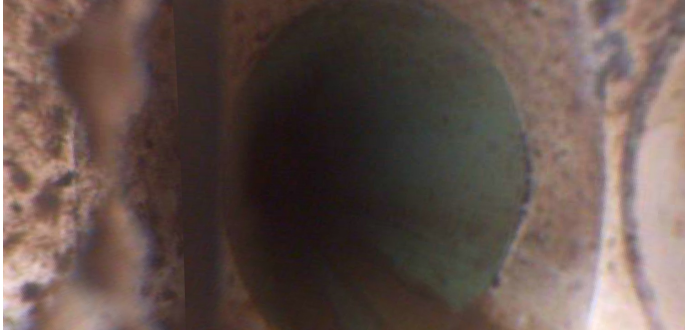
Code: **TF**
Description: **Tap Factory**

Distance (ft): **108.6**
Structural Grade: **0**
O&M Grade: **0**
Clock Start/From: **3**
Clock To:
1st Value: **4.000**
2nd Value:
Value Percent:
Continuous Index:
Within 8" of Joint:
Remarks:

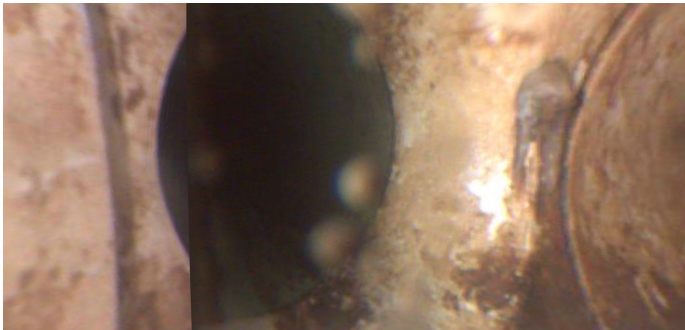
Code: **TF**
Description: **Tap Factory**

Distance (ft): **189.5**
Structural Grade: **0**
O&M Grade: **0**
Clock Start/From: **9**
Clock To:
1st Value: **4.000**
2nd Value:
Value Percent:
Continuous Index:
Within 8" of Joint:
Remarks:

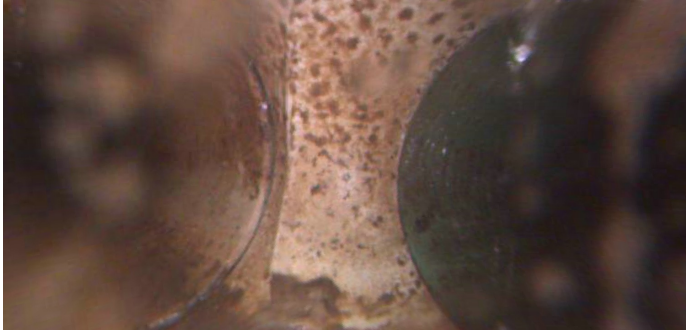
Code: **TF**
Description: **Tap Factory**

Distance (ft): **203.3**
Structural Grade: **0**
O&M Grade: **0**
Clock Start/From: **3**
Clock To:
1st Value: **4.000**
2nd Value:
Value Percent:
Continuous Index:
Within 8" of Joint:
Remarks:

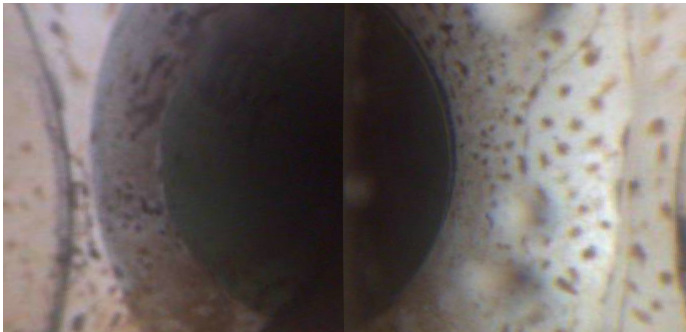
Code: **TF**
Description: **Tap Factory**

Distance (ft): **284.8**
Structural Grade: **0**
O&M Grade: **0**
Clock Start/From: **9**
Clock To:
1st Value: **4.000**
2nd Value:
Value Percent:
Continuous Index:
Within 8" of Joint:
Remarks:

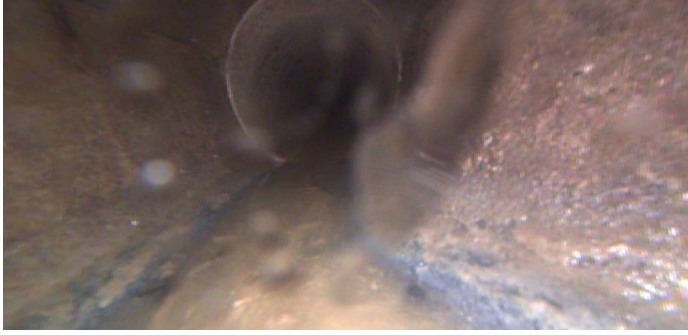
Code:	AMH
Description:	Manhole
Distance (ft):	340.6
Structural Grade:	0
O&M Grade:	0
Clock Start/From:	
Clock To:	
1st Value:	
2nd Value:	
Value Percent:	
Continuous Index:	
Within 8" of Joint:	NO
Remarks:	M-308-016
