## Profile/Photo Observation Report

Date:	<b>03/21/2018</b>	Weather:		Coding:	<b>PACP 6.0</b>
Pipe Length (ft):	<b>379.2</b>	Owner:	<b>NA</b>	Pre Clean:	<b>No Pre-Cleaning</b>
P.O.#:		Surveyor:	<b>JUSTIN GONZALES</b>	PSR:	<b>P-308-017-018</b>
Customer:		Clean Date:	<b>01/01/1900</b>	Shape:	<b>C</b>

Street:	<b>EMERALD DR &amp; RUBY CT</b>	Flow Control:	<b>Not Controlled</b>
City:	<b>Hobart, IN</b>	Year Renewed:	
Location:	<b>Light Highway</b>	Tape/Media #:	
Purpose:	<b>Routine Assessment</b>	Dia/Height:	<b>8"</b>
Use:	<b>Sanitary</b>	Material:	<b>PVC</b>
Drain Area:	<b>NA</b>	Lining:	
Category:	<b>NA</b>		
Comment:	<b>P_C in O_C at 393 ft . Flow direction wrong</b>		
Location Details:		Direction of Survey:	<b>Upstream</b>
US MH:	<b>M-308-018</b>	DS MH:	<b>M-308-017</b>
		Total Length Surveyed (ft):	<b>394.6</b>

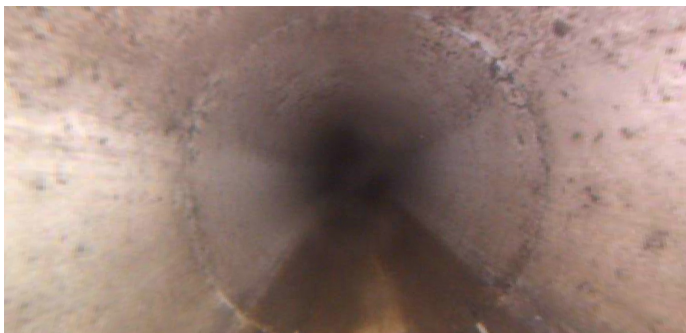
Code: **AMH**  
Description: **Manhole**

Distance (ft): **.0**  
Structural Grade: **0**  
O&M Grade: **0**  
Clock Start/From:  
Clock To:  
1st Value:  
2nd Value:  
Value Percent:  
Continuous Index:  
Within 8" of Joint: **NO**  
Remarks: **M-308-017**

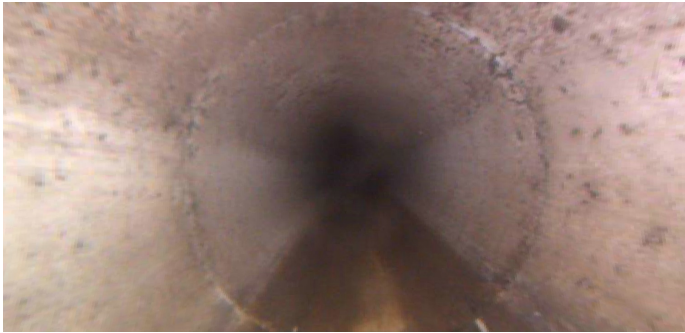
Code:	<b>MWL</b>
Description:	<b>Water Level</b>

Distance (ft):	<b>.0</b>
Structural Grade:	<b>0</b>
O&M Grade:	<b>0</b>
Clock Start/From:	
Clock To:	
1st Value:	
2nd Value:	
Value Percent:	<b>5.000</b>
Continuous Index:	
Within 8" of Joint:	<b>NO</b>
Remarks:

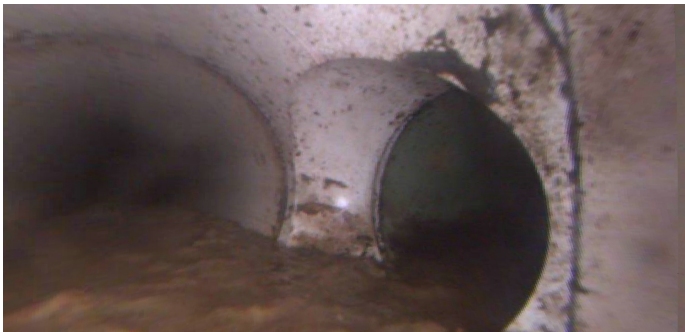
Code:	<b>TFA</b>
Description:	<b>Tap Factory Active</b>

Distance (ft):	<b>41.2</b>
Structural Grade:	<b>0</b>
O&M Grade:	<b>0</b>
Clock Start/From:	<b>3</b>
Clock To:	
1st Value:	<b>4.000</b>
2nd Value:	
Value Percent:	
Continuous Index:	
Within 8" of Joint:	
Remarks:

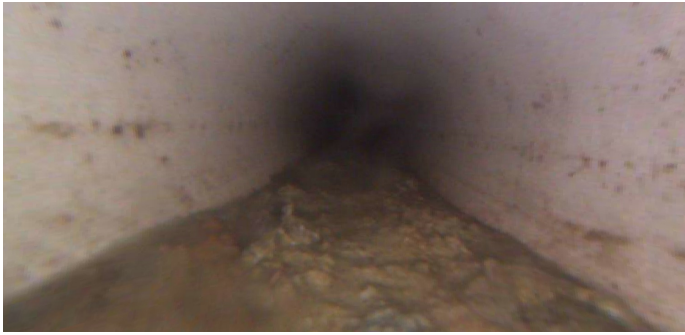
Code: **DSZ**  
Description: **Deposits Settled Other**

Distance (ft): **46.1**  
Structural Grade: **0**  
O&M Grade: **2**  
Clock Start/From: **6**  
Clock To:  
1st Value:  
2nd Value:  
Value Percent: **10.000**  
Continuous Index: **S01**  
Within 8" of Joint: **YES**  
Remarks: **UNKNOWN DEPOSIT SETTLED**

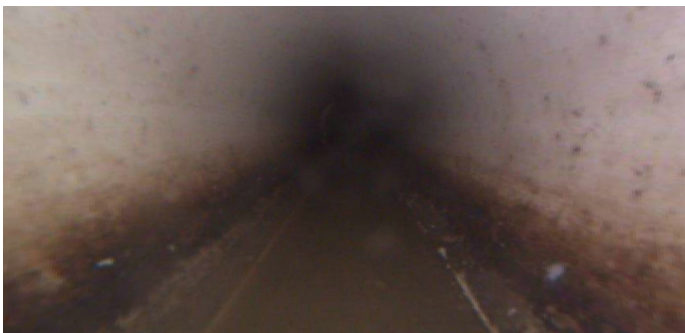
Code: **DSZ**  
Description: **Deposits Settled Other**

Distance (ft): **52.5**  
Structural Grade: **0**  
O&M Grade: **2**  
Clock Start/From: **6**  
Clock To:  
1st Value:  
2nd Value:  
Value Percent: **10.000**  
Continuous Index: **F01**  
Within 8" of Joint: **YES**  
Remarks: **UNKNOWN DEPOSIT SETTLED**

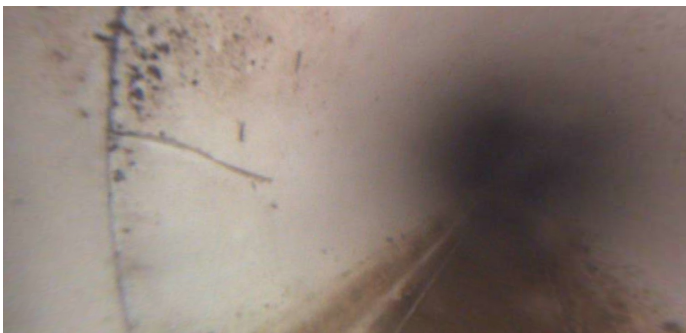
Code: **RFJ**  
Description: **Roots Fine Joint**

Distance (ft): **82.4**  
Structural Grade: **0**  
O&M Grade: **1**  
Clock Start/From: **9**  
Clock To:  
1st Value:  
2nd Value:  
Value Percent:  
Continuous Index:  
Within 8" of Joint: **YES**  
Remarks:

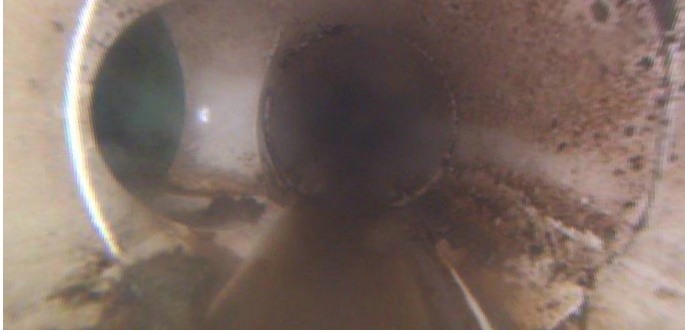
Code: **TF**  
Description: **Tap Factory**

Distance (ft): **135.8**  
Structural Grade: **0**  
O&M Grade: **0**  
Clock Start/From: **9**  
Clock To:  
1st Value: **4.000**  
2nd Value:  
Value Percent:  
Continuous Index:  
Within 8" of Joint:  
Remarks:
