Profile/Photo Observation Report

Street:	FOXCROFT STREET	Flow Control:	Not Controlled
City:	Hobart, IN	Year Renewed:	
Location:	Light Highway	Tape/Media #:	
Purpose:	Routine Assessment	Dia/Height:	8"
Use:	Sanitary	Material:	PVC
Drain Area:	NA	Lining:	
Category:	NA		
Comment:	P_C in O_C at 393 ft . Flow direction wrong		
Location Details:		Direction of Survey:	Upstream
US MH:	M-308-018	DS MH:	M-308-017
		Total Length Surveyed (ft):	394.6

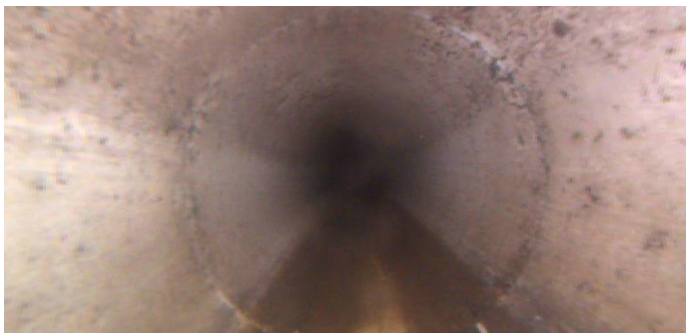
Code: **AMH**
Description: **Manhole**

Distance (ft): **.0**
Structural Grade: **0**
O&M Grade: **0**
Clock Start/From:
Clock To:
1st Value:
2nd Value:
Value Percent:
Continuous Index:
Within 8" of Joint: **NO**
Remarks: **M-308-017**

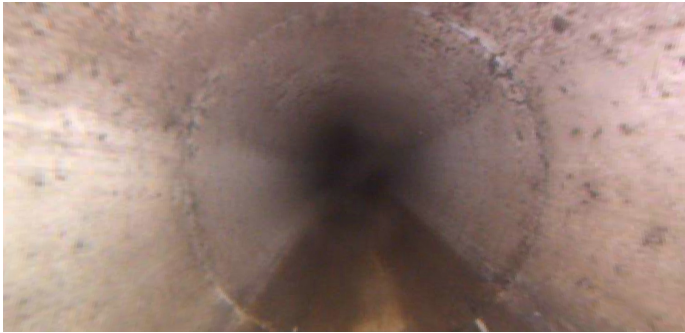
Code:	MWL
Description:	Water Level

Distance (ft):	.0
Structural Grade:	0
O&M Grade:	0
Clock Start/From:	
Clock To:	
1st Value:	
2nd Value:	
Value Percent:	5.000
Continuous Index:	
Within 8" of Joint:	NO
Remarks:

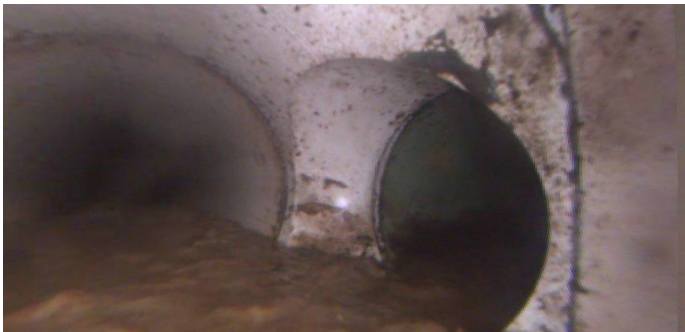
Code:	TFA
Description:	Tap Factory Active

Distance (ft):	41.2
Structural Grade:	0
O&M Grade:	0
Clock Start/From:	3
Clock To:	
1st Value:	4.000
2nd Value:	
Value Percent:	
Continuous Index:	
Within 8" of Joint:	
Remarks:

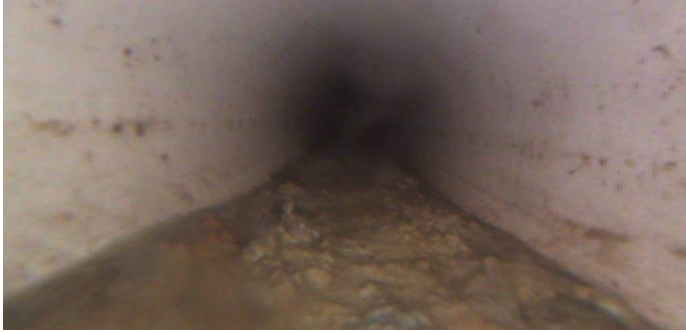
Code: **DSZ**
Description: **Deposits Settled Other**

Distance (ft): **46.1**
Structural Grade: **0**
O&M Grade: **2**
Clock Start/From: **6**
Clock To:
1st Value:
2nd Value:
Value Percent: **10.000**
Continuous Index: **S01**
Within 8" of Joint: **YES**
Remarks: **UNKNOWN DEPOSIT SETTLED**

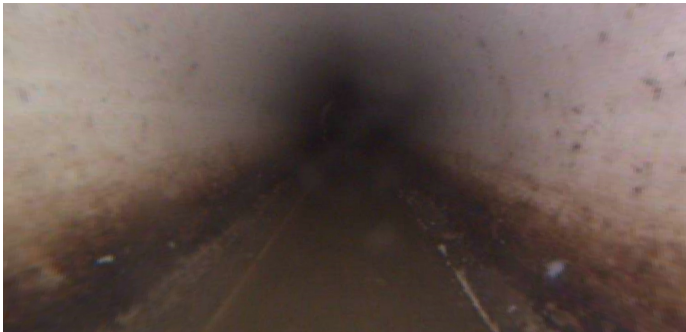
Code: **DSZ**
Description: **Deposits Settled Other**

Distance (ft): **52.5**
Structural Grade: **0**
O&M Grade: **2**
Clock Start/From: **6**
Clock To:
1st Value:
2nd Value:
Value Percent: **10.000**
Continuous Index: **F01**
Within 8" of Joint: **YES**
Remarks: **UNKNOWN DEPOSIT SETTLED**

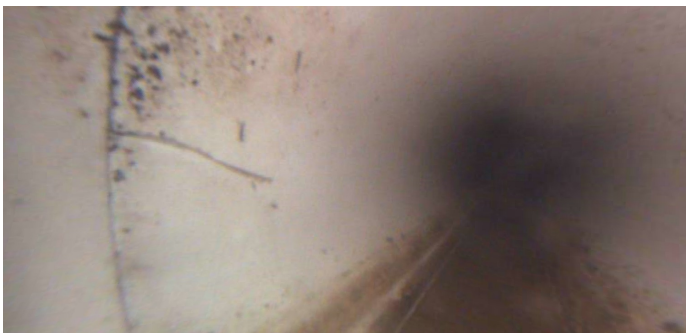
Code: **RFJ**
Description: **Roots Fine Joint**

Distance (ft): **82.4**
Structural Grade: **0**
O&M Grade: **1**
Clock Start/From: **9**
Clock To:
1st Value:
2nd Value:
Value Percent:
Continuous Index:
Within 8" of Joint: **YES**
Remarks:
