Profile/Photo Observation Report

Date:	03/21/2018	Weather:		Coding:	PACP 6.0
Pipe Length (ft):	168.8	Owner:	NA	Pre Clean:	No Pre-Cleaning
P.O.#:		Surveyor:	Justin Gonzales	PSR:	P-308-020-019
Customer:		Clean Date:	01/01/1900	Shape:	C

Street:	FOXCROFT STREET	Flow Control:	Not Controlled
City:	Hobart, IN	Year Renewed:	
Location:	Light Highway	Tape/Media #:	
Purpose:	Routine Assessment	Dia/Height:	8"
Use:	Sanitary	Material:	PVC
Drain Area:	NA	Lining:	
Category:	NA		
Comment:	Flow direction wrong		
Location Details:		Direction of Survey:	Upstream
US MH:	M-308-019	DS MH:	M-308-020
		Total Length Surveyed (ft):	164.4

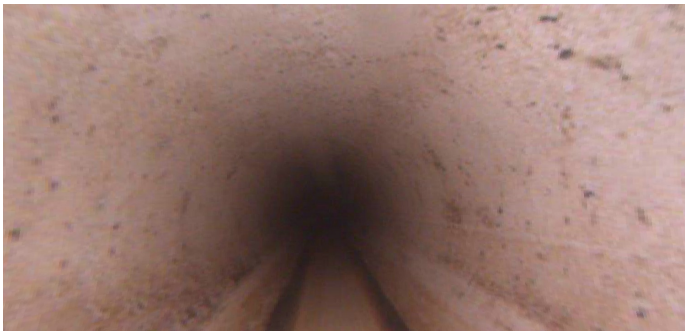
Code: **AMH**
Description: **Manhole**

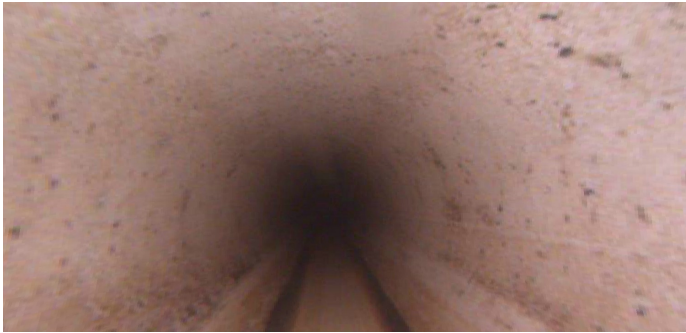
Code:	MWL
Description:	Water Level

Distance (ft):	.0
Structural Grade:	0
O&M Grade:	0
Clock Start/From:	
Clock To:	
1st Value:	
2nd Value:	
Value Percent:	5.000
Continuous Index:	
Within 8" of Joint:	NO
Remarks:

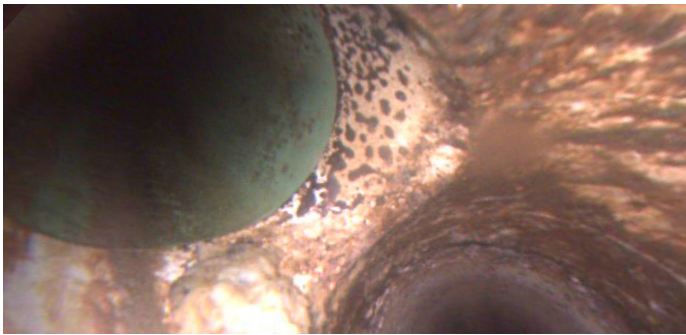
Code:	TF
Description:	Tap Factory

Distance (ft):	47.1
Structural Grade:	0
O&M Grade:	0
Clock Start/From:	10
Clock To:	
1st Value:	4.000
2nd Value:	
Value Percent:	
Continuous Index:	
Within 8" of Joint:	
Remarks:

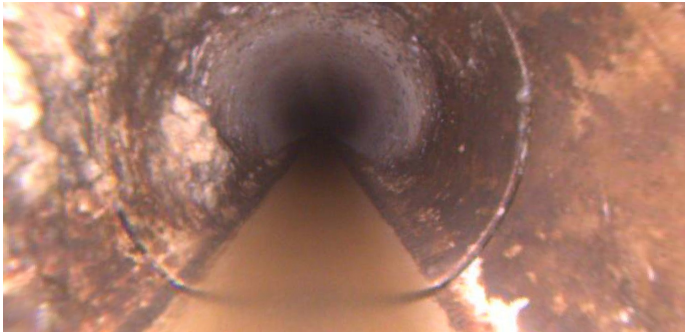
Code: **DAGS**
Description: **Deposits Attached Grease**

Distance (ft): **47.3**
Structural Grade: **0**
O&M Grade: **2**
Clock Start/From: **8**
Clock To: **9**
1st Value:
2nd Value:
Value Percent: **5.000**
Continuous Index:
Within 8" of Joint: **NO**
Remarks:

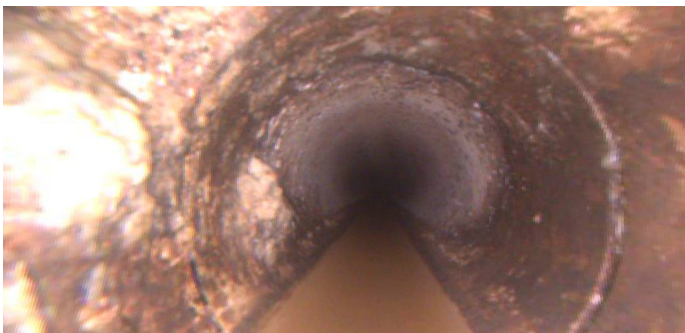
Code: **DAZ**
Description: **Deposits Attached Other**

Distance (ft): **47.3**
Structural Grade: **0**
O&M Grade: **2**
Clock Start/From: **7**
Clock To: **5**
1st Value:
2nd Value:
Value Percent: **5.000**
Continuous Index:
Within 8" of Joint: **YES**
Remarks:

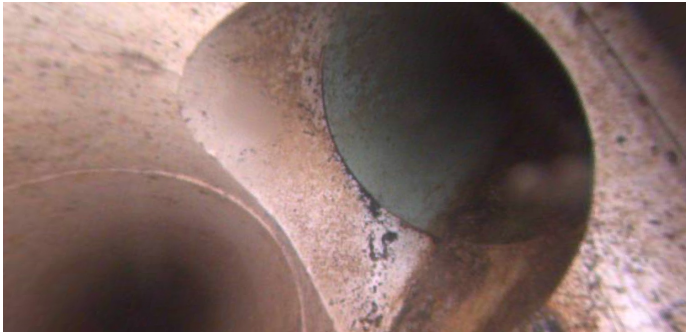
Code: **TF**
Description: **Tap Factory**

Distance (ft): **60.2**
Structural Grade: **0**
O&M Grade: **0**
Clock Start/From: **2**
Clock To:
1st Value: **4.000**
2nd Value:
Value Percent:
Continuous Index:
Within 8" of Joint:
Remarks:

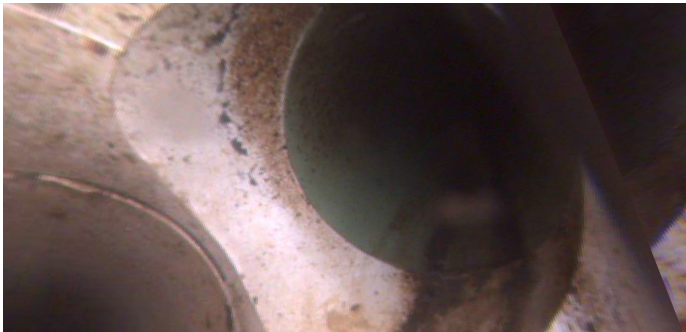
Code: **TF**
Description: **Tap Factory**

Distance (ft): **123.8**
Structural Grade: **0**
O&M Grade: **0**
Clock Start/From: **2**
Clock To:
1st Value: **4.000**
2nd Value:
Value Percent:
Continuous Index:
Within 8" of Joint:
Remarks:

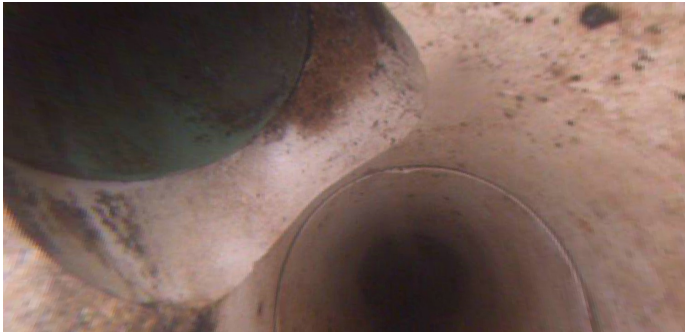
Code: **TF**
Description: **Tap Factory**

Distance (ft): **136.8**
Structural Grade: **0**
O&M Grade: **0**
Clock Start/From: **10**
Clock To:
1st Value: **4.000**
2nd Value:
Value Percent:
Continuous Index:
Within 8" of Joint:
Remarks:

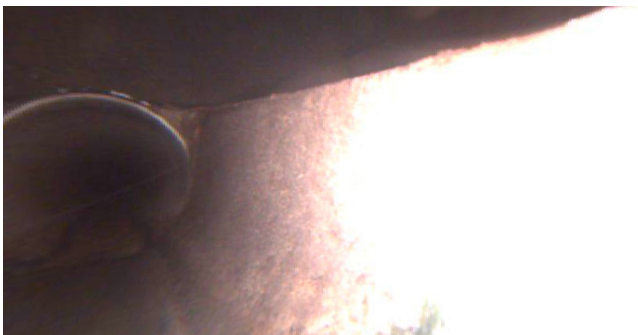
Code: **AMH**
Description: **Manhole**

Distance (ft): **164.4**
Structural Grade: **0**
O&M Grade: **0**
Clock Start/From:
Clock To:
1st Value:
2nd Value:
Value Percent:
Continuous Index:
Within 8" of Joint: **NO**
Remarks: **M-308-019**
