Profile/Photo Observation Report

Date:	03/21/2018	Weather:		Coding:	PACP 6.0
Pipe Length (ft):	165.3	Owner:	NA	Pre Clean:	No Pre-Cleaning
P.O.#:		Surveyor:	Selasie Honu	PSR:	P-308-023-022
Customer:		Clean Date:	01/01/1900	Shape:	C

Street:	FOXCROFT STREET	Flow Control:	Not Controlled
City:	Hobart, IN	Year Renewed:	
Location:	Light Highway	Tape/Media #:	
Purpose:	Routine Assessment	Dia/Height:	8"
Use:	Sanitary	Material:	PVC
Drain Area:	NA	Lining:	
Category:	NA		
Comment:	Flow direction wrong

Location Details:		Direction of Survey:	Downstream
US MH:	M-308-022	DS MH:	M-308-024
		Total Length Surveyed (ft):	169.4

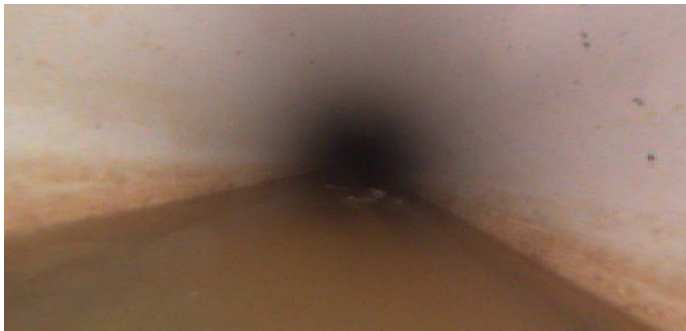
Code: **AMH**
Description: **Manhole**

Distance (ft): **.0**
Structural Grade: **0**
O&M Grade: **0**
Clock Start/From:
Clock To:
1st Value:
2nd Value:
Value Percent:
Continuous Index:
Within 8" of Joint: **NO**
Remarks: **M-308-022**

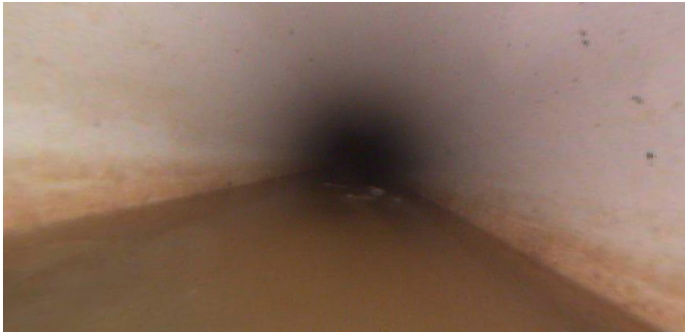
Code:	MWL
Description:	Water Level

Distance (ft):	.0
Structural Grade:	0
O&M Grade:	0
Clock Start/From:	
Clock To:	
1st Value:	
2nd Value:	
Value Percent:	5.000
Continuous Index:	
Within 8" of Joint:	NO
Remarks:

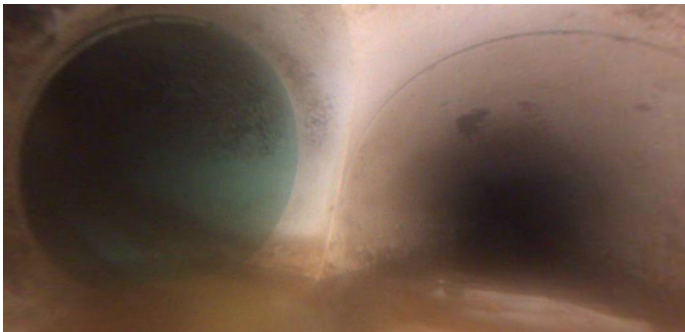
Code:	TFA
Description:	Tap Factory Active

Distance (ft):	25.6
Structural Grade:	0
O&M Grade:	0
Clock Start/From:	9
Clock To:	
1st Value:	4.000
2nd Value:	
Value Percent:	
Continuous Index:	
Within 8" of Joint:	
Remarks:

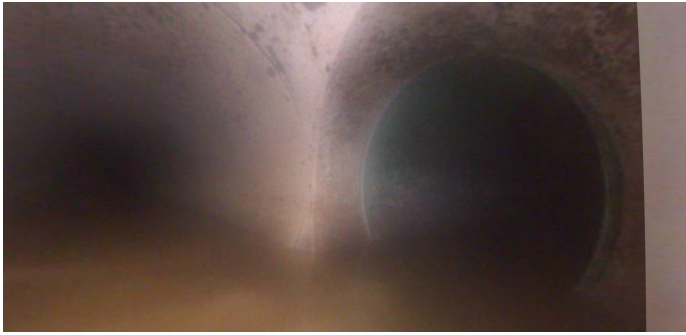
Code: **TFA**
Description: **Tap Factory Active**

Distance (ft): **39.6**
Structural Grade: **0**
O&M Grade: **0**
Clock Start/From: **3**
Clock To:
1st Value: **4.000**
2nd Value:
Value Percent:
Continuous Index:
Within 8" of Joint:
Remarks:

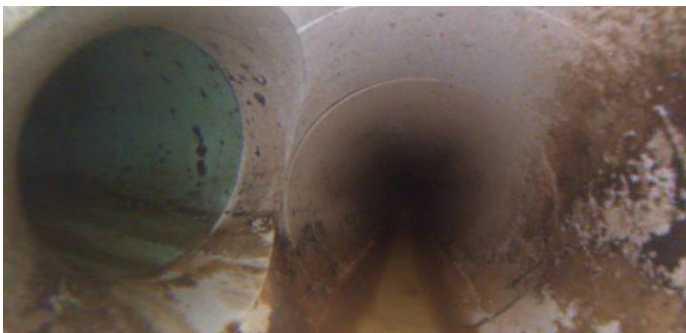
Code: **TF**
Description: **Tap Factory**

Distance (ft): **120.7**
Structural Grade: **0**
O&M Grade: **0**
Clock Start/From: **9**
Clock To:
1st Value: **4.000**
2nd Value:
Value Percent:
Continuous Index:
Within 8" of Joint:
Remarks:

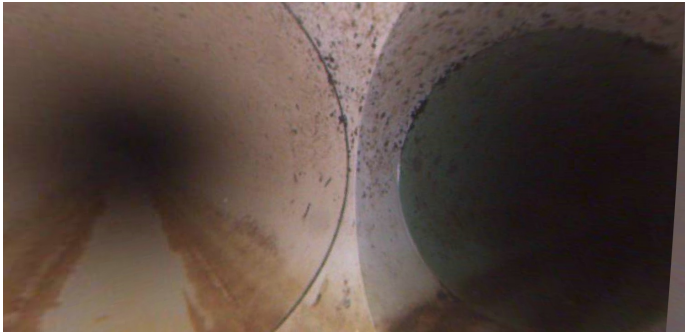
Code: **TF**
Description: **Tap Factory**

Distance (ft): **134.9**
Structural Grade: **0**
O&M Grade: **0**
Clock Start/From: **3**
Clock To:
1st Value: **4.000**
2nd Value:
Value Percent:
Continuous Index:
Within 8" of Joint:
Remarks:

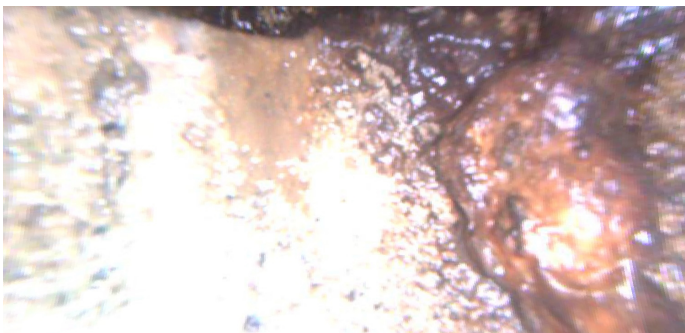
Code: **AMH**
Description: **Manhole**

Distance (ft): **169.4**
Structural Grade: **0**
O&M Grade: **0**
Clock Start/From:
Clock To:
1st Value:
2nd Value:
Value Percent:
Continuous Index:
Within 8" of Joint: **NO**
Remarks: **M-308-024**
