## Profile/Photo Observation Report

Date:	<b>03/21/2018</b>	Weather:		Coding:	<b>PACP 6.0</b>
Pipe Length (ft):	<b>302.9</b>	Owner:	<b>NA</b>	Pre Clean:	<b>No Pre-Cleaning</b>
P.O.#:		Surveyor:	<b>Selasie Honu</b>	PSR:	<b>P-308-025-026</b>
Customer:		Clean Date:	<b>01/01/1900</b>	Shape:	<b>C</b>

Street:	<b>FOXCROFT STREET</b>	Flow Control:	<b>Not Controlled</b>
City:	<b>Hobart, IN</b>	Year Renewed:	
Location:	<b>Light Highway</b>	Tape/Media #:	
Purpose:	<b>Routine Assessment</b>	Dia/Height:	<b>8"</b>
Use:	<b>Sanitary</b>	Material:	<b>PVC</b>
Drain Area:	<b>NA</b>	Lining:	
Category:	<b>NA</b>		
Comment:	<b>Flow direction wrong</b>		
Location Details:		Direction of Survey:	<b>Upstream</b>
US MH:	<b>M-308-026</b>	DS MH:	<b>M-308-025</b>
		Total Length Surveyed (ft):	<b>297.2</b>

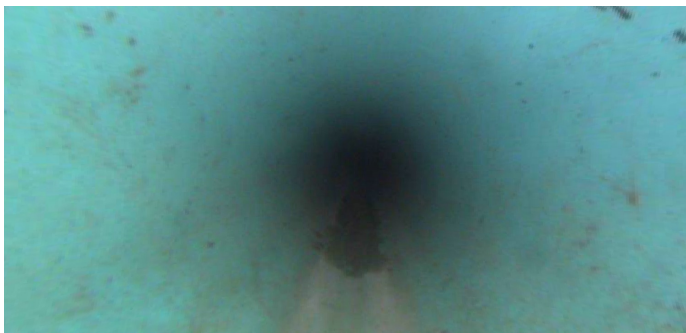
Code: **AMH**  
Description: **Manhole**

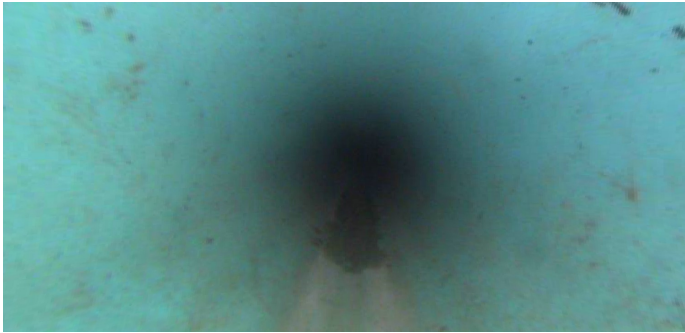
Code:	<b>MWL</b>
Description:	<b>Water Level</b>

Distance (ft):	<b>.0</b>
Structural Grade:	<b>0</b>
O&M Grade:	<b>0</b>
Clock Start/From:	
Clock To:	
1st Value:	
2nd Value:	
Value Percent:	<b>5.000</b>
Continuous Index:	
Within 8" of Joint:	<b>NO</b>
Remarks:

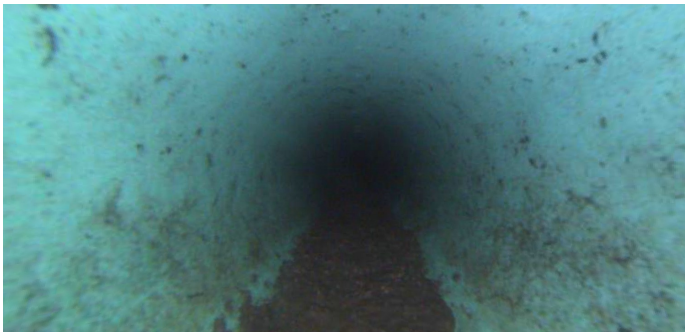
Code:	<b>DSF</b>
Description:	<b>Deposits Settled Fine</b>

Distance (ft):	<b>8.3</b>
Structural Grade:	<b>0</b>
O&M Grade:	<b>2</b>
Clock Start/From:	<b>6</b>
Clock To:	
1st Value:	
2nd Value:	
Value Percent:	<b>5.000</b>
Continuous Index:	<b>S01</b>
Within 8" of Joint:	<b>NO</b>
Remarks:

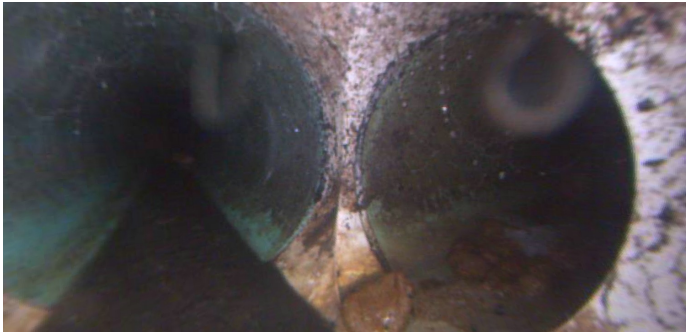
Code: **TF**  
Description: **Tap Factory**

Distance (ft): **25.6**  
Structural Grade: **0**  
O&M Grade: **0**  
Clock Start/From: **3**  
Clock To:  
1st Value: **4.000**  
2nd Value:  
Value Percent:  
Continuous Index:  
Within 8" of Joint:  
Remarks:

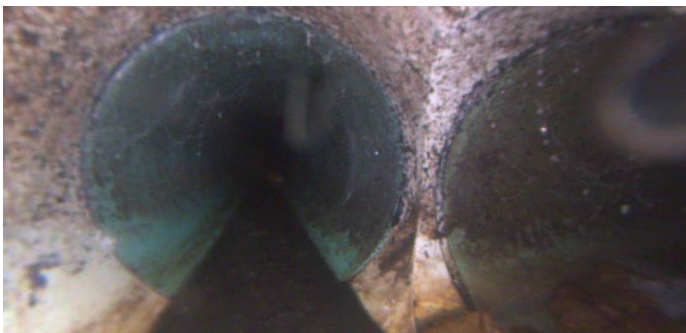
Code: **DSF**  
Description: **Deposits Settled Fine**

Distance (ft): **25.6**  
Structural Grade: **0**  
O&M Grade: **2**  
Clock Start/From: **6**  
Clock To:  
1st Value:  
2nd Value:  
Value Percent: **5.000**  
Continuous Index: **F01**  
Within 8" of Joint: **NO**  
Remarks:

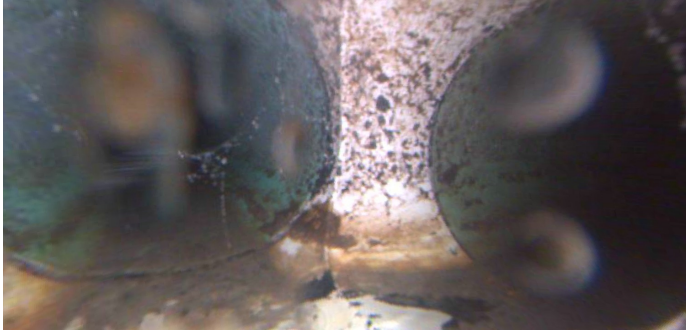
Code: **TFA**  
Description: **Tap Factory Active**

Distance (ft): **120.2**  
Structural Grade: **0**  
O&M Grade: **0**  
Clock Start/From: **3**  
Clock To:  
1st Value: **4.000**  
2nd Value:  
Value Percent:  
Continuous Index:  
Within 8" of Joint:  
Remarks:

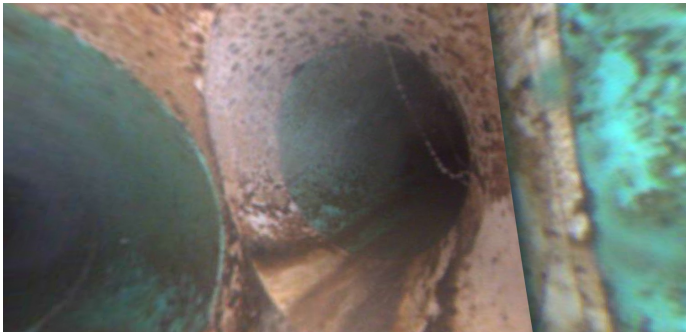
Code: **TF**  
Description: **Tap Factory**

Distance (ft): **182.3**  
Structural Grade: **0**  
O&M Grade: **0**  
Clock Start/From: **9**  
Clock To:  
1st Value: **4.000**  
2nd Value:  
Value Percent:  
Continuous Index:  
Within 8" of Joint:  
Remarks:

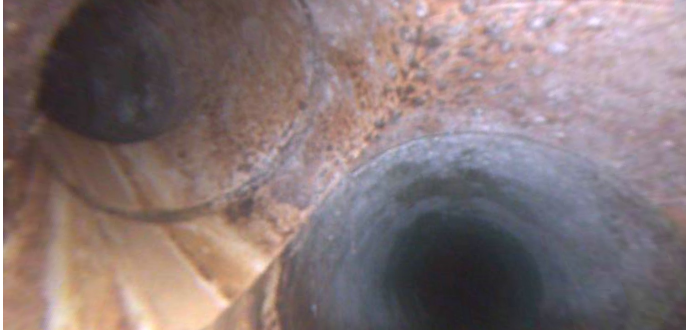
Code: **TF**  
Description: **Tap Factory**

Distance (ft): **216.0**  
Structural Grade: **0**  
O&M Grade: **0**  
Clock Start/From: **2**  
Clock To:  
1st Value: **4.000**  
2nd Value:  
Value Percent:  
Continuous Index:  
Within 8" of Joint:  
Remarks:

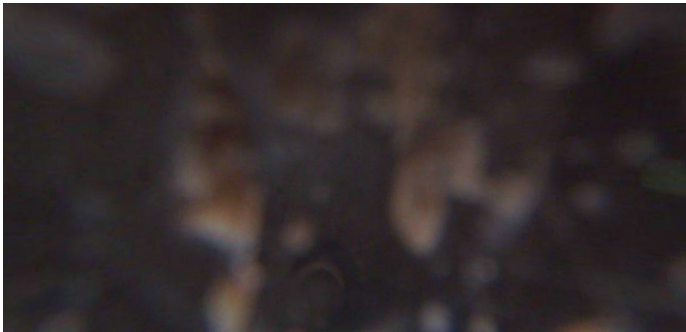
Code: **AMH**  
Description: **Manhole**

Distance (ft): **297.2**  
Structural Grade: **0**  
O&M Grade: **0**  
Clock Start/From:  
Clock To:  
1st Value:  
2nd Value:  
Value Percent:  
Continuous Index:  
Within 8" of Joint: **NO**  
Remarks: **M-308-026**
