Profile/Photo Observation Report

Street:	SAPHIRE CT	Flow Control:	Not Controlled
City:	Hobart, IN	Year Renewed:	
Location:	Light Highway	Tape/Media #:	
Purpose:	Routine Assessment	Dia/Height:	8"
Use:	Sanitary	Material:	PVC
Drain Area:	NA	Lining:	
Category:	NA		
Comment:	Flow direction wrong		
Location Details:		Direction of Survey:	Downstream
US MH:	M-308-026	DS MH:	M-308-027
		Total Length Surveyed (ft):	46.1

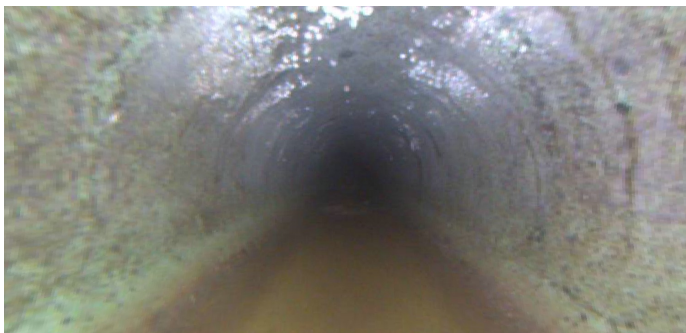
Code: **AMH**
Description: **Manhole**

Distance (ft): **.0**
Structural Grade: **0**
O&M Grade: **0**
Clock Start/From:
Clock To:
1st Value:
2nd Value:
Value Percent:
Continuous Index:
Within 8" of Joint: **NO**
Remarks: **M-308-026**

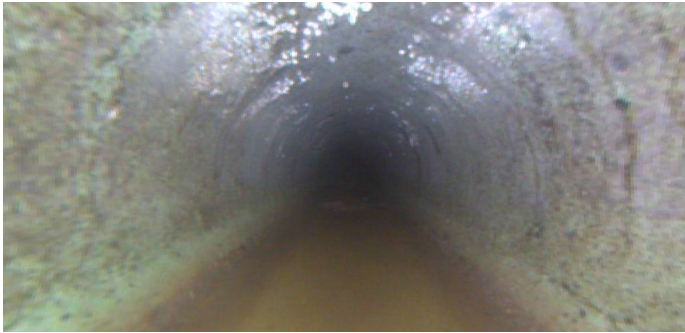
Code:	MWL
Description:	Water Level

Distance (ft):	.0
Structural Grade:	0
O&M Grade:	0
Clock Start/From:	
Clock To:	
1st Value:	
2nd Value:	
Value Percent:	5.000
Continuous Index:	
Within 8" of Joint:	NO
Remarks:

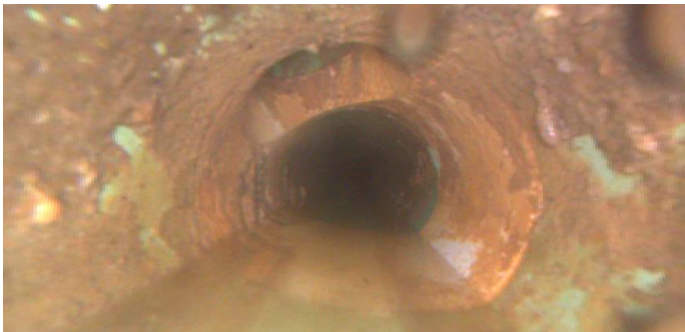
Code:	TF
Description:	Tap Factory

Distance (ft):	25.1
Structural Grade:	0
O&M Grade:	0
Clock Start/From:	11
Clock To:	
1st Value:	4.000
2nd Value:	
Value Percent:	
Continuous Index:	
Within 8" of Joint:	
Remarks:

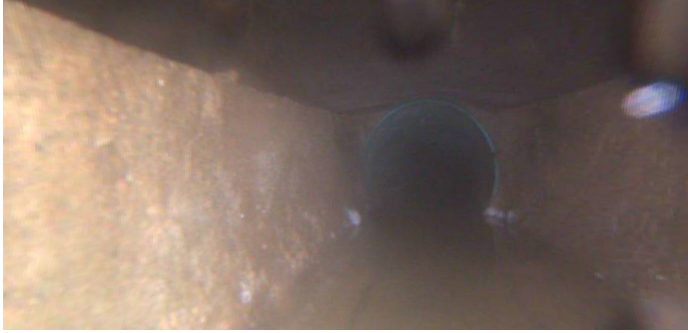
Code:	AMH
Description:	Manhole
Distance (ft):	46.1
Structural Grade:	0
O&M Grade:	0
Clock Start/From:	
Clock To:	
1st Value:	
2nd Value:	
Value Percent:	
Continuous Index:	
Within 8" of Joint:	NO
Remarks:	M-308-027
