Profile/Photo Observation Report

Street:	SAPHIRE CT	Flow Control:	Not Controlled
City:	Hobart, IN	Year Renewed:	
Location:	Light Highway	Tape/Media #:	
Purpose:	Routine Assessment	Dia/Height:	8"
Use:	Sanitary	Material:	PVC
Drain Area:	NA	Lining:	
Category:	NA		
Comment:	Flow direction wrong

Location Details:		Direction of Survey:	Upstream
US MH:	M-308-027	DS MH:	M-308-028
		Total Length Surveyed (ft):	116.7

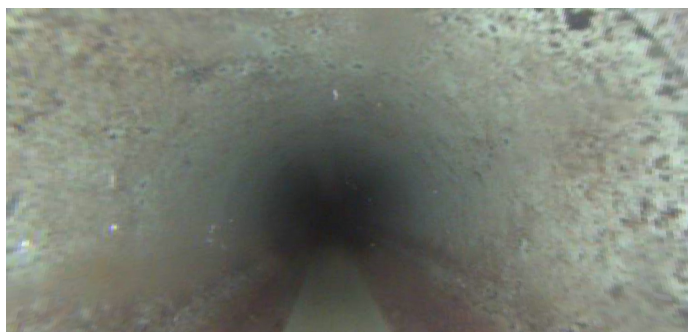
Code: **AMH**
 Description: **Manhole**
 Distance (ft): **.0**
 Structural Grade: **0**
 O&M Grade: **0**
 Clock Start/From:
 Clock To:
 1st Value:
 2nd Value:
 Value Percent:
 Continuous Index:
 Within 8" of Joint: **NO**
 Remarks: **M-308-028**

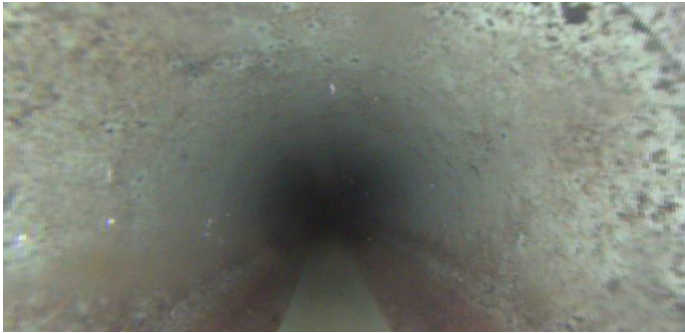
Code:	MWL
Description:	Water Level

Distance (ft):	.0
Structural Grade:	0
O&M Grade:	0
Clock Start/From:	
Clock To:	
1st Value:	
2nd Value:	
Value Percent:	5.000
Continuous Index:	
Within 8" of Joint:	NO
Remarks:

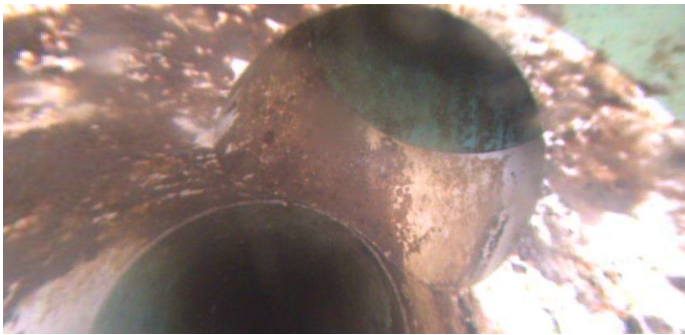
Code:	TF
Description:	Tap Factory

Distance (ft):	13.8
Structural Grade:	0
O&M Grade:	0
Clock Start/From:	2
Clock To:	
1st Value:	4.000
2nd Value:	
Value Percent:	
Continuous Index:	
Within 8" of Joint:	
Remarks:

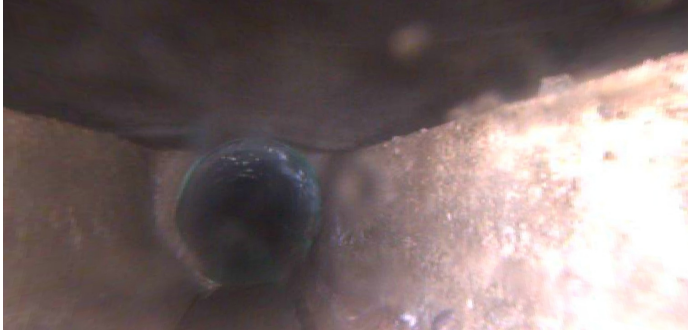
Code:	AMH
Description:	Manhole
Distance (ft):	116.7
Structural Grade:	0
O&M Grade:	0
Clock Start/From:	
Clock To:	
1st Value:	
2nd Value:	
Value Percent:	
Continuous Index:	
Within 8" of Joint:	NO
Remarks:	M-308-027
