Profile/Photo Observation Report

Street:	FOXCROFT STREET	Flow Control:	Not Controlled
City:	Hobart, IN	Year Renewed:	
Location:	Light Highway	Tape/Media #:	
Purpose:	Routine Assessment	Dia/Height:	8"
Use:	Sanitary	Material:	PVC
Drain Area:	NA	Lining:	
Category:	NA		
Comment:	Flow direction wrong

Location Details:		Direction of Survey:	Upstream
US MH:	M-308-027	DS MH:	M-308-028
		Total Length Surveyed (ft):	116.7

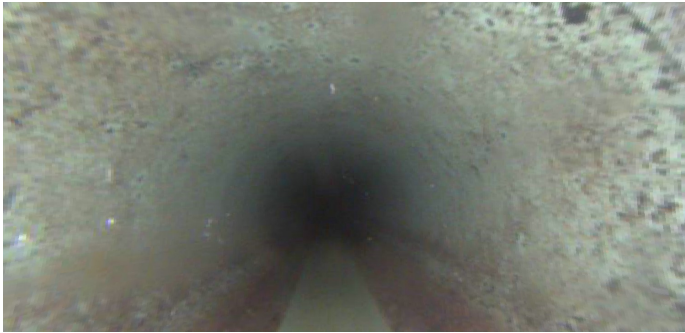
Code:	MWL
Description:	Water Level

Distance (ft):	.0
Structural Grade:	0
O&M Grade:	0
Clock Start/From:	
Clock To:	
1st Value:	
2nd Value:	
Value Percent:	5.000
Continuous Index:	
Within 8" of Joint:	NO
Remarks:

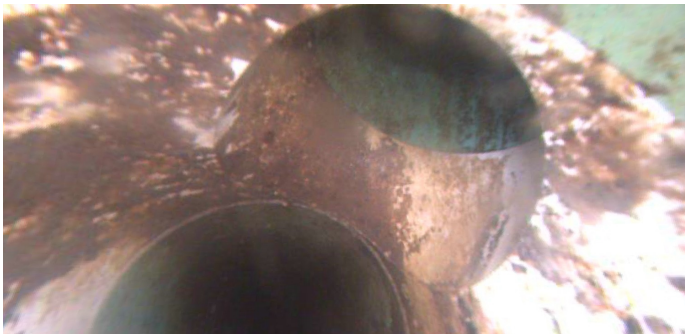
Code:	TF
Description:	Tap Factory

Distance (ft):	13.8
Structural Grade:	0
O&M Grade:	0
Clock Start/From:	2
Clock To:	
1st Value:	4.000
2nd Value:	
Value Percent:	
Continuous Index:	
Within 8" of Joint:	
Remarks:

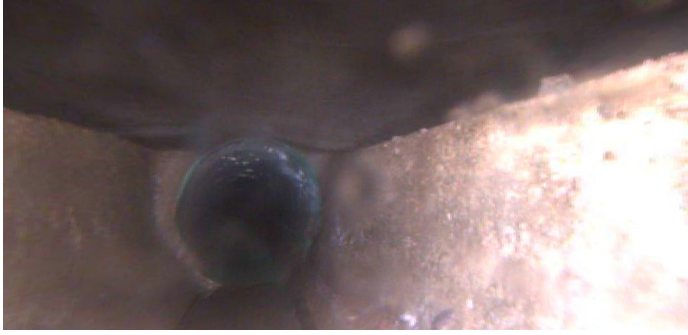
Code:	AMH
Description:	Manhole
Distance (ft):	116.7
Structural Grade:	0
O&M Grade:	0
Clock Start/From:	
Clock To:	
1st Value:	
2nd Value:	
Value Percent:	
Continuous Index:	
Within 8" of Joint:	NO
Remarks:	M-308-027
