Profile/Photo Observation Report

Street:	OFF W 61ST AVE	Flow Control:	Not Controlled
City:	Hobart, IN	Year Renewed:	
Location:	Light Highway	Tape/Media #:	
Purpose:	Routine Assessment	Dia/Height:	8"
Use:	Sanitary	Material:	PVC
Drain Area:	NA	Lining:	
Category:	NA		
Comment:	P_C at 363 ft nothing visible .Flow direction wrong		
Location Details:		Direction of Survey:	Downstream
US MH:	M-308-034	DS MH:	M-308-033
		Total Length Surveyed (ft):	364.7

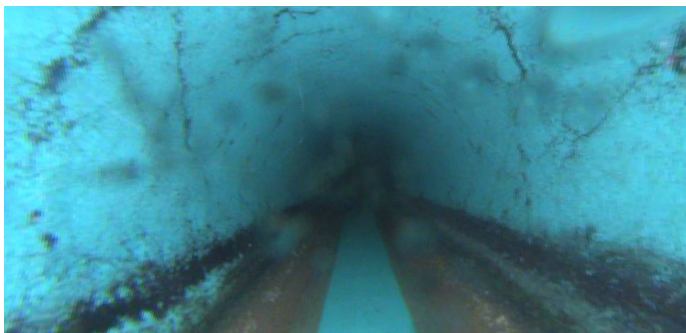
Code: **AMH**
Description: **Manhole**

Distance (ft): **.0**
Structural Grade: **0**
O&M Grade: **0**
Clock Start/From:
Clock To:
1st Value:
2nd Value:
Value Percent:
Continuous Index:
Within 8" of Joint: **NO**
Remarks: **M-308-034**

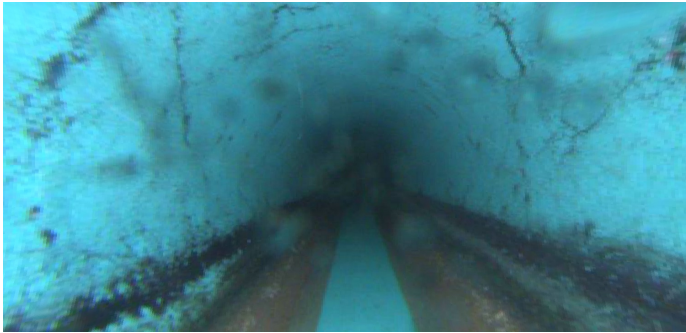
Code:	MWL
Description:	Water Level

Distance (ft):	.0
Structural Grade:	0
O&M Grade:	0
Clock Start/From:	
Clock To:	
1st Value:	
2nd Value:	
Value Percent:	5.000
Continuous Index:	
Within 8" of Joint:	NO
Remarks:

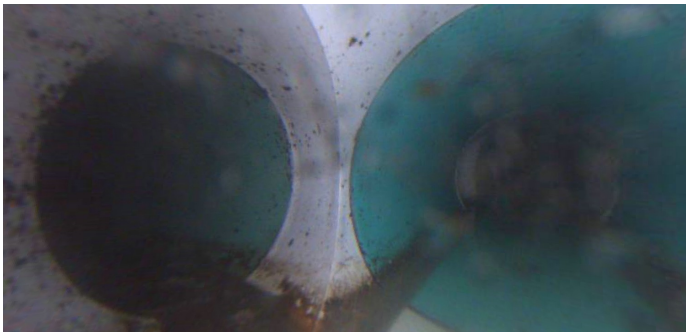
Code:	TFA
Description:	Tap Factory Active

Distance (ft):	66.5
Structural Grade:	0
O&M Grade:	0
Clock Start/From:	9
Clock To:	
1st Value:	4.000
2nd Value:	
Value Percent:	
Continuous Index:	
Within 8" of Joint:	
Remarks:

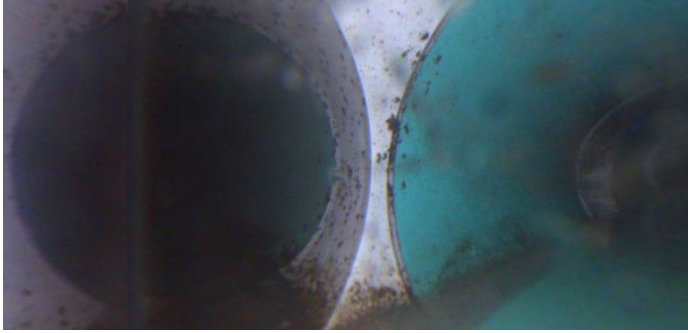
Code: **TFA**
Description: **Tap Factory Active**

Distance (ft): **68.4**
Structural Grade: **0**
O&M Grade: **0**
Clock Start/From: **9**
Clock To:
1st Value: **4.000**
2nd Value:
Value Percent:
Continuous Index:
Within 8" of Joint:
Remarks:

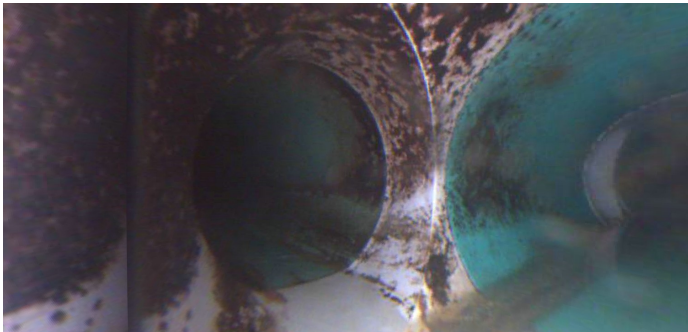
Code: **TFA**
Description: **Tap Factory Active**

Distance (ft): **70.0**
Structural Grade: **0**
O&M Grade: **0**
Clock Start/From: **9**
Clock To:
1st Value: **4.000**
2nd Value:
Value Percent:
Continuous Index:
Within 8" of Joint:
Remarks:

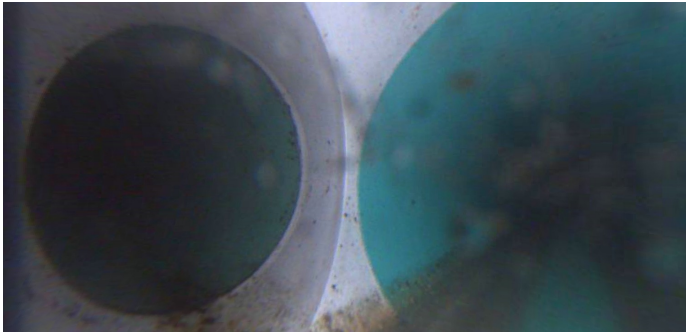
Code: **TF**
Description: **Tap Factory**

Distance (ft): **71.9**
Structural Grade: **0**
O&M Grade: **0**
Clock Start/From: **9**
Clock To:
1st Value: **4.000**
2nd Value:
Value Percent:
Continuous Index:
Within 8" of Joint:
Remarks:

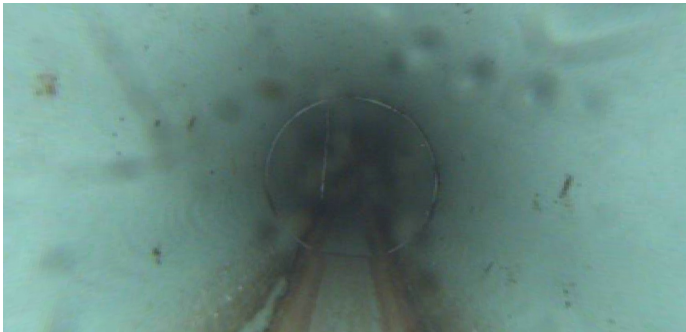
Code: **RFJ**
Description: **Roots Fine Joint**

Distance (ft): **174.9**
Structural Grade: **0**
O&M Grade: **1**
Clock Start/From: **11**
Clock To:
1st Value:
2nd Value:
Value Percent:
Continuous Index:
Within 8" of Joint: **YES**
Remarks:

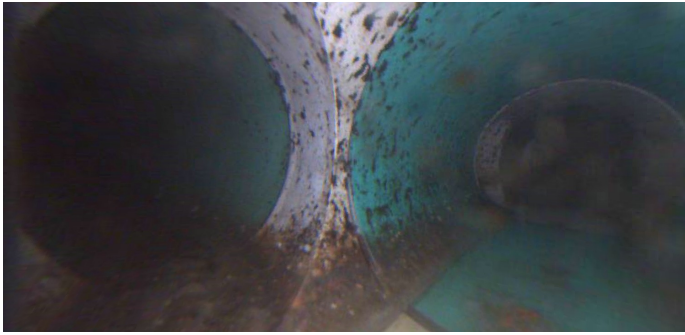
Code: **TFA**
Description: **Tap Factory Active**

Distance (ft): **187.2**
Structural Grade: **0**
O&M Grade: **0**
Clock Start/From: **9**
Clock To:
1st Value: **4.000**
2nd Value:
Value Percent:
Continuous Index:
Within 8" of Joint:
Remarks:

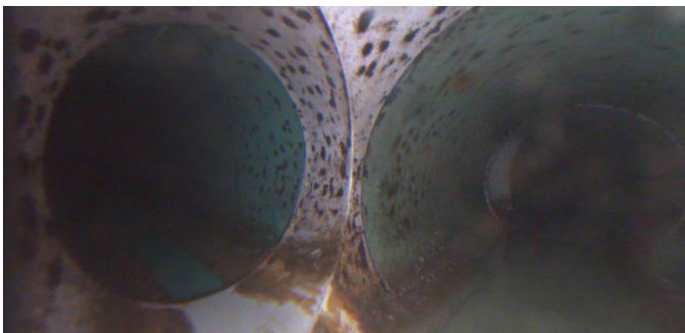
Code: **TFA**
Description: **Tap Factory Active**

Distance (ft): **188.8**
Structural Grade: **0**
O&M Grade: **0**
Clock Start/From: **9**
Clock To:
1st Value: **4.000**
2nd Value:
Value Percent:
Continuous Index:
Within 8" of Joint:
Remarks:

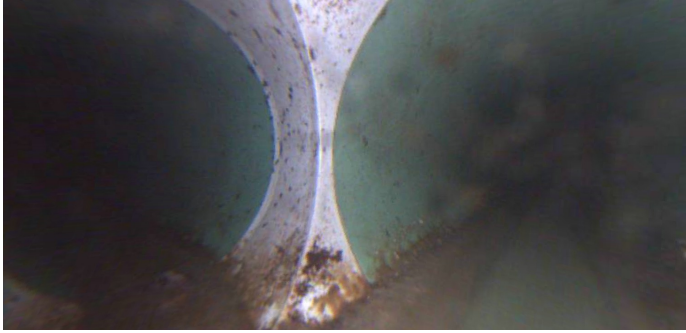
Code: **TFA**
Description: **Tap Factory Active**

Distance (ft): **190.6**
Structural Grade: **0**
O&M Grade: **0**
Clock Start/From: **9**
Clock To:
1st Value: **4.000**
2nd Value:
Value Percent:
Continuous Index:
Within 8" of Joint:
Remarks:

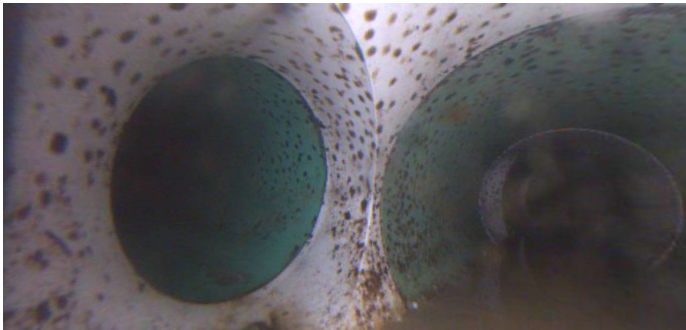
Code: **TF**
Description: **Tap Factory**

Distance (ft): **344.0**
Structural Grade: **0**
O&M Grade: **0**
Clock Start/From: **9**
Clock To:
1st Value: **4.000**
2nd Value:
Value Percent:
Continuous Index:
Within 8" of Joint:
Remarks:

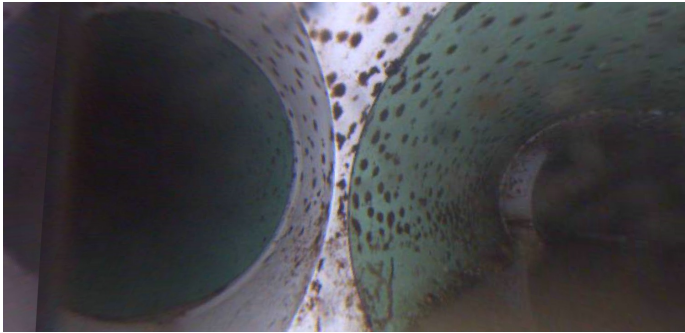
Code: **TF**
Description: **Tap Factory**

Distance (ft): **345.8**
Structural Grade: **0**
O&M Grade: **0**
Clock Start/From: **9**
Clock To:
1st Value: **4.000**
2nd Value:
Value Percent:
Continuous Index:
Within 8" of Joint:
Remarks:

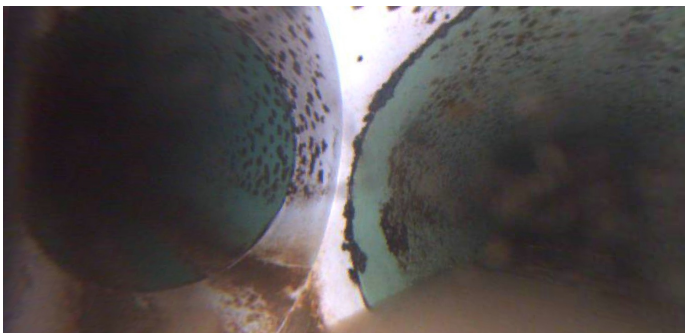
Code: **TF**
Description: **Tap Factory**

Distance (ft): **347.4**
Structural Grade: **0**
O&M Grade: **0**
Clock Start/From: **9**
Clock To:
1st Value: **4.000**
2nd Value:
Value Percent:
Continuous Index:
Within 8" of Joint:
Remarks:

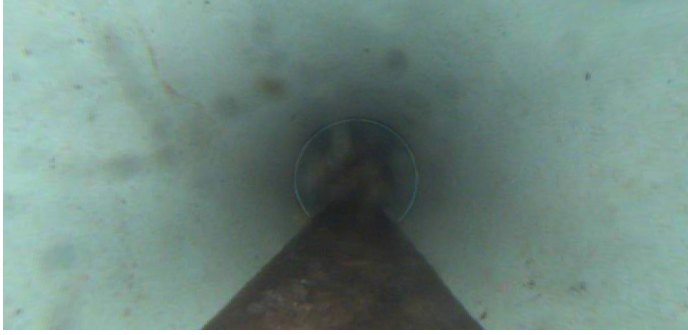
Code:	MSA
Description:	Abandoned Survey
Distance (ft):	364.7
Structural Grade:	0
O&M Grade:	0
Clock Start/From:	
Clock To:	
1st Value:	
2nd Value:	
Value Percent:	
Continuous Index:	
Within 8" of Joint:	NO
Remarks:	unknown
