Profile/Photo Observation Report

Street:	FOXCROFT STREET	Flow Control:	Not Controlled
City:	Hobart, IN	Year Renewed:	
Location:	Light Highway	Tape/Media #:	
Purpose:	Routine Assessment	Dia/Height:	8"
Use:	Sanitary	Material:	PVC
Drain Area:	NA	Lining:	
Category:	NA		
Comment:	P_C at 363 ft nothing visible .Flow direction wrong		
Location Details:		Direction of Survey:	Downstream
US MH:	M-308-034	DS MH:	M-308-033
		Total Length Surveyed (ft):	364.7

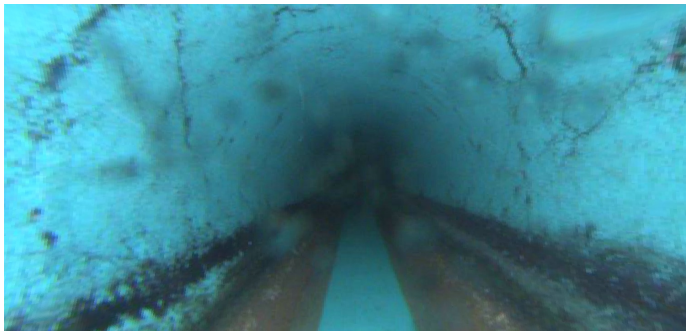
Code: **AMH**
Description: **Manhole**

Distance (ft): **.0**
Structural Grade: **0**
O&M Grade: **0**
Clock Start/From:
Clock To:
1st Value:
2nd Value:
Value Percent:
Continuous Index:
Within 8" of Joint: **NO**
Remarks: **M-308-034**

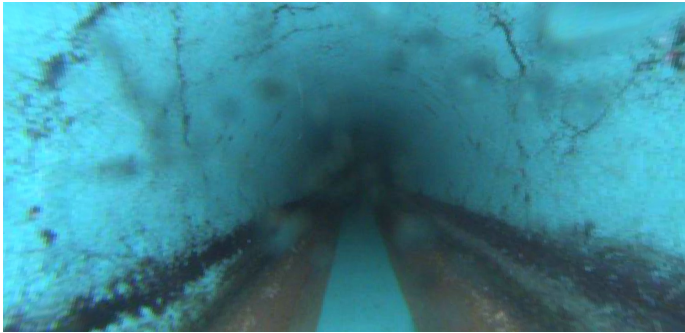
Code:	MWL
Description:	Water Level

Distance (ft):	.0
Structural Grade:	0
O&M Grade:	0
Clock Start/From:	
Clock To:	
1st Value:	
2nd Value:	
Value Percent:	5.000
Continuous Index:	
Within 8" of Joint:	NO
Remarks:

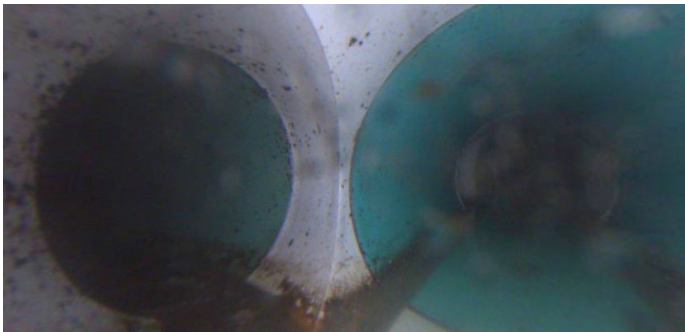
Code:	TFA
Description:	Tap Factory Active

Distance (ft):	66.5
Structural Grade:	0
O&M Grade:	0
Clock Start/From:	9
Clock To:	
1st Value:	4.000
2nd Value:	
Value Percent:	
Continuous Index:	
Within 8" of Joint:	
Remarks:

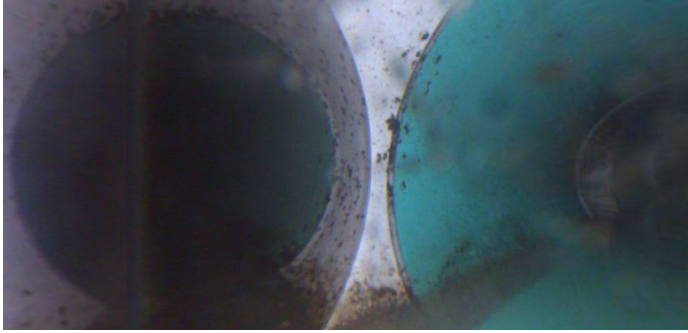
Code: **TFA**
Description: **Tap Factory Active**

Distance (ft): **68.4**
Structural Grade: **0**
O&M Grade: **0**
Clock Start/From: **9**
Clock To:
1st Value: **4.000**
2nd Value:
Value Percent:
Continuous Index:
Within 8" of Joint:
Remarks:

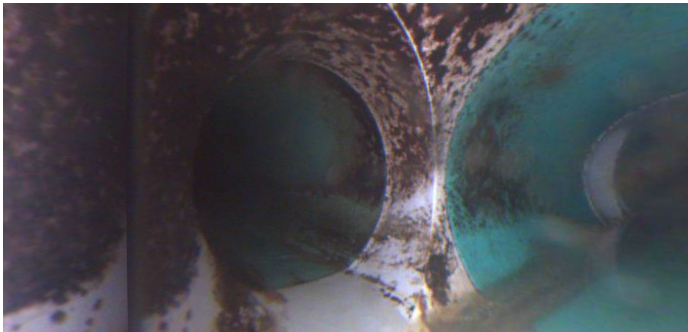
Code: **TFA**
Description: **Tap Factory Active**

Distance (ft): **70.0**
Structural Grade: **0**
O&M Grade: **0**
Clock Start/From: **9**
Clock To:
1st Value: **4.000**
2nd Value:
Value Percent:
Continuous Index:
Within 8" of Joint:
Remarks:

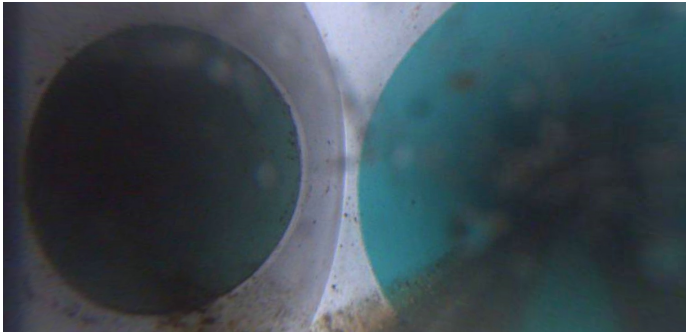
Code: **TF**
Description: **Tap Factory**

Distance (ft): **71.9**
Structural Grade: **0**
O&M Grade: **0**
Clock Start/From: **9**
Clock To:
1st Value: **4.000**
2nd Value:
Value Percent:
Continuous Index:
Within 8" of Joint:
Remarks:

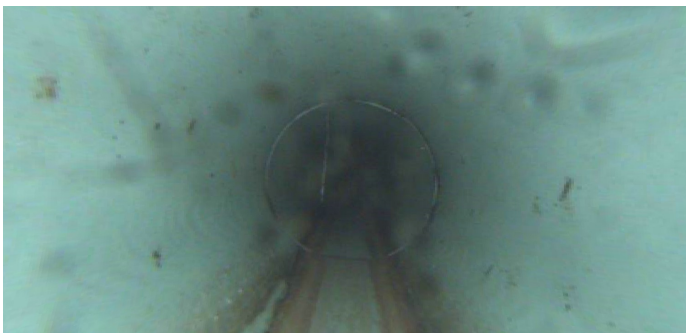
Code: **RFJ**
Description: **Roots Fine Joint**

Distance (ft): **174.9**
Structural Grade: **0**
O&M Grade: **1**
Clock Start/From: **11**
Clock To:
1st Value:
2nd Value:
Value Percent:
Continuous Index:
Within 8" of Joint: **YES**
Remarks:

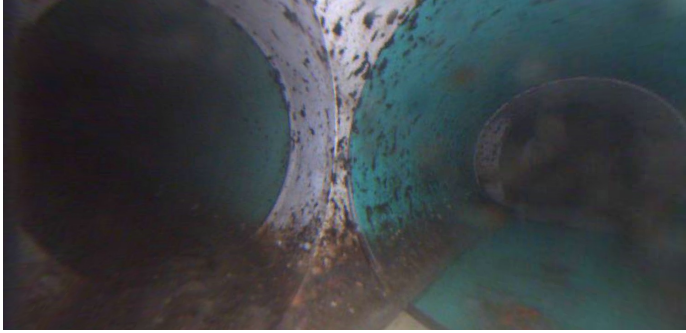
Code: **TFA**
Description: **Tap Factory Active**

Distance (ft): **187.2**
Structural Grade: **0**
O&M Grade: **0**
Clock Start/From: **9**
Clock To:
1st Value: **4.000**
2nd Value:
Value Percent:
Continuous Index:
Within 8" of Joint:
Remarks:

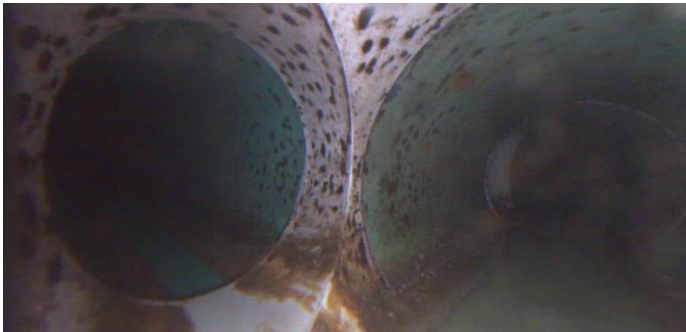
Code: **TFA**
Description: **Tap Factory Active**

Distance (ft): **188.8**
Structural Grade: **0**
O&M Grade: **0**
Clock Start/From: **9**
Clock To:
1st Value: **4.000**
2nd Value:
Value Percent:
Continuous Index:
Within 8" of Joint:
Remarks:

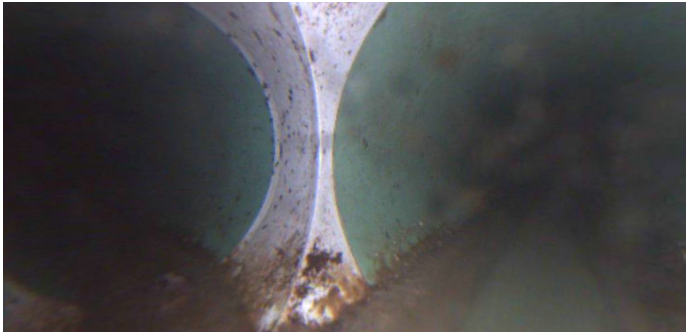
Code: **TFA**
Description: **Tap Factory Active**

Distance (ft): **190.6**
Structural Grade: **0**
O&M Grade: **0**
Clock Start/From: **9**
Clock To:
1st Value: **4.000**
2nd Value:
Value Percent:
Continuous Index:
Within 8" of Joint:
Remarks:

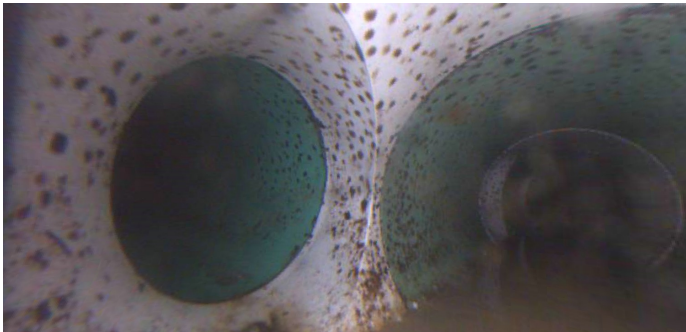
Code: **TF**
Description: **Tap Factory**

Distance (ft): **344.0**
Structural Grade: **0**
O&M Grade: **0**
Clock Start/From: **9**
Clock To:
1st Value: **4.000**
2nd Value:
Value Percent:
Continuous Index:
Within 8" of Joint:
Remarks:

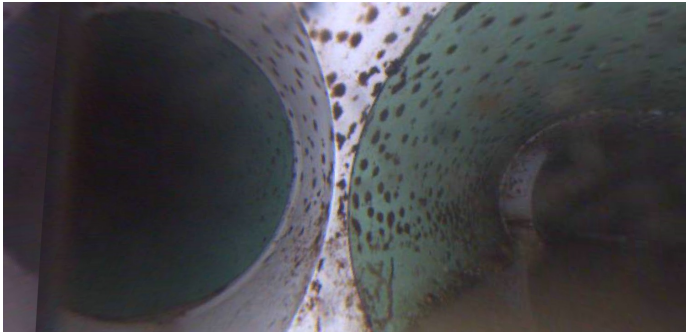
Code: **TF**
Description: **Tap Factory**

Distance (ft): **345.8**
Structural Grade: **0**
O&M Grade: **0**
Clock Start/From: **9**
Clock To:
1st Value: **4.000**
2nd Value:
Value Percent:
Continuous Index:
Within 8" of Joint:
Remarks:

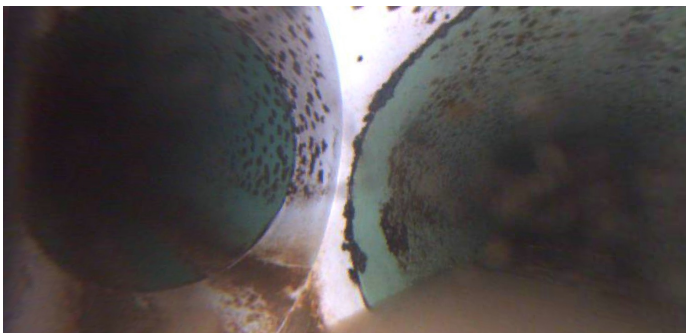
Code: **TF**
Description: **Tap Factory**

Distance (ft): **347.4**
Structural Grade: **0**
O&M Grade: **0**
Clock Start/From: **9**
Clock To:
1st Value: **4.000**
2nd Value:
Value Percent:
Continuous Index:
Within 8" of Joint:
Remarks:

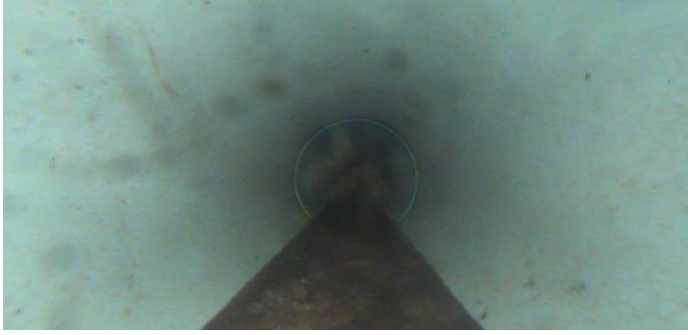
Code:	MSA
Description:	Abandoned Survey
Distance (ft):	364.7
Structural Grade:	0
O&M Grade:	0
Clock Start/From:	
Clock To:	
1st Value:	
2nd Value:	
Value Percent:	
Continuous Index:	
Within 8" of Joint:	NO
Remarks:	unknown
