Profile/Photo Observation Report

Street:	OFF W 61ST AVE	Flow Control:	Not Controlled
City:	Hobart, IN	Year Renewed:	
Location:	Light Highway	Tape/Media #:	
Purpose:	Routine Assessment	Dia/Height:	8"
Use:	Sanitary	Material:	PVC
Drain Area:	NA	Lining:	
Category:	NA		
Comment:	P_C at 364 ft nothing visible . Flow direction wrong		
Location Details:		Direction of Survey:	Upstream
US MH:	M-308-034	DS MH:	M-308-033
		Total Length Surveyed (ft):	365.1

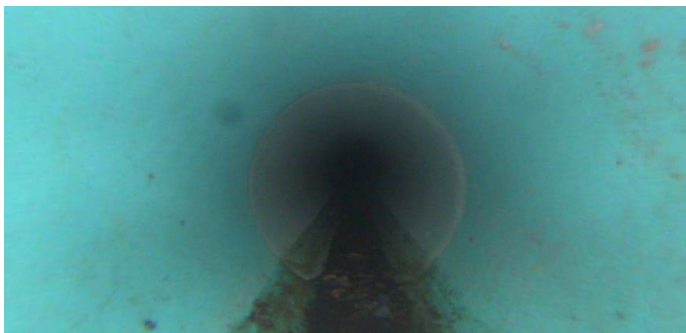
Code: **AMH**
Description: **Manhole**

Distance (ft): **.0**
Structural Grade: **0**
O&M Grade: **0**
Clock Start/From:
Clock To:
1st Value:
2nd Value:
Value Percent:
Continuous Index:
Within 8" of Joint: **NO**
Remarks: **M-308-033**

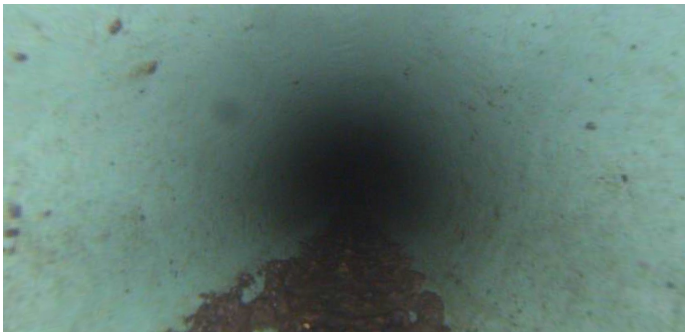
Code:	DSF
Description:	Deposits Settled Fine

Distance (ft):	4.9
Structural Grade:	0
O&M Grade:	2
Clock Start/From:	6
Clock To:	
1st Value:	
2nd Value:	
Value Percent:	5.000
Continuous Index:	
Within 8" of Joint:	NO
Remarks:

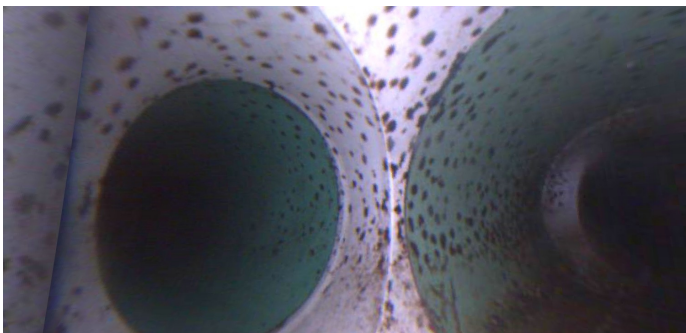
Code: **TF**
Description: **Tap Factory**

Distance (ft): **23.2**
Structural Grade: **0**
O&M Grade: **0**
Clock Start/From: **3**
Clock To:
1st Value: **4.000**
2nd Value:
Value Percent:
Continuous Index:
Within 8" of Joint:
Remarks:

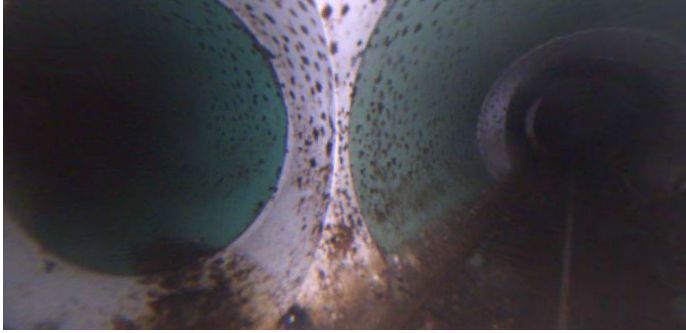
Code: **TF**
Description: **Tap Factory**

Distance (ft): **24.8**
Structural Grade: **0**
O&M Grade: **0**
Clock Start/From: **3**
Clock To:
1st Value: **4.000**
2nd Value:
Value Percent:
Continuous Index:
Within 8" of Joint:
Remarks:

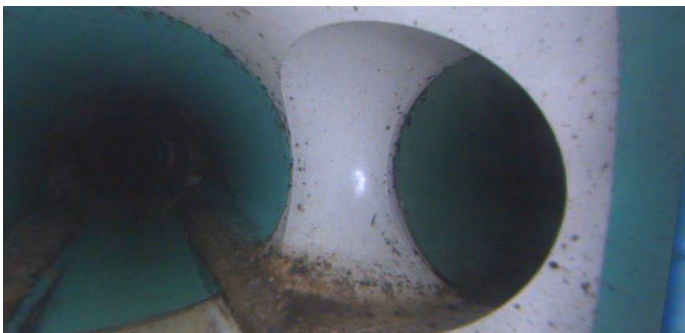
Code: **TF**
Description: **Tap Factory**

Distance (ft): **296.9**
Structural Grade: **0**
O&M Grade: **0**
Clock Start/From: **3**
Clock To:
1st Value: **4.000**
2nd Value:
Value Percent:
Continuous Index:
Within 8" of Joint:
Remarks:

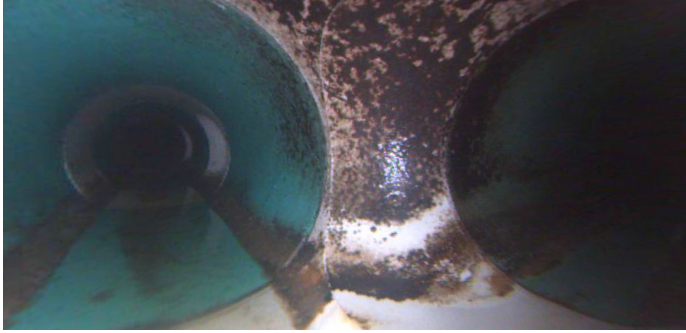
Code: **TF**
Description: **Tap Factory**

Distance (ft): **298.7**
Structural Grade: **0**
O&M Grade: **0**
Clock Start/From: **3**
Clock To:
1st Value: **4.000**
2nd Value:
Value Percent:
Continuous Index:
Within 8" of Joint:
Remarks:

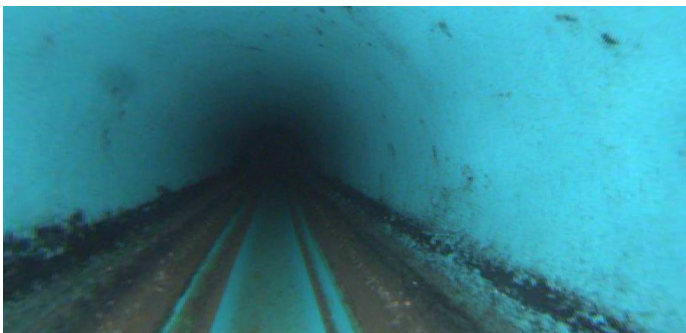
Code: **MSA**
Description: **Abandoned Survey**

Distance (ft): **365.1**
Structural Grade: **0**
O&M Grade: **0**
Clock Start/From:
Clock To:
1st Value:
2nd Value:
Value Percent:
Continuous Index:
Within 8" of Joint: **NO**
Remarks: **CAMERA STOPPED**
