## Profile/Photo Observation Report

Date:	<b>03/22/2018</b>	Weather:		Coding:	<b>PACP 6.0</b>
Pipe Length (ft):	<b>372.7</b>	Owner:	<b>NA</b>	Pre Clean:	<b>No Pre-Cleaning</b>
P.O.#:		Surveyor:	<b>Selasie Honu</b>	PSR:	<b>P-308-033-034</b>
Customer:		Clean Date:	<b>01/01/1900</b>	Shape:	<b>C</b>

Street:	<b>FOXCROFT STREET</b>	Flow Control:	<b>Not Controlled</b>
City:	<b>Hobart, IN</b>	Year Renewed:	
Location:	<b>Light Highway</b>	Tape/Media #:	
Purpose:	<b>Routine Assessment</b>	Dia/Height:	<b>8"</b>
Use:	<b>Sanitary</b>	Material:	<b>PVC</b>
Drain Area:	<b>NA</b>	Lining:	
Category:	<b>NA</b>		
Comment:	<b>P_C at 364 ft nothing visible . Flow direction wrong</b>		
Location Details:		Direction of Survey:	<b>Upstream</b>
US MH:	<b>M-308-034</b>	DS MH:	<b>M-308-033</b>
		Total Length Surveyed (ft):	<b>365.1</b>

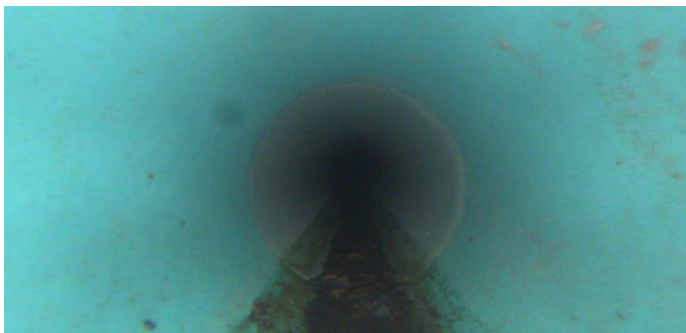
Code: **AMH**  
Description: **Manhole**

Distance (ft): **.0**  
Structural Grade: **0**  
O&M Grade: **0**  
Clock Start/From:  
Clock To:  
1st Value:  
2nd Value:  
Value Percent:  
Continuous Index:  
Within 8" of Joint: **NO**  
Remarks: **M-308-033**

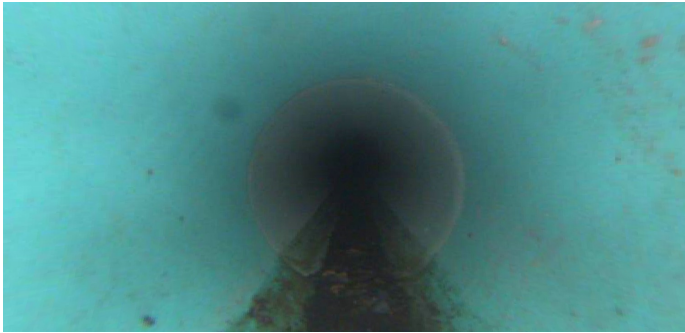
Code:	<b>MWL</b>
Description:	<b>Water Level</b>

Distance (ft):	<b>.0</b>
Structural Grade:	<b>0</b>
O&M Grade:	<b>0</b>
Clock Start/From:	
Clock To:	
1st Value:	
2nd Value:	
Value Percent:	<b>5.000</b>
Continuous Index:	
Within 8" of Joint:	<b>NO</b>
Remarks:

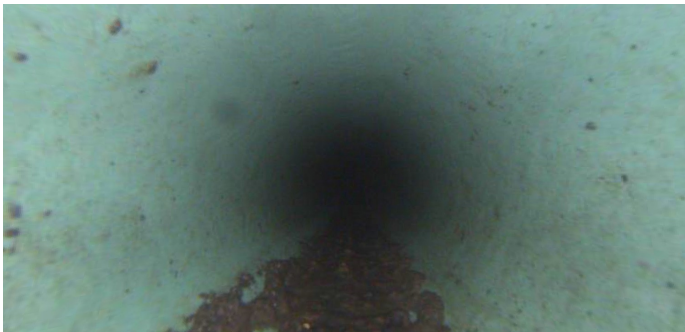
Code:	<b>DSF</b>
Description:	<b>Deposits Settled Fine</b>

Distance (ft):	<b>4.9</b>
Structural Grade:	<b>0</b>
O&M Grade:	<b>2</b>
Clock Start/From:	<b>6</b>
Clock To:	
1st Value:	
2nd Value:	
Value Percent:	<b>5.000</b>
Continuous Index:	
Within 8" of Joint:	<b>NO</b>
Remarks:

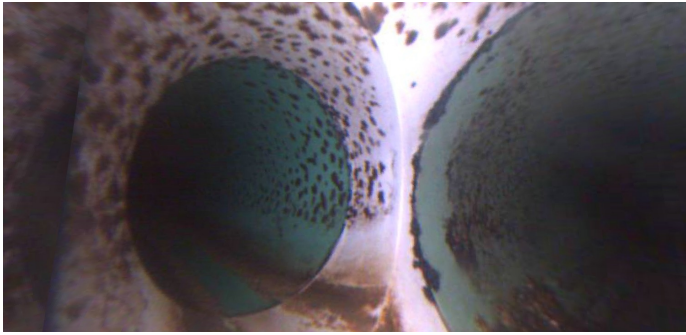
Code: **TF**  
Description: **Tap Factory**

Distance (ft): **21.6**  
Structural Grade: **0**  
O&M Grade: **0**  
Clock Start/From: **3**  
Clock To:  
1st Value: **4.000**  
2nd Value:  
Value Percent:  
Continuous Index:  
Within 8" of Joint:  
Remarks:

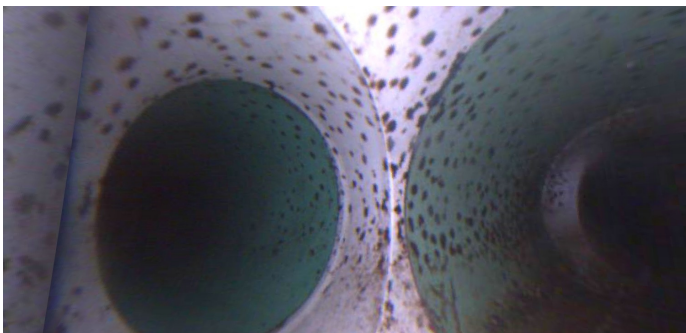
Code: **TF**  
Description: **Tap Factory**

Distance (ft): **23.2**  
Structural Grade: **0**  
O&M Grade: **0**  
Clock Start/From: **3**  
Clock To:  
1st Value: **4.000**  
2nd Value:  
Value Percent:  
Continuous Index:  
Within 8" of Joint:  
Remarks:

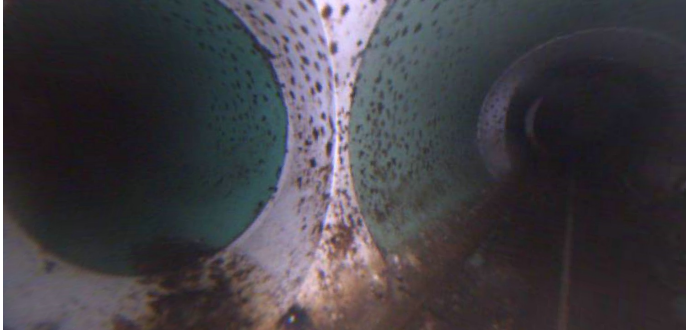
Code: **TF**  
Description: **Tap Factory**

Distance (ft): **24.8**  
Structural Grade: **0**  
O&M Grade: **0**  
Clock Start/From: **3**  
Clock To:  
1st Value: **4.000**  
2nd Value:  
Value Percent:  
Continuous Index:  
Within 8" of Joint:  
Remarks:

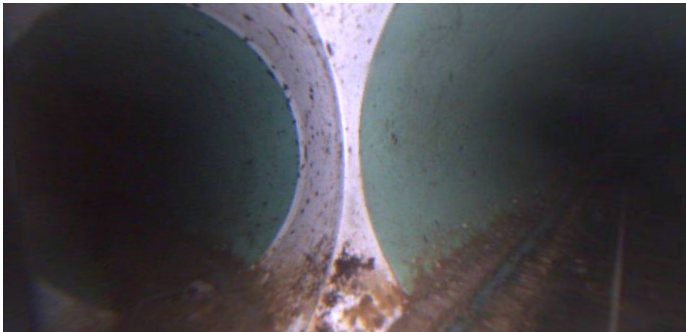
Code: **TFA**  
Description: **Tap Factory Active**

Distance (ft): **178.2**  
Structural Grade: **0**  
O&M Grade: **0**  
Clock Start/From: **3**  
Clock To:  
1st Value: **4.000**  
2nd Value:  
Value Percent:  
Continuous Index:  
Within 8" of Joint:  
Remarks:

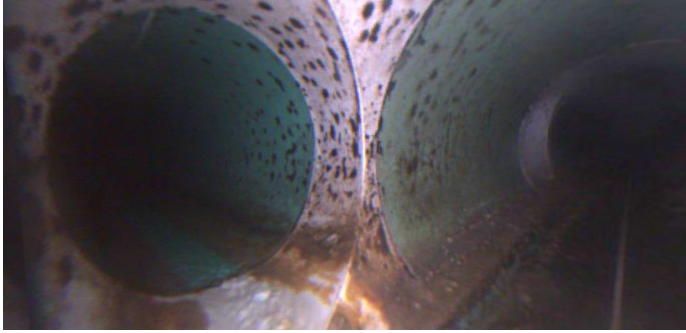
Code: **TFA**  
Description: **Tap Factory Active**

Distance (ft): **180.0**  
Structural Grade: **0**  
O&M Grade: **0**  
Clock Start/From: **3**  
Clock To:  
1st Value: **4.000**  
2nd Value:  
Value Percent:  
Continuous Index:  
Within 8" of Joint:  
Remarks:

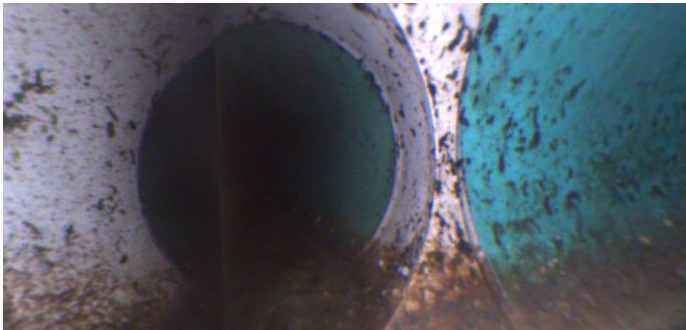
Code: **TFA**  
Description: **Tap Factory Active**

Distance (ft): **181.5**  
Structural Grade: **0**  
O&M Grade: **0**  
Clock Start/From: **3**  
Clock To:  
1st Value: **4.000**  
2nd Value:  
Value Percent:  
Continuous Index:  
Within 8" of Joint:  
Remarks:

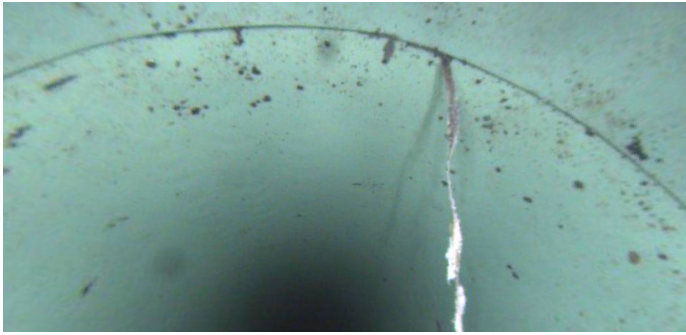
Code: **RFJ**  
Description: **Roots Fine Joint**

Distance (ft): **192.6**  
Structural Grade: **0**  
O&M Grade: **1**  
Clock Start/From: **1**  
Clock To:  
1st Value:  
2nd Value:  
Value Percent:  
Continuous Index:  
Within 8" of Joint: **YES**  
Remarks:

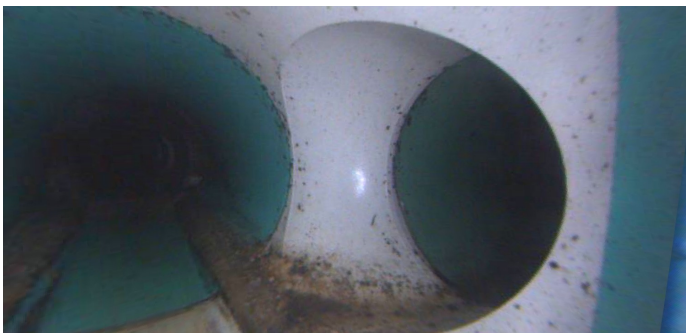
Code: **TF**  
Description: **Tap Factory**

Distance (ft): **296.9**  
Structural Grade: **0**  
O&M Grade: **0**  
Clock Start/From: **3**  
Clock To:  
1st Value: **4.000**  
2nd Value:  
Value Percent:  
Continuous Index:  
Within 8" of Joint:  
Remarks:

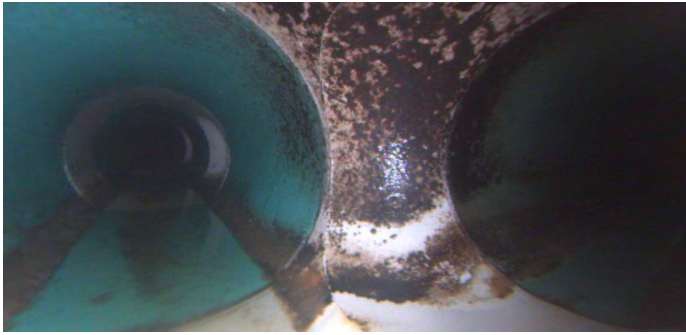
Code: **TF**  
Description: **Tap Factory**

Distance (ft): **298.7**  
Structural Grade: **0**  
O&M Grade: **0**  
Clock Start/From: **3**  
Clock To:  
1st Value: **4.000**  
2nd Value:  
Value Percent:  
Continuous Index:  
Within 8" of Joint:  
Remarks:

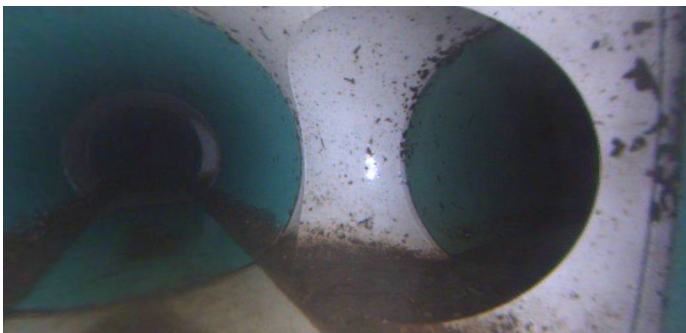
Code: **TFA**  
Description: **Tap Factory Active**

Distance (ft): **300.4**  
Structural Grade: **0**  
O&M Grade: **0**  
Clock Start/From: **3**  
Clock To:  
1st Value: **4.000**  
2nd Value:  
Value Percent:  
Continuous Index:  
Within 8" of Joint:  
Remarks:

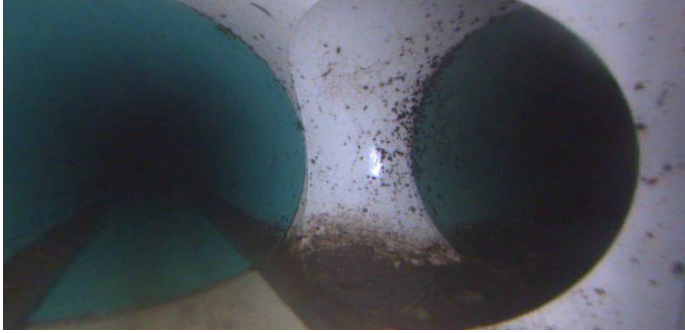
Code: **TFA**  
Description: **Tap Factory Active**

Distance (ft): **302.1**  
Structural Grade: **0**  
O&M Grade: **0**  
Clock Start/From: **3**  
Clock To:  
1st Value: **4.000**  
2nd Value:  
Value Percent:  
Continuous Index:  
Within 8" of Joint:  
Remarks:

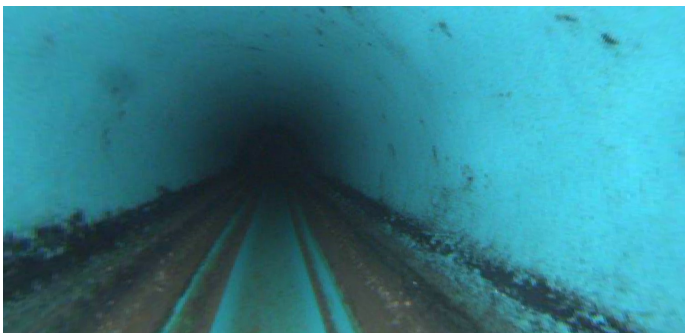
Code: **MSA**  
Description: **Abandoned Survey**

Distance (ft): **365.1**  
Structural Grade: **0**  
O&M Grade: **0**  
Clock Start/From:  
Clock To:  
1st Value:  
2nd Value:  
Value Percent:  
Continuous Index:  
Within 8" of Joint: **NO**  
Remarks: **CAMERA STOPPED**
