Profile/Photo Observation Report

Date:	03/22/2018	Weather:		Coding:	PACP 6.0
Pipe Length (ft):	258.6	Owner:	NA	Pre Clean:	No Pre-Cleaning
P.O.#:		Surveyor:	Selasie Honu	PSR:	P-308-034-035
Customer:		Clean Date:	01/01/1900	Shape:	C

Street:	FOXCROFT STREET	Flow Control:	Not Controlled
City:	Hobart, IN	Year Renewed:	
Location:	Light Highway	Tape/Media #:	
Purpose:	Routine Assessment	Dia/Height:	8"
Use:	Sanitary	Material:	PVC
Drain Area:	NA	Lining:	
Category:	NA		
Comment:	Flow direction wrong		
Location Details:		Direction of Survey:	Upstream
US MH:	M-308-035	DS MH:	M-308-034
		Total Length Surveyed (ft):	244.2

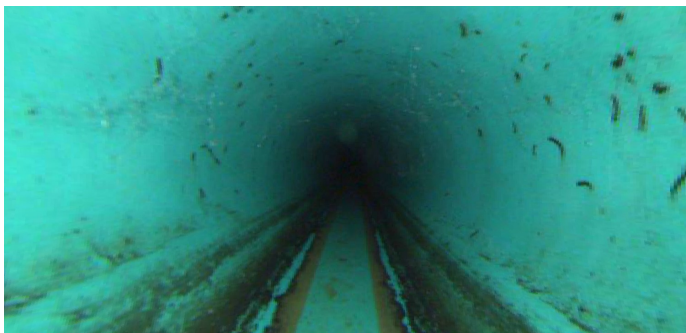
Code: **AMH**
Description: **Manhole**

Distance (ft): **.0**
Structural Grade: **0**
O&M Grade: **0**
Clock Start/From:
Clock To:
1st Value:
2nd Value:
Value Percent:
Continuous Index:
Within 8" of Joint: **NO**
Remarks: **M-308-034**

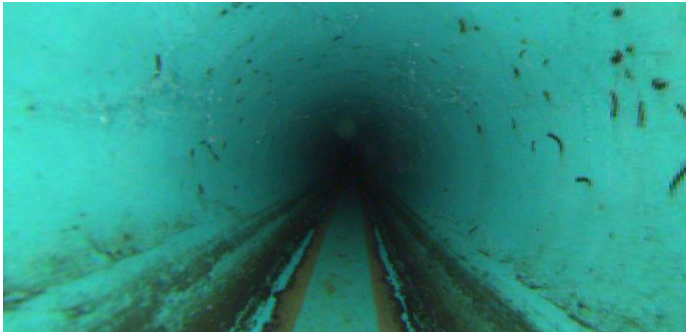
Code: **MWL**
Description: **Water Level**

Distance (ft): **.0**
Structural Grade: **0**
O&M Grade: **0**
Clock Start/From:
Clock To:
1st Value:
2nd Value:
Value Percent: **5.000**
Continuous Index:
Within 8" of Joint: **NO**
Remarks:

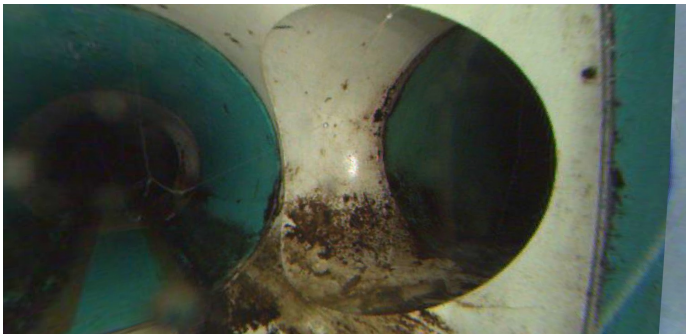
Code: **TF**
Description: **Tap Factory**

Distance (ft): **50.5**
Structural Grade: **0**
O&M Grade: **0**
Clock Start/From: **3**
Clock To:
1st Value: **4.000**
2nd Value:
Value Percent:
Continuous Index:
Within 8" of Joint:
Remarks:

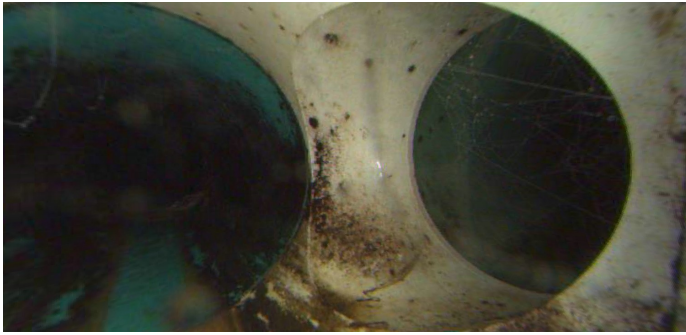
Code: **TF**
Description: **Tap Factory**

Distance (ft): **52.1**
Structural Grade: **0**
O&M Grade: **0**
Clock Start/From: **3**
Clock To:
1st Value: **4.000**
2nd Value:
Value Percent:
Continuous Index:
Within 8" of Joint:
Remarks:

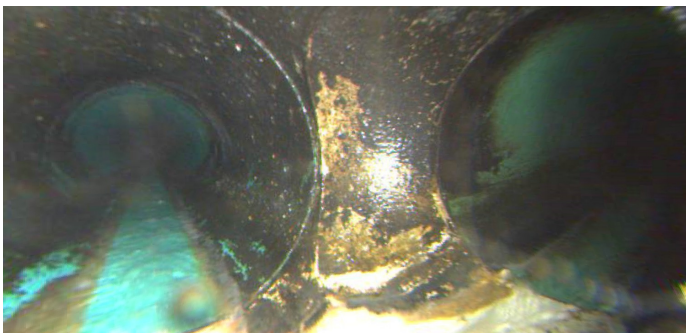
Code: **TFA**
Description: **Tap Factory Active**

Distance (ft): **53.8**
Structural Grade: **0**
O&M Grade: **0**
Clock Start/From: **3**
Clock To:
1st Value: **4.000**
2nd Value:
Value Percent:
Continuous Index:
Within 8" of Joint:
Remarks:

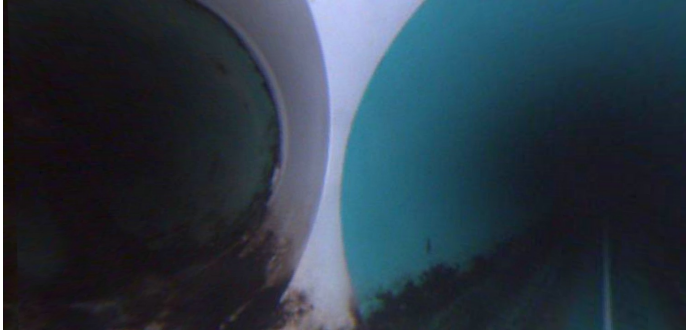
Code: **TF**
Description: **Tap Factory**

Distance (ft): **164.8**
Structural Grade: **0**
O&M Grade: **0**
Clock Start/From: **3**
Clock To:
1st Value: **4.000**
2nd Value:
Value Percent:
Continuous Index:
Within 8" of Joint:
Remarks:

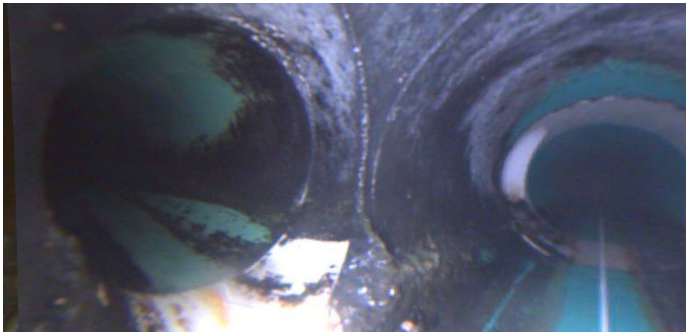
Code: **TFA**
Description: **Tap Factory Active**

Distance (ft): **166.5**
Structural Grade: **0**
O&M Grade: **0**
Clock Start/From: **3**
Clock To:
1st Value: **4.000**
2nd Value:
Value Percent:
Continuous Index:
Within 8" of Joint:
Remarks:

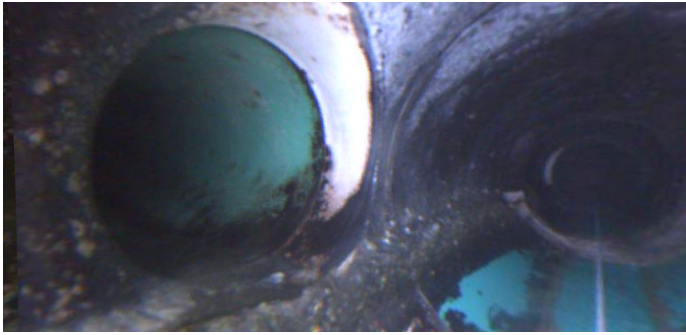
Code: **TF**
Description: **Tap Factory**

Distance (ft): **168.2**
Structural Grade: **0**
O&M Grade: **0**
Clock Start/From: **3**
Clock To:
1st Value: **4.000**
2nd Value:
Value Percent:
Continuous Index:
Within 8" of Joint:
Remarks:

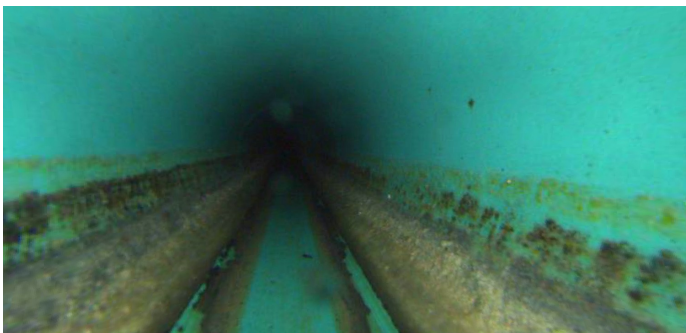
Code: **DAGS**
Description: **Deposits Attached Grease**

Distance (ft): **228.1**
Structural Grade: **0**
O&M Grade: **2**
Clock Start/From: **7**
Clock To: **5**
1st Value:
2nd Value:
Value Percent: **5.000**
Continuous Index: **S01**
Within 8" of Joint: **NO**
Remarks:

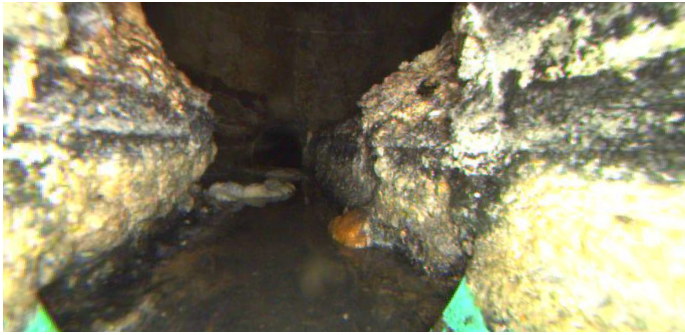
Code: **DAGS**
Description: **Deposits Attached Grease**

Distance (ft): **242.0**
Structural Grade: **0**
O&M Grade: **2**
Clock Start/From: **7**
Clock To: **5**
1st Value:
2nd Value:
Value Percent: **5.000**
Continuous Index: **F01**
Within 8" of Joint: **NO**
Remarks:

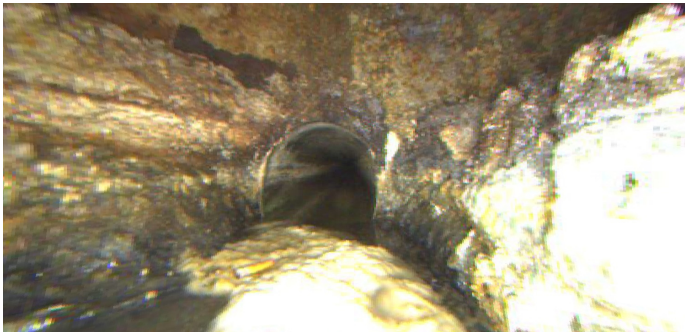
Code: **AMH**
Description: **Manhole**

Distance (ft): **244.2**
Structural Grade: **0**
O&M Grade: **0**
Clock Start/From:
Clock To:
1st Value:
2nd Value:
Value Percent:
Continuous Index:
Within 8" of Joint: **NO**
Remarks: **M-308-035**
