Profile/Photo Observation Report

Street:	GILL ST	Flow Control:	Not Controlled
City:	Hobart, IN	Year Renewed:	
Location:	Other	Tape/Media #:	
Purpose:	Not Known	Dia/Height:	10"
Use:	Sanitary	Material:	VCP
Drain Area:	NA	Lining:	
Category:	NA		
Comment:

Location Details:		Direction of Survey:	Downstream
US MH:	M-403-002	DS MH:	M-403-001
		Total Length Surveyed (ft):	112.4

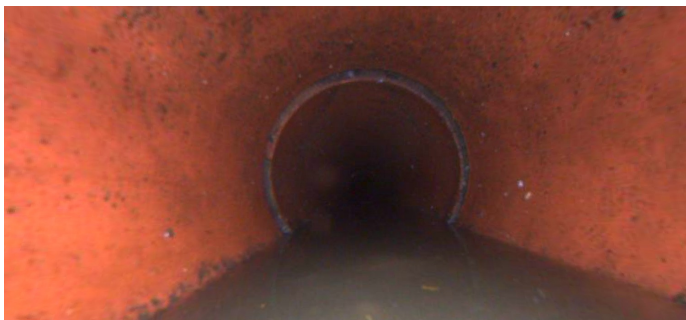
Code: **AMH**
Description: **Manhole**

Distance (ft): **.0**
Structural Grade: **0**
O&M Grade: **0**
Clock Start/From:
Clock To:
1st Value:
2nd Value:
Value Percent:
Continuous Index:
Within 8" of Joint: **NO**
Remarks: **M-403-002**

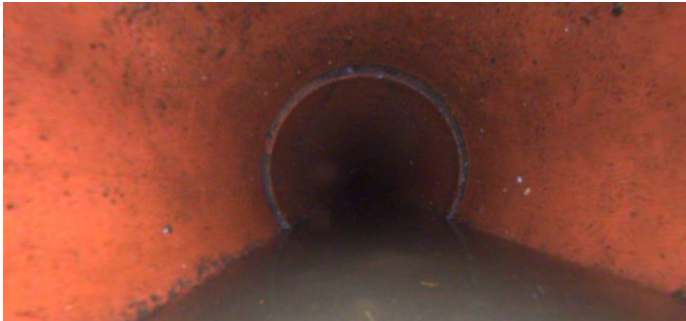
Code: **MWL**
Description: **Water Level**

Distance (ft): **.0**
Structural Grade: **0**
O&M Grade: **0**
Clock Start/From:
Clock To:
1st Value:
2nd Value:
Value Percent: **20.000**
Continuous Index:
Within 8" of Joint: **NO**
Remarks:

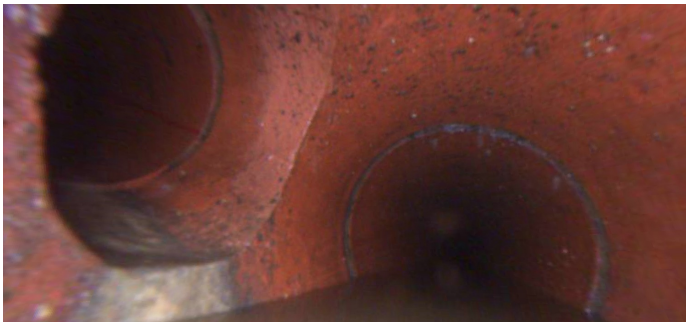
Code: **TFA**
Description: **Tap Factory Active**

Distance (ft): **23.4**
Structural Grade: **0**
O&M Grade: **0**
Clock Start/From: **9**
Clock To:
1st Value: **4.000**
2nd Value:
Value Percent:
Continuous Index:
Within 8" of Joint:
Remarks:

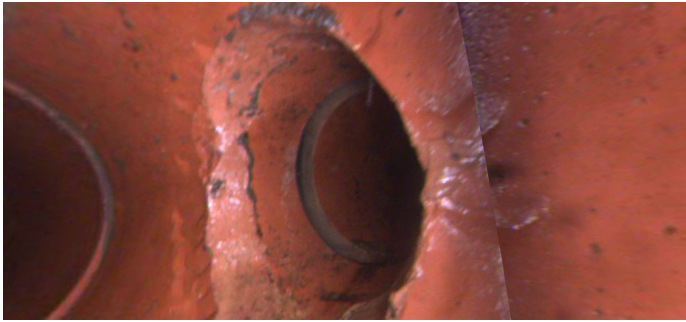
Code: **TF**
Description: **Tap Factory**

Distance (ft): **40.3**
Structural Grade: **0**
O&M Grade: **0**
Clock Start/From: **3**
Clock To:
1st Value: **4.000**
2nd Value:
Value Percent:
Continuous Index:
Within 8" of Joint:
Remarks:

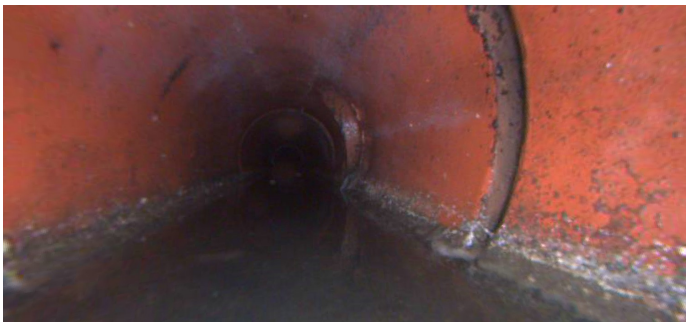
Code: **MSA**
Description: **Abandoned Survey**

Distance (ft): **112.4**
Structural Grade: **0**
O&M Grade: **0**
Clock Start/From:
Clock To:
1st Value:
2nd Value:
Value Percent:
Continuous Index:
Within 8" of Joint: **NO**
Remarks: **DEBRIS UNDER WATER**
