Profile/Photo Observation Report

Street:	W 38TH AVE & GILL ST	Flow Control:	Not Controlled
City:	Hobart, IN	Year Renewed:	
Location:	Light Highway	Tape/Media #:	
Purpose:	Routine Assessment	Dia/Height:	10"
Use:	Sanitary	Material:	VCP
Drain Area:	NA	Lining:	
Category:	NA		
Comment:

Location Details:		Direction of Survey:	Downstream
US MH:	M-403-002	DS MH:	M-403-001
		Total Length Surveyed (ft):	151.1

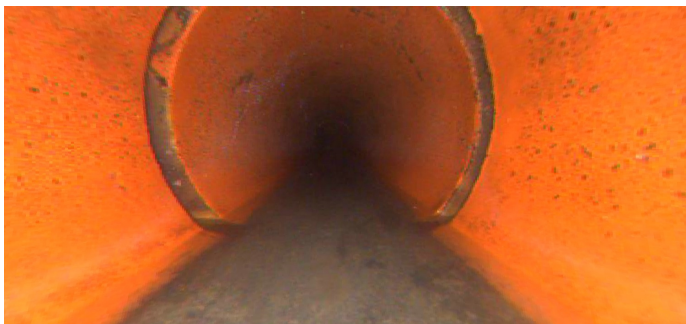
Code: **AMH**
Description: **Manhole**

Distance (ft): **.0**
Structural Grade: **0**
O&M Grade: **0**
Clock Start/From:
Clock To:
1st Value:
2nd Value:
Value Percent:
Continuous Index:
Within 8" of Joint: **NO**
Remarks: **M-403-002**

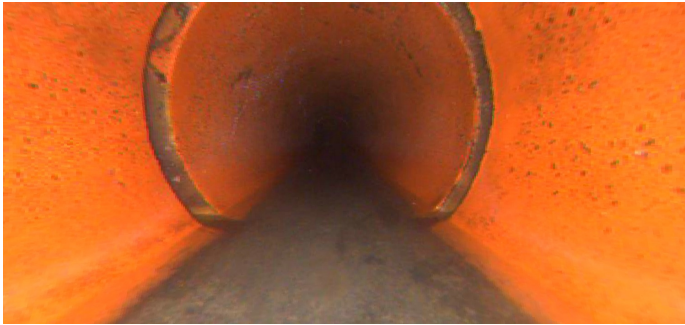
Code:	MWL
Description:	Water Level

Distance (ft):	.0
Structural Grade:	0
O&M Grade:	0
Clock Start/From:	
Clock To:	
1st Value:	
2nd Value:	
Value Percent:	5.000
Continuous Index:	
Within 8" of Joint:	NO
Remarks:

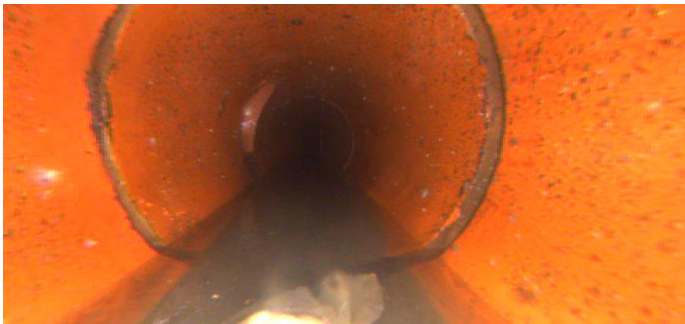
Code:	TF
Description:	Tap Factory

Distance (ft):	21.7
Structural Grade:	0
O&M Grade:	0
Clock Start/From:	9
Clock To:	
1st Value:	4.000
2nd Value:	
Value Percent:	
Continuous Index:	
Within 8" of Joint:	
Remarks:

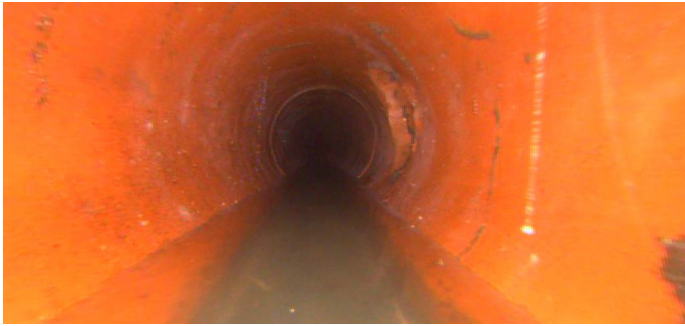
Code: **TF**
Description: **Tap Factory**

Distance (ft): **38.7**
Structural Grade: **0**
O&M Grade: **0**
Clock Start/From: **3**
Clock To:
1st Value: **4.000**
2nd Value:
Value Percent:
Continuous Index:
Within 8" of Joint:
Remarks:

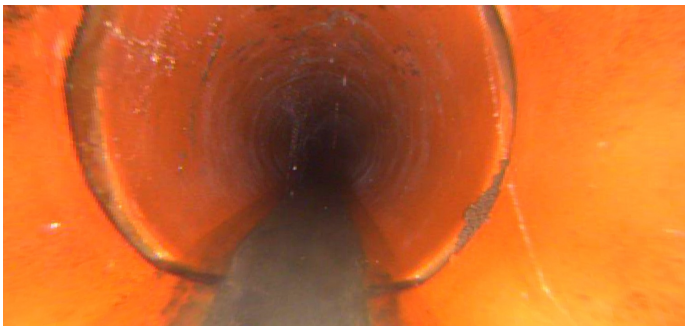
Code: **RFJ**
Description: **Roots Fine Joint**

Distance (ft): **45.3**
Structural Grade: **0**
O&M Grade: **1**
Clock Start/From: **4**
Clock To: **5**
1st Value:
2nd Value:
Value Percent:
Continuous Index:
Within 8" of Joint: **YES**
Remarks:

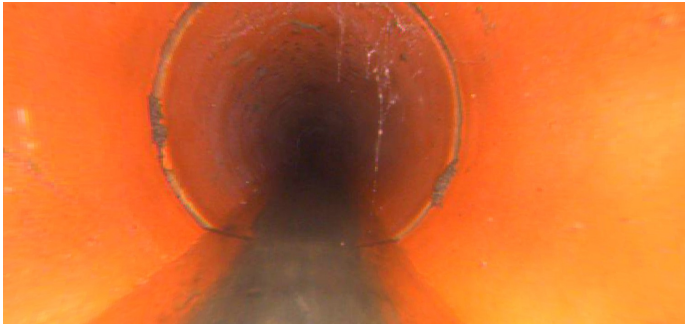
Code: **RFJ**
Description: **Roots Fine Joint**

Distance (ft): **50.5**
Structural Grade: **0**
O&M Grade: **1**
Clock Start/From: **7**
Clock To: **5**
1st Value:
2nd Value:
Value Percent:
Continuous Index:
Within 8" of Joint: **YES**
Remarks:

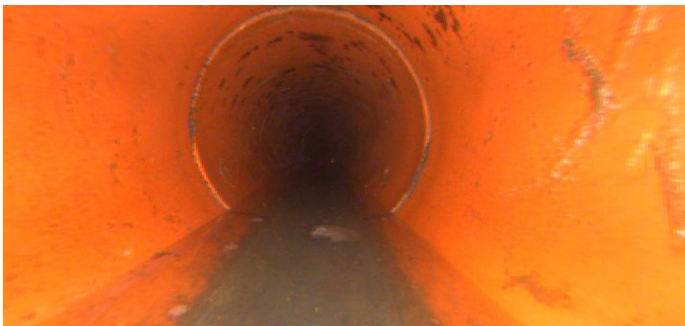
Code: **RFJ**
Description: **Roots Fine Joint**

Distance (ft): **81.1**
Structural Grade: **0**
O&M Grade: **1**
Clock Start/From: **7**
Clock To: **5**
1st Value:
2nd Value:
Value Percent:
Continuous Index:
Within 8" of Joint: **YES**
Remarks:

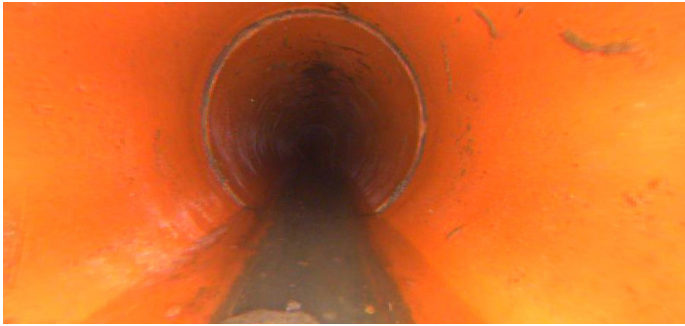
Code: **RFJ**
Description: **Roots Fine Joint**

Distance (ft): **85.7**
Structural Grade: **0**
O&M Grade: **1**
Clock Start/From: **7**
Clock To: **5**
1st Value:
2nd Value:
Value Percent:
Continuous Index:
Within 8" of Joint: **YES**
Remarks:

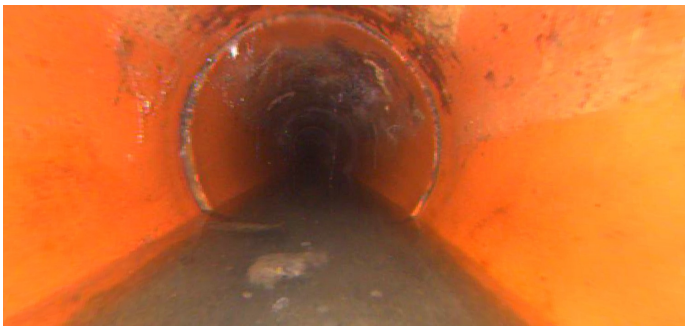
Code: **RFJ**
Description: **Roots Fine Joint**

Distance (ft): **95.3**
Structural Grade: **0**
O&M Grade: **1**
Clock Start/From: **7**
Clock To: **5**
1st Value:
2nd Value:
Value Percent:
Continuous Index:
Within 8" of Joint: **YES**
Remarks:

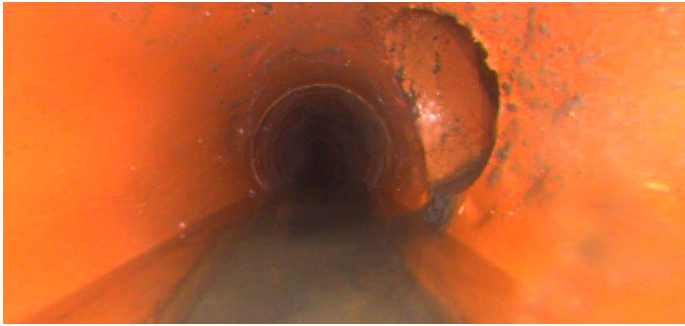
Code: **TF**
Description: **Tap Factory**

Distance (ft): **112.1**
Structural Grade: **0**
O&M Grade: **0**
Clock Start/From: **3**
Clock To:
1st Value: **4.000**
2nd Value:
Value Percent:
Continuous Index:
Within 8" of Joint:
Remarks:

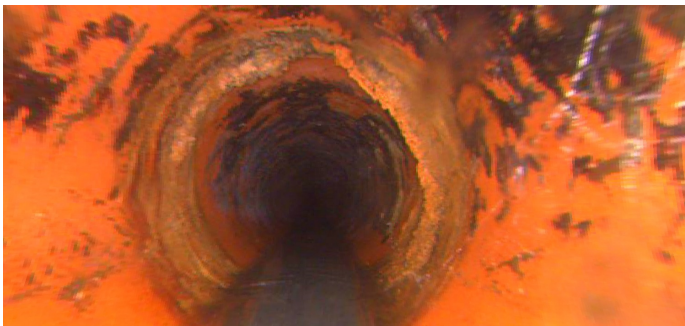
Code: **DAE**
Description: **Deposits Attached Encrustation**

Distance (ft): **133.3**
Structural Grade: **0**
O&M Grade: **3**
Clock Start/From: **7**
Clock To: **5**
1st Value:
2nd Value:
Value Percent: **20.000**
Continuous Index:
Within 8" of Joint: **YES**
Remarks:

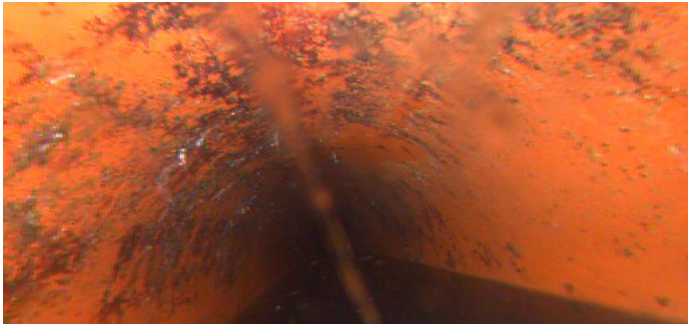
Code:	MSA
Description:	Abandoned Survey
Distance (ft):	151.1
Structural Grade:	0
O&M Grade:	0
Clock Start/From:	
Clock To:	
1st Value:	
2nd Value:	
Value Percent:	
Continuous Index:	
Within 8" of Joint:	NO
Remarks:	camera stopped
