Profile/Photo Observation Report

Street:	Dill St.	Flow Control:	Not Controlled
City:	Hobart, IN	Year Renewed:	
Location:	Light Highway	Tape/Media #:	
Purpose:	Routine Assessment	Dia/Height:	10"
Use:	Sanitary	Material:	VCP
Drain Area:	NA	Lining:	
Category:	NA		
Comment:

Location Details:		Direction of Survey:	Downstream
US MH:	M-403-002	DS MH:	M-403-001
		Total Length Surveyed (ft):	151.1

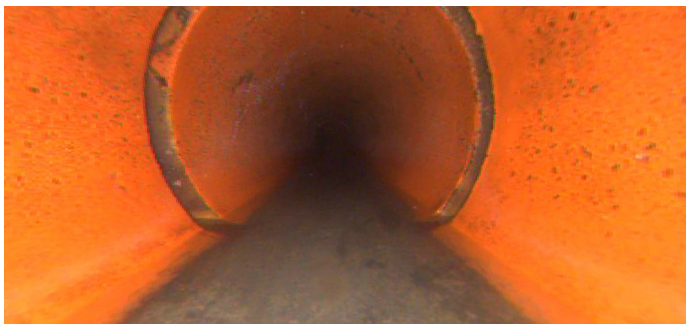
Code: **AMH**
Description: **Manhole**

Distance (ft): **.0**
Structural Grade: **0**
O&M Grade: **0**
Clock Start/From:
Clock To:
1st Value:
2nd Value:
Value Percent:
Continuous Index:
Within 8" of Joint: **NO**
Remarks: **M-403-002**

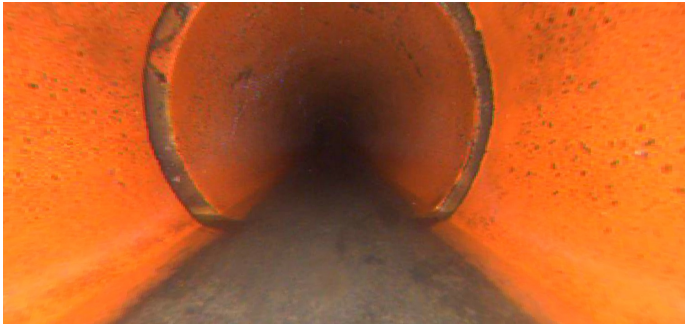
Code:	MWL
Description:	Water Level

Distance (ft):	.0
Structural Grade:	0
O&M Grade:	0
Clock Start/From:	
Clock To:	
1st Value:	
2nd Value:	
Value Percent:	5.000
Continuous Index:	
Within 8" of Joint:	NO
Remarks:

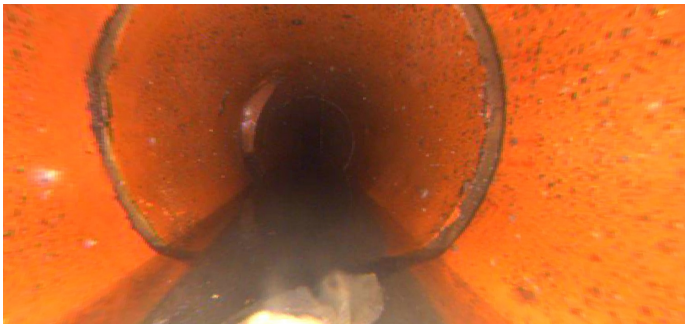
Code:	TF
Description:	Tap Factory

Distance (ft):	21.7
Structural Grade:	0
O&M Grade:	0
Clock Start/From:	9
Clock To:	
1st Value:	4.000
2nd Value:	
Value Percent:	
Continuous Index:	
Within 8" of Joint:	
Remarks:

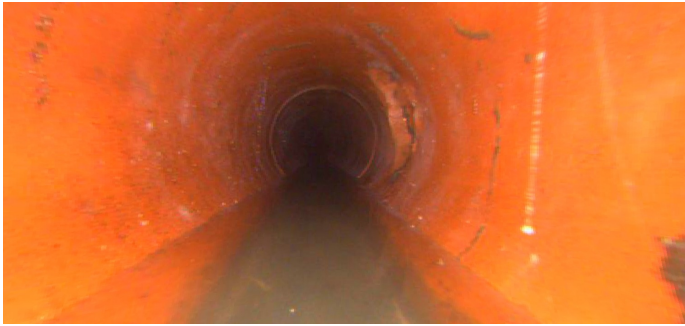
Code: **TF**
Description: **Tap Factory**

Distance (ft): **38.7**
Structural Grade: **0**
O&M Grade: **0**
Clock Start/From: **3**
Clock To:
1st Value: **4.000**
2nd Value:
Value Percent:
Continuous Index:
Within 8" of Joint:
Remarks:

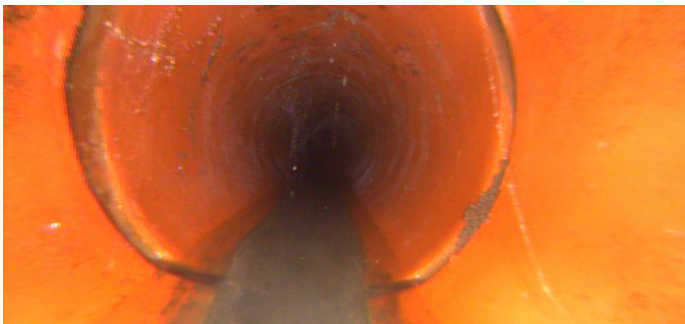
Code: **RFJ**
Description: **Roots Fine Joint**

Distance (ft): **45.3**
Structural Grade: **0**
O&M Grade: **1**
Clock Start/From: **4**
Clock To: **5**
1st Value:
2nd Value:
Value Percent:
Continuous Index:
Within 8" of Joint: **YES**
Remarks:

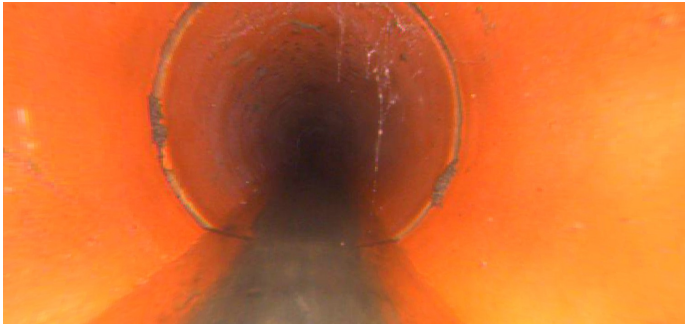
Code: **RFJ**
Description: **Roots Fine Joint**

Distance (ft): **50.5**
Structural Grade: **0**
O&M Grade: **1**
Clock Start/From: **7**
Clock To: **5**
1st Value:
2nd Value:
Value Percent:
Continuous Index:
Within 8" of Joint: **YES**
Remarks:

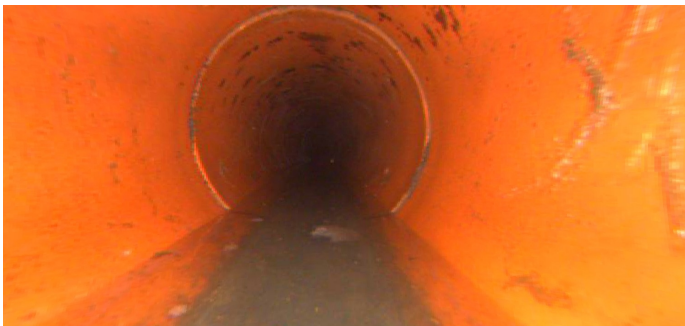
Code: **RFJ**
Description: **Roots Fine Joint**

Distance (ft): **81.1**
Structural Grade: **0**
O&M Grade: **1**
Clock Start/From: **7**
Clock To: **5**
1st Value:
2nd Value:
Value Percent:
Continuous Index:
Within 8" of Joint: **YES**
Remarks:

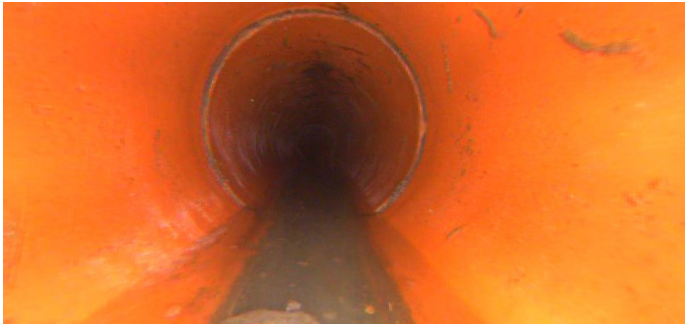
Code: **RFJ**
Description: **Roots Fine Joint**

Distance (ft): **85.7**
Structural Grade: **0**
O&M Grade: **1**
Clock Start/From: **7**
Clock To: **5**
1st Value:
2nd Value:
Value Percent:
Continuous Index:
Within 8" of Joint: **YES**
Remarks:

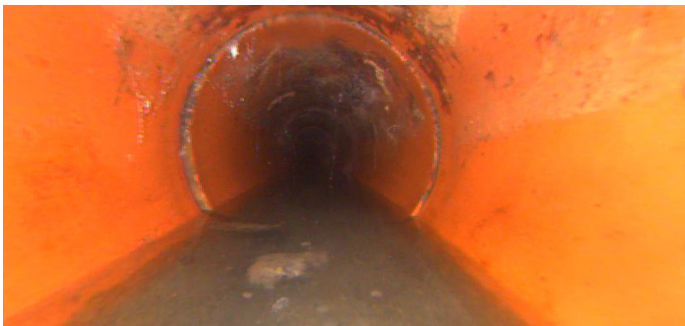
Code: **RFJ**
Description: **Roots Fine Joint**

Distance (ft): **95.3**
Structural Grade: **0**
O&M Grade: **1**
Clock Start/From: **7**
Clock To: **5**
1st Value:
2nd Value:
Value Percent:
Continuous Index:
Within 8" of Joint: **YES**
Remarks:

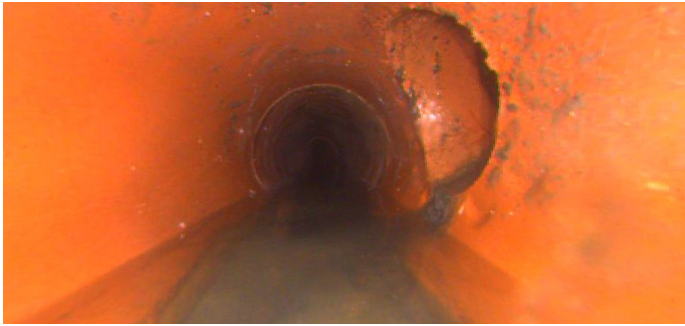
Code: **TF**
Description: **Tap Factory**

Distance (ft): **112.1**
Structural Grade: **0**
O&M Grade: **0**
Clock Start/From: **3**
Clock To:
1st Value: **4.000**
2nd Value:
Value Percent:
Continuous Index:
Within 8" of Joint:
Remarks:

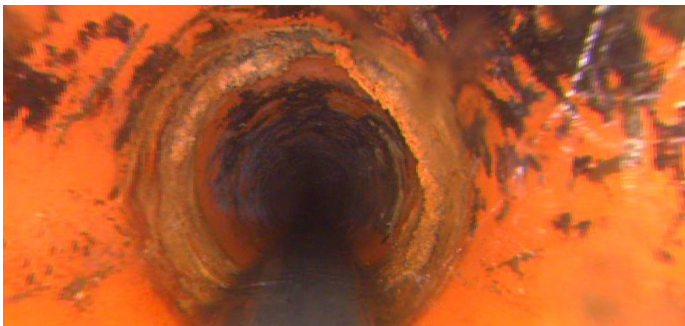
Code: **DAE**
Description: **Deposits Attached Encrustation**

Distance (ft): **133.3**
Structural Grade: **0**
O&M Grade: **3**
Clock Start/From: **7**
Clock To: **5**
1st Value:
2nd Value:
Value Percent: **20.000**
Continuous Index:
Within 8" of Joint: **YES**
Remarks:

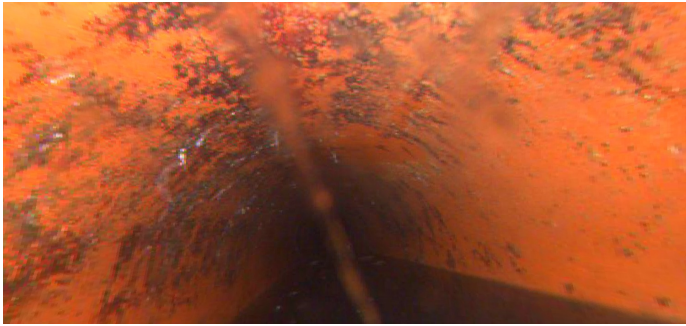
Code:	MSA
Description:	Abandoned Survey
Distance (ft):	151.1
Structural Grade:	0
O&M Grade:	0
Clock Start/From:	
Clock To:	
1st Value:	
2nd Value:	
Value Percent:	
Continuous Index:	
Within 8" of Joint:	NO
Remarks:	camera stopped
