Profile/Photo Observation Report

Street:	W 38TH AVE & GILL ST	Flow Control:	Not Controlled
City:	Hobart, IN	Year Renewed:	
Location:	Other	Tape/Media #:	
Purpose:	Not Known	Dia/Height:	10"
Use:	Sanitary	Material:	VCP
Drain Area:	NA	Lining:	
Category:	NA		
Comment:

Location Details:		Direction of Survey:	Upstream
US MH:	M-403-003	DS MH:	M-403-002
		Total Length Surveyed (ft):	238.1

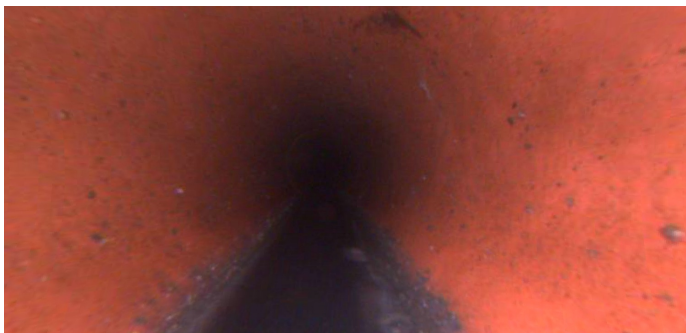
Code: **AMH**
Description: **Manhole**

Distance (ft): **.0**
Structural Grade: **0**
O&M Grade: **0**
Clock Start/From:
Clock To:
1st Value:
2nd Value:
Value Percent:
Continuous Index:
Within 8" of Joint: **NO**
Remarks: **M-403-002**

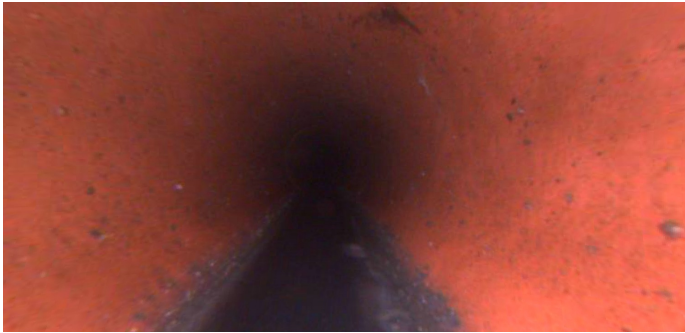
Code:	MWL
Description:	Water Level

Distance (ft):	.0
Structural Grade:	0
O&M Grade:	0
Clock Start/From:	
Clock To:	
1st Value:	
2nd Value:	
Value Percent:	5.000
Continuous Index:	
Within 8" of Joint:	NO
Remarks:

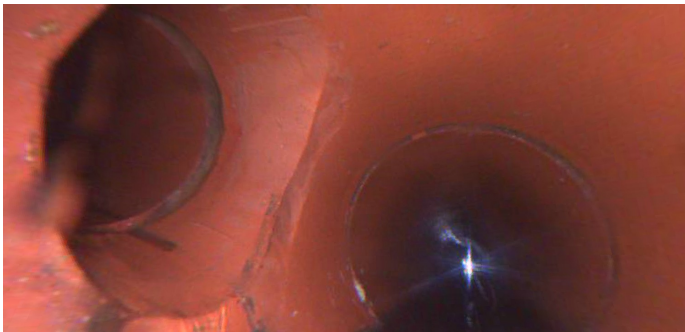
Code:	TF
Description:	Tap Factory

Distance (ft):	40.7
Structural Grade:	0
O&M Grade:	0
Clock Start/From:	2
Clock To:	
1st Value:	4.000
2nd Value:	
Value Percent:	
Continuous Index:	
Within 8" of Joint:	
Remarks:

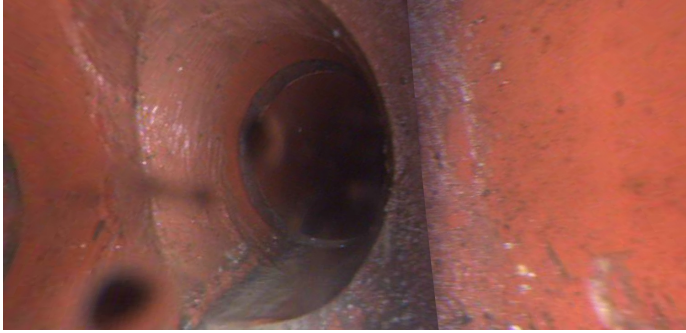
Code: **TF**
Description: **Tap Factory**

Distance (ft): **72.9**
Structural Grade: **0**
O&M Grade: **0**
Clock Start/From: **9**
Clock To:
1st Value: **4.000**
2nd Value:
Value Percent:
Continuous Index:
Within 8" of Joint:
Remarks:

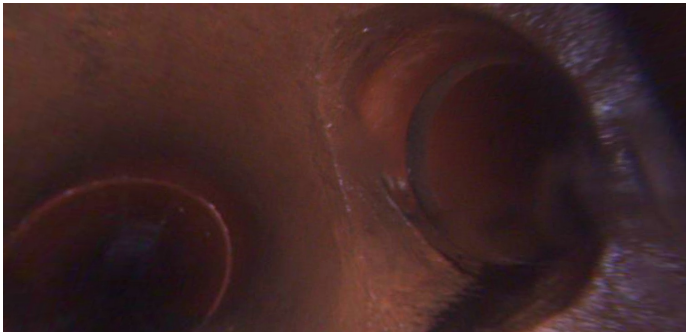
Code: **TFA**
Description: **Tap Factory Active**

Distance (ft): **104.7**
Structural Grade: **0**
O&M Grade: **0**
Clock Start/From: **2**
Clock To:
1st Value: **4.000**
2nd Value:
Value Percent:
Continuous Index:
Within 8" of Joint:
Remarks:

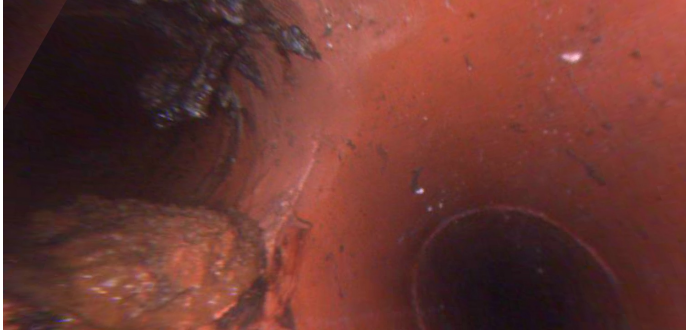
Code: **TF**
Description: **Tap Factory**

Distance (ft): **132.2**
Structural Grade: **0**
O&M Grade: **0**
Clock Start/From: **10**
Clock To:
1st Value: **4.000**
2nd Value:
Value Percent:
Continuous Index:
Within 8" of Joint:
Remarks:

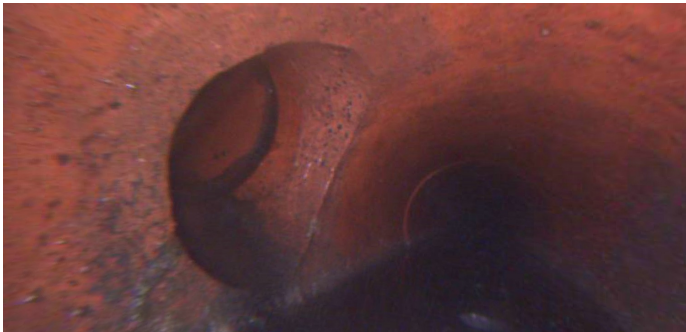
Code: **TF**
Description: **Tap Factory**

Distance (ft): **225.7**
Structural Grade: **0**
O&M Grade: **0**
Clock Start/From: **9**
Clock To:
1st Value: **4.000**
2nd Value:
Value Percent:
Continuous Index:
Within 8" of Joint:
Remarks:

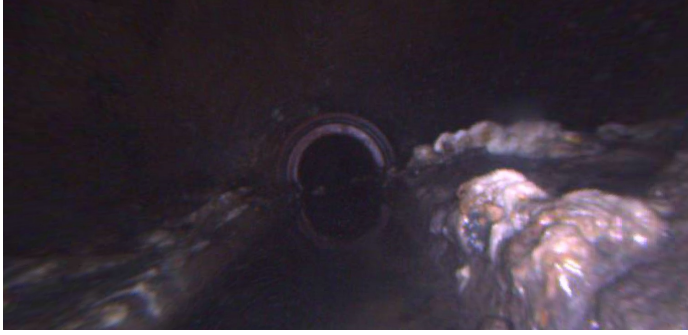
Code:	AMH
Description:	Manhole
Distance (ft):	238.1
Structural Grade:	0
O&M Grade:	0
Clock Start/From:	
Clock To:	
1st Value:	
2nd Value:	
Value Percent:	
Continuous Index:	
Within 8" of Joint:	NO
Remarks:	M-403-003
