Profile/Photo Observation Report

Street:	Gill Street	Flow Control:	Not Controlled
City:	Hobart, IN	Year Renewed:	
Location:	Light Highway	Tape/Media #:	DEP 5
Purpose:	Routine Assessment	Dia/Height:	15"
Use:	Sanitary	Material:	VCP
Drain Area:		Lining:	
Category:	NA		
Comment:			
Location Details:		Direction of Survey:	Downstream
US MH:	M-403-008	DS MH:	M-403-004
		Total Length Surveyed (ft):	8.1

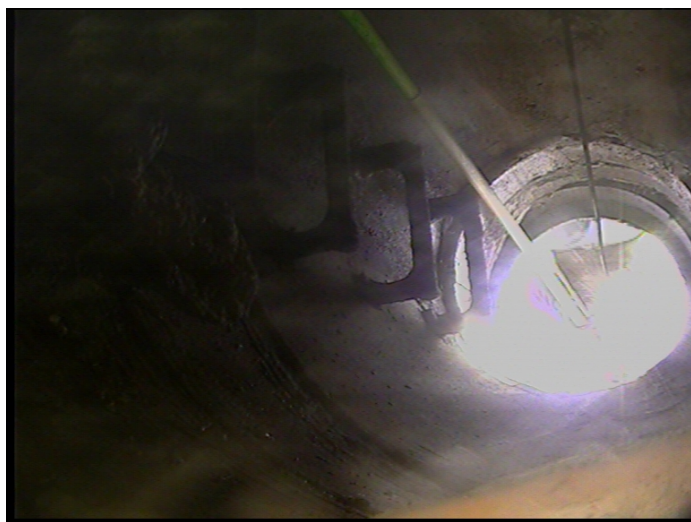
Code: **AMH**
Description: **Manhole**

Distance (ft): **.0**
Structural Grade: **0**
O&M Grade: **0**
Clock Start/From:
Clock To:
1st Value:
2nd Value:
Value Percent:
Continuous Index:
Within 8" of Joint: **NO**
Remarks: **M-403-008**

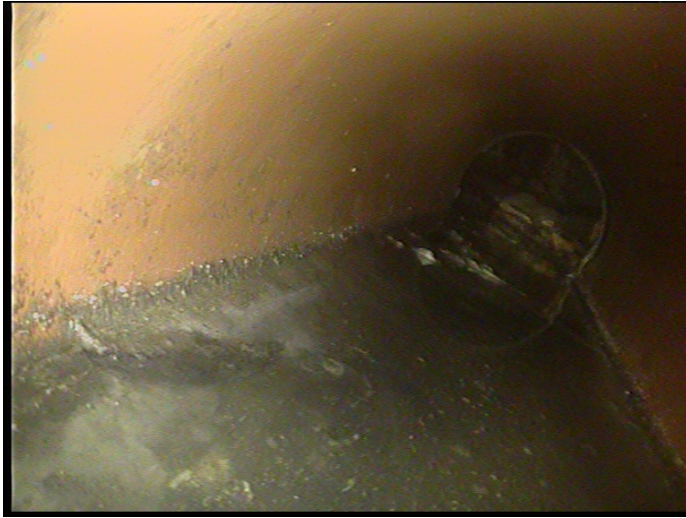
Code:	MWL
Description:	Water Level
Distance (ft):	.0
Structural Grade:	0
O&M Grade:	0
Clock Start/From:	
Clock To:	
1st Value:	
2nd Value:	
Value Percent:	10.000
Continuous Index:	
Within 8" of Joint:	NO
Remarks:
