Profile/Photo Observation Report

Street:	Gill Street	Flow Control:	Not Controlled
City:	Hobart, IN	Year Renewed:	
Location:	Light Highway	Tape/Media #:	DEP 5
Purpose:	Routine Assessment	Dia/Height:	15"
Use:	Sanitary	Material:	VCP
Drain Area:		Lining:	
Category:	NA		
Comment:			
Location Details:		Direction of Survey:	Downstream
US MH:	M-403-008	DS MH:	M-403-004
		Total Length Surveyed (ft):	8.1

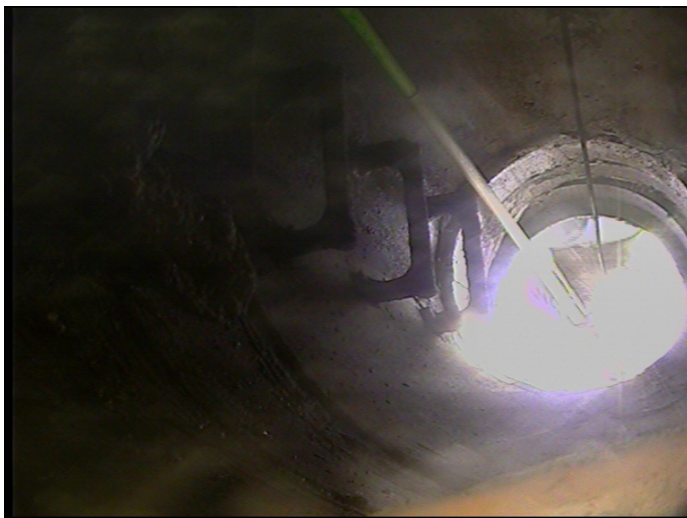
Code: **AMH**
 Description: **Manhole**

Distance (ft): **.0**
 Structural Grade: **0**
 O&M Grade: **0**
 Clock Start/From:
 Clock To:
 1st Value:
 2nd Value:
 Value Percent:
 Continuous Index:
 Within 8" of Joint: **NO**
 Remarks: **M-403-008**

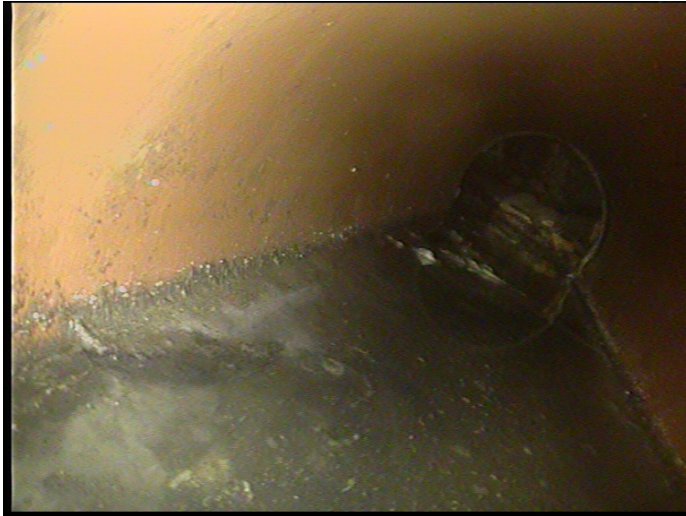
Code:	MWL
Description:	Water Level
Distance (ft):	.0
Structural Grade:	0
O&M Grade:	0
Clock Start/From:	
Clock To:	
1st Value:	
2nd Value:	
Value Percent:	10.000
Continuous Index:	
Within 8" of Joint:	NO
Remarks:

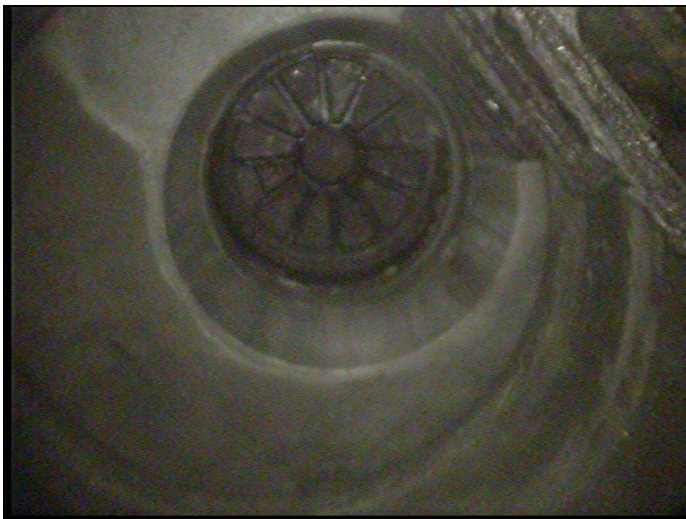
Code:	AMH
Description:	Manhole
Distance (ft):	8.1
Structural Grade:	0
O&M Grade:	0
Clock Start/From:	
Clock To:	
1st Value:	
2nd Value:	
Value Percent:	
Continuous Index:	
Within 8" of Joint:	NO
Remarks:	M-403-004
