## Profile/Photo Observation Report

Street:	<b>W 41ST AVE</b>	Flow Control:	<b>Not Controlled</b>
City:	<b>Hobart, IN</b>	Year Renewed:	
Location:	<b>Other</b>	Tape/Media #:	
Purpose:	<b>Not Known</b>	Dia/Height:	<b>10"</b>
Use:	<b>Sanitary</b>	Material:	<b>VCP</b>
Drain Area:	<b>NA</b>	Lining:	
Category:	<b>NA</b>		
Comment:

Location Details:		Direction of Survey:	<b>Downstream</b>
US MH:	<b>M-403-009</b>	DS MH:	<b>M-404-024</b>
		Total Length Surveyed (ft):	<b>23.3</b>

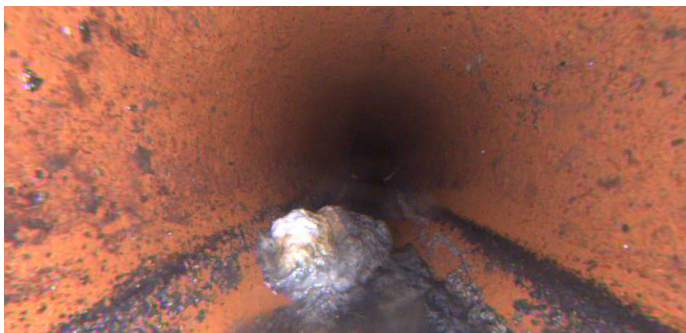
Code: **AMH**  
Description: **Manhole**

Distance (ft): **.0**  
Structural Grade: **0**  
O&M Grade: **0**  
Clock Start/From:  
Clock To:  
1st Value:  
2nd Value:  
Value Percent:  
Continuous Index:  
Within 8" of Joint: **NO**  
Remarks: **M-403-009**

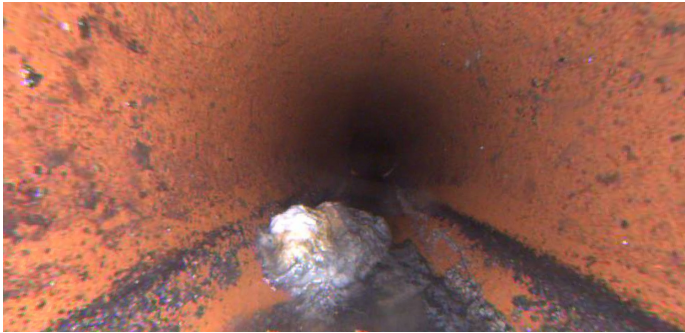
Code:	<b>MWL</b>
Description:	<b>Water Level</b>

Distance (ft):	<b>.0</b>
Structural Grade:	<b>0</b>
O&M Grade:	<b>0</b>
Clock Start/From:	
Clock To:	
1st Value:	
2nd Value:	
Value Percent:	<b>5.000</b>
Continuous Index:	
Within 8" of Joint:	<b>NO</b>
Remarks:

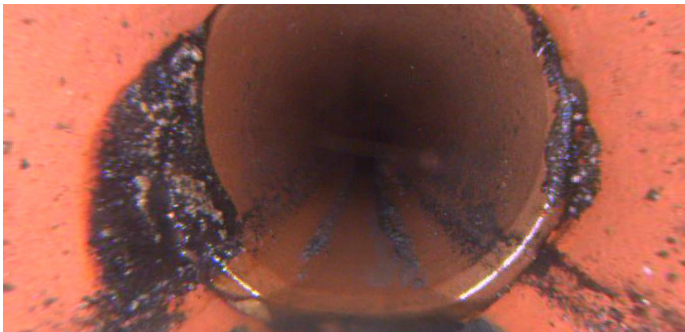
Code:	<b>DAE</b>
Description:	<b>Deposits Attached Encrustation</b>

Distance (ft):	<b>4.3</b>
Structural Grade:	<b>0</b>
O&M Grade:	<b>2</b>
Clock Start/From:	<b>8</b>
Clock To:	<b>4</b>
1st Value:	
2nd Value:	
Value Percent:	<b>5.000</b>
Continuous Index:	<b>S01</b>
Within 8" of Joint:	<b>YES</b>
Remarks:

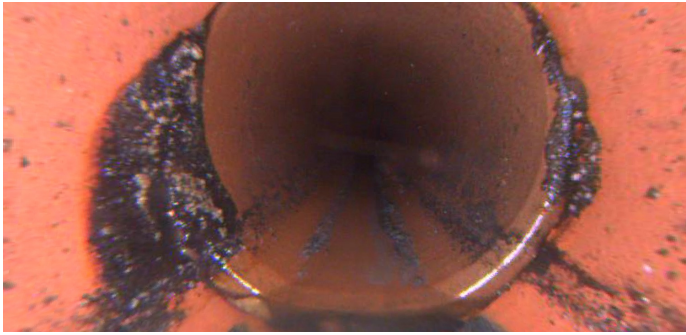
Code: **IW**  
Description: **Infil Weeper**

Distance (ft): **4.3**  
Structural Grade: **0**  
O&M Grade: **2**  
Clock Start/From: **8**  
Clock To: **4**  
1st Value:  
2nd Value:  
Value Percent:  
Continuous Index: **S02**  
Within 8" of Joint: **YES**  
Remarks:

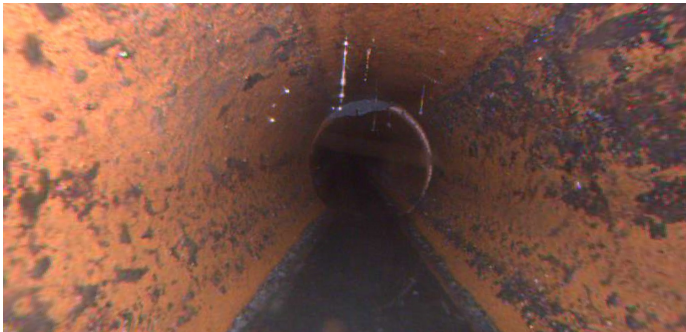
Code: **DAE**  
Description: **Deposits Attached Encrustation**

Distance (ft): **23.3**  
Structural Grade: **0**  
O&M Grade: **2**  
Clock Start/From: **8**  
Clock To: **4**  
1st Value:  
2nd Value:  
Value Percent: **5.000**  
Continuous Index: **F01**  
Within 8" of Joint: **YES**  
Remarks:

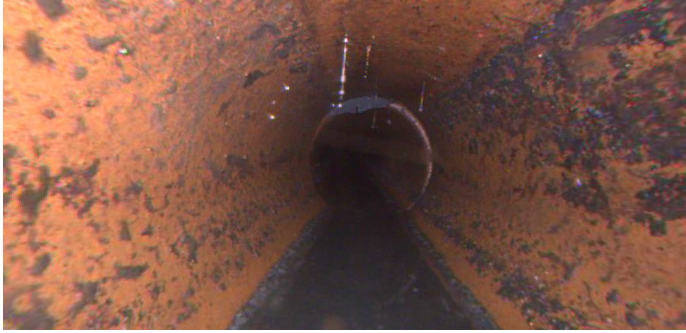
Code: **IW**  
Description: **Infil Weeper**

Distance (ft): **23.3**  
Structural Grade: **0**  
O&M Grade: **2**  
Clock Start/From: **8**  
Clock To: **4**  
1st Value:  
2nd Value:  
Value Percent:  
Continuous Index: **F02**  
Within 8" of Joint: **YES**  
Remarks:

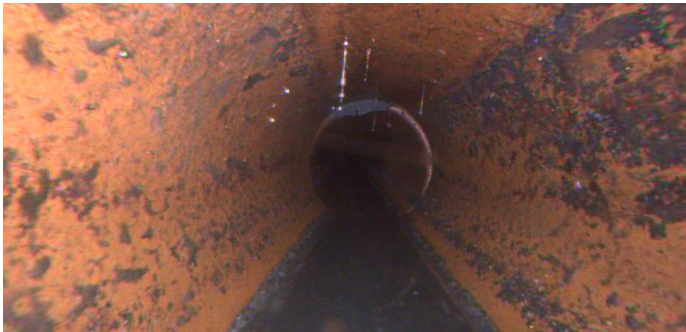
Code: **MSA**  
Description: **Abandoned Survey**

Distance (ft): **23.3**  
Structural Grade: **0**  
O&M Grade: **0**  
Clock Start/From:  
Clock To:  
1st Value:  
2nd Value:  
Value Percent:  
Continuous Index:  
Within 8" of Joint: **NO**  
Remarks: **DEBRIS UNDER WATER**
