Profile/Photo Observation Report

Date:	04/16/2018	Weather:		Coding:	PACP 6.0
Pipe Length (ft):		Owner:	City of Hobart	Pre Clean:	No Pre-Cleaning
P.O.#:	57-1	Surveyor:	M. Pielacha	PSR:	M-404-001-M-504-028
Customer:	City of Hobart	Clean Date:		Shape:	C

Street:	Cleveland Avenue	Flow Control:	Not Controlled
City:	Hobart, IN	Year Renewed:	
Location:	Light Highway	Tape/Media #:	DEP 57
Purpose:	Routine Assessment	Dia/Height:	18"
Use:	Sanitary	Material:	VCP
Drain Area:		Lining:	
Category:	NA		
Comment:			
Location Details:		Direction of Survey:	Downstream
US MH:	M-404-001	DS MH:	M-504-028
		Total Length Surveyed (ft):	79.0

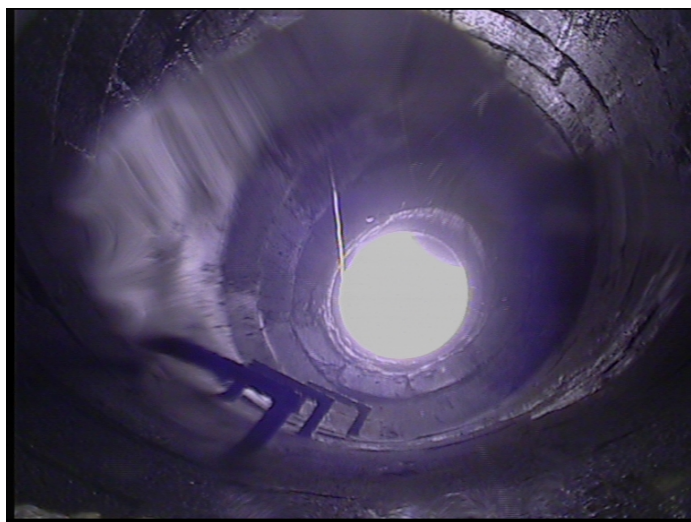
Code: **AMH**
Description: **Manhole**

Distance (ft): **.0**
Structural Grade: **0**
O&M Grade: **0**
Clock Start/From:
Clock To:
1st Value:
2nd Value:
Value Percent:
Continuous Index:
Within 8" of Joint: **NO**
Remarks: **M-404-001**

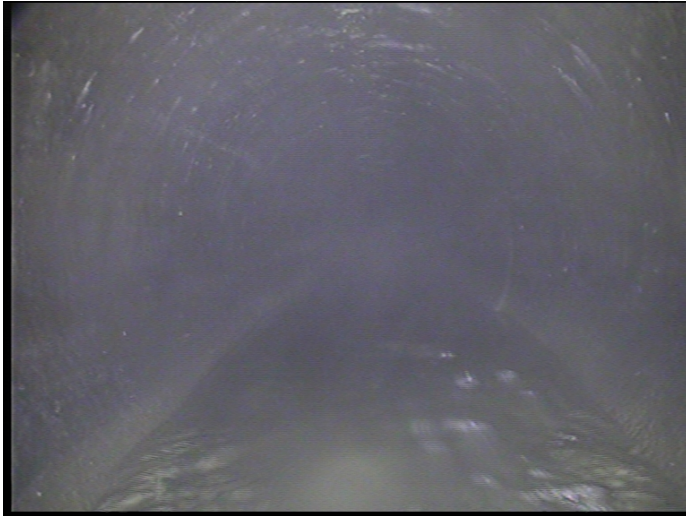
Code: **MWL**
Description: **Water Level**

Distance (ft): **.0**
Structural Grade: **0**
O&M Grade: **0**
Clock Start/From:
Clock To:
1st Value:
2nd Value:
Value Percent: **10.000**
Continuous Index:
Within 8" of Joint: **NO**
Remarks:

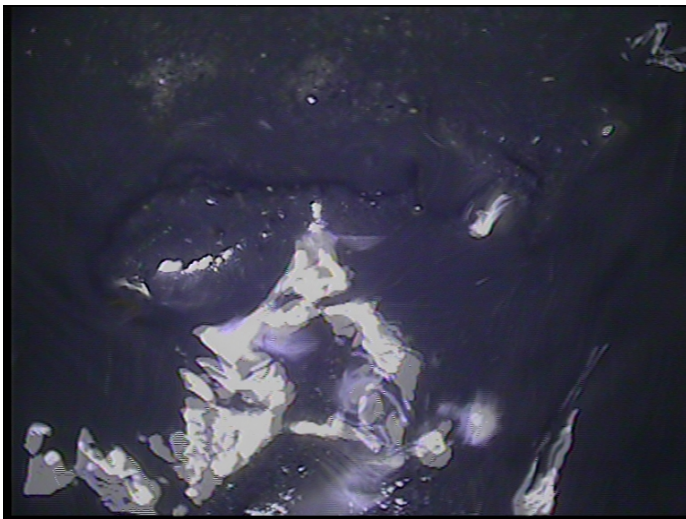
Code: **DSF**
Description: **Deposits Settled Fine**

Distance (ft): **54.9**
Structural Grade: **0**
O&M Grade: **3**
Clock Start/From: **5**
Clock To: **7**
1st Value:
2nd Value:
Value Percent: **15.000**
Continuous Index: **S01**
Within 8" of Joint: **YES**
Remarks:

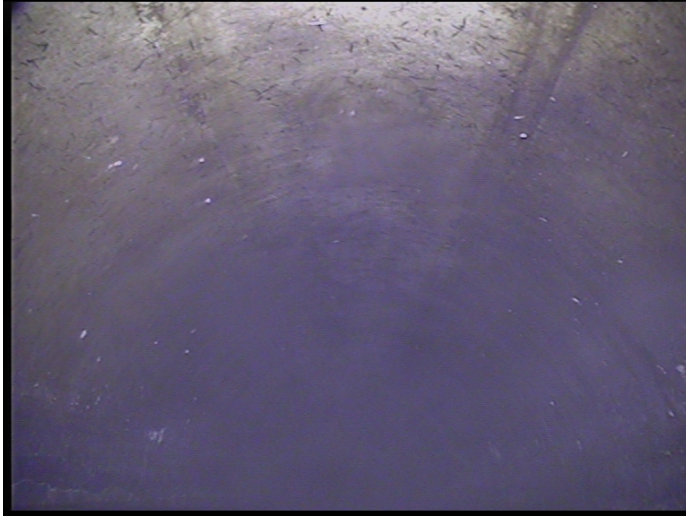
Code: **DSF**
Description: **Deposits Settled Fine**

Distance (ft): **77.5**
Structural Grade: **0**
O&M Grade: **3**
Clock Start/From: **5**
Clock To: **7**
1st Value:
2nd Value:
Value Percent: **15.000**
Continuous Index: **F01**
Within 8" of Joint: **NO**
Remarks:

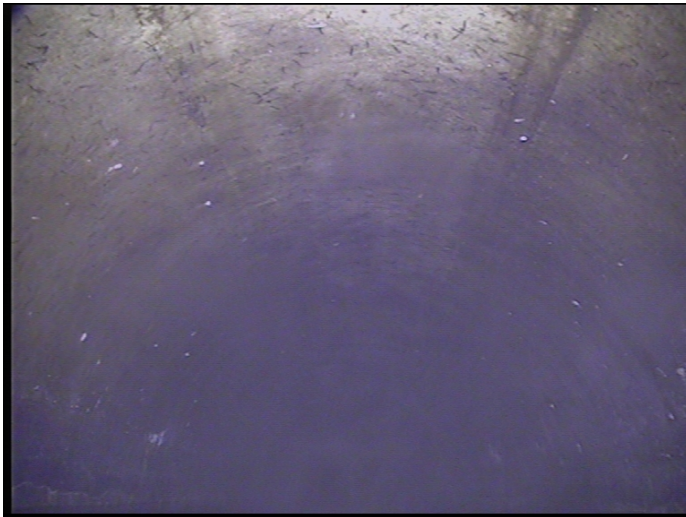
Code: **MSA**
Description: **Abandoned Survey**

Distance (ft): **77.5**
Structural Grade: **0**
O&M Grade: **0**
Clock Start/From:
Clock To:
1st Value:
2nd Value:
Value Percent:
Continuous Index:
Within 8" of Joint: **NO**
Remarks: **sediment**
