## Profile/Photo Observation Report

Date:	<b>04/16/2018</b>	Weather:		Coding:	<b>PACP 6.0</b>
Pipe Length (ft):		Owner:	<b>City of Hobart</b>	Pre Clean:	<b>No Pre-Cleaning</b>
P.O.#:	<b>57-1</b>	Surveyor:	<b>M. Pielacha</b>	PSR:	<b>M-404-001-M-504-028</b>
Customer:	<b>City of Hobart</b>	Clean Date:		Shape:	<b>C</b>

Street:	<b>Cleveland Avenue</b>	Flow Control:	<b>Not Controlled</b>
City:	<b>Hobart, IN</b>	Year Renewed:	
Location:	<b>Light Highway</b>	Tape/Media #:	<b>DEP 57</b>
Purpose:	<b>Routine Assessment</b>	Dia/Height:	<b>18"</b>
Use:	<b>Sanitary</b>	Material:	<b>VCP</b>
Drain Area:		Lining:	
Category:	<b>NA</b>		
Comment:			
Location Details:		Direction of Survey:	<b>Downstream</b>
US MH:	<b>M-404-001</b>	DS MH:	<b>M-504-028</b>
		Total Length Surveyed (ft):	<b>79.0</b>

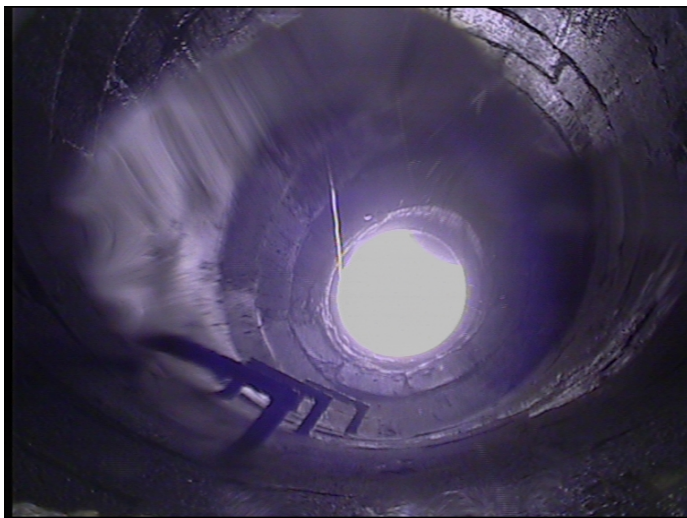
Code: **AMH**  
 Description: **Manhole**

Distance (ft): **.0**  
 Structural Grade: **0**  
 O&M Grade: **0**  
 Clock Start/From:  
 Clock To:  
 1st Value:  
 2nd Value:  
 Value Percent:  
 Continuous Index:  
 Within 8" of Joint: **NO**  
 Remarks: **M-404-001**

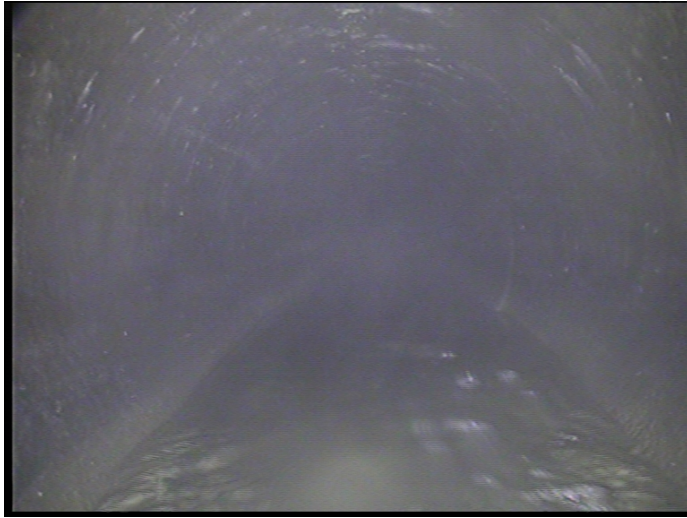
Code: **MWL**  
Description: **Water Level**

Distance (ft): **.0**  
Structural Grade: **0**  
O&M Grade: **0**  
Clock Start/From:  
Clock To:  
1st Value:  
2nd Value:  
Value Percent: **10.000**  
Continuous Index:  
Within 8" of Joint: **NO**  
Remarks:

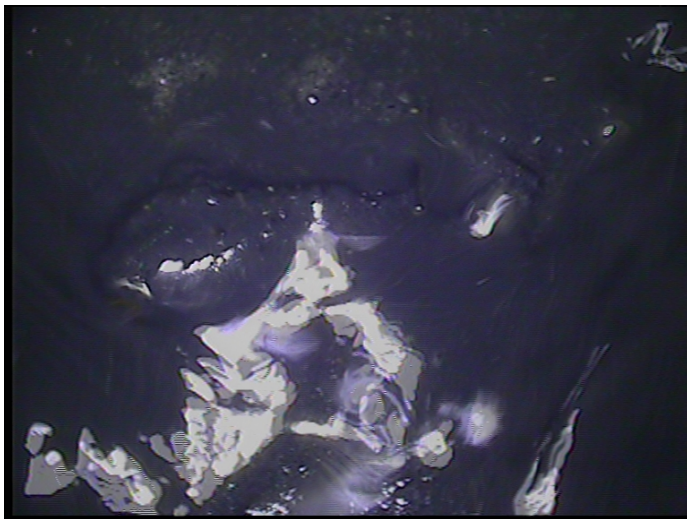
Code: **DSF**  
Description: **Deposits Settled Fine**

Distance (ft): **54.9**  
Structural Grade: **0**  
O&M Grade: **3**  
Clock Start/From: **5**  
Clock To: **7**  
1st Value:  
2nd Value:  
Value Percent: **15.000**  
Continuous Index: **S01**  
Within 8" of Joint: **YES**  
Remarks:
