Profile/Photo Observation Report

Street:	Cleveland Avenue	Flow Control:	Not Controlled
City:	Hobart, IN	Year Renewed:	
Location:	Light Highway	Tape/Media #:	DEP 58
Purpose:	Routine Assessment	Dia/Height:	18"
Use:	Sanitary	Material:	VCP
Drain Area:		Lining:	
Category:	NA		
Comment:			
Location Details:		Direction of Survey:	Upstream
US MH:	M-404-001	DS MH:	M-504-028
		Total Length Surveyed (ft):	46.5

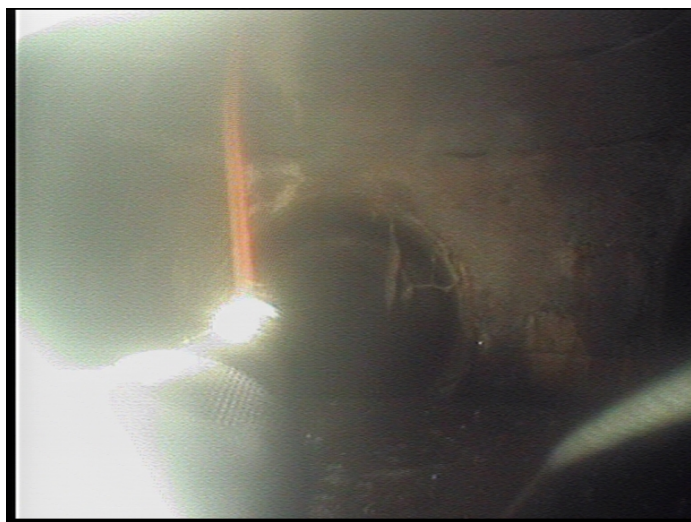
Code: **AMH**
Description: **Manhole**

Distance (ft): **.0**
Structural Grade: **0**
O&M Grade: **0**
Clock Start/From:
Clock To:
1st Value:
2nd Value:
Value Percent:
Continuous Index:
Within 8" of Joint: **NO**
Remarks: **M-504-028**

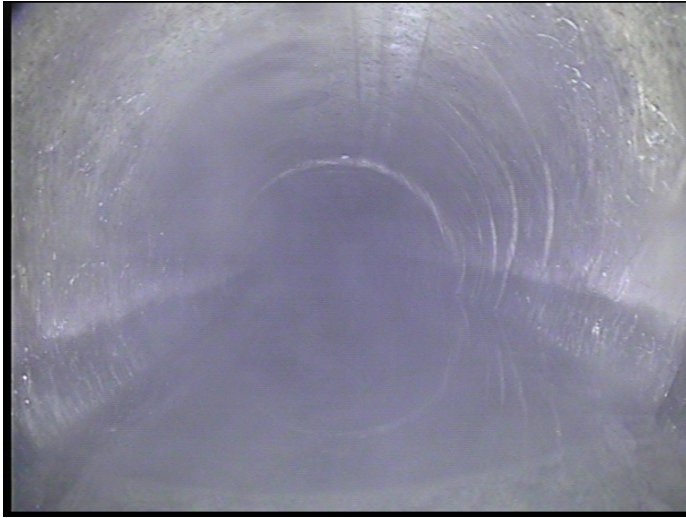
Code: **MWL**
Description: **Water Level**

Distance (ft): **.0**
Structural Grade: **0**
O&M Grade: **0**
Clock Start/From:
Clock To:
1st Value:
2nd Value:
Value Percent: **15.000**
Continuous Index:
Within 8" of Joint: **NO**
Remarks:

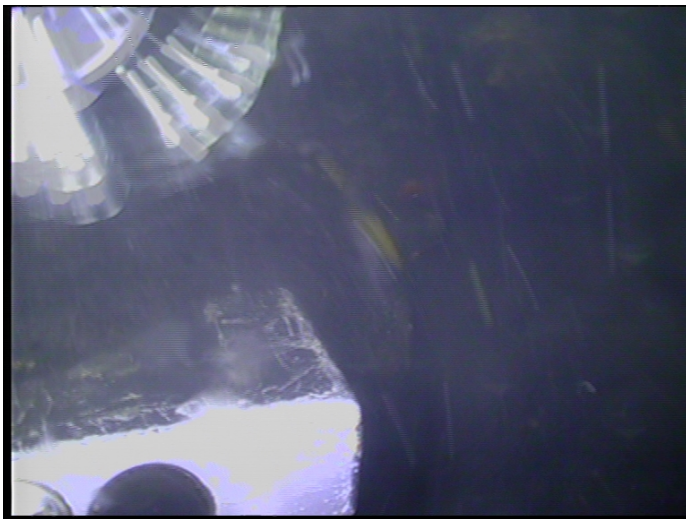
Code: **DSF**
Description: **Deposits Settled Fine**

Distance (ft): **37.3**
Structural Grade: **0**
O&M Grade: **3**
Clock Start/From: **5**
Clock To: **7**
1st Value:
2nd Value:
Value Percent: **20.000**
Continuous Index: **S01**
Within 8" of Joint: **YES**
Remarks:

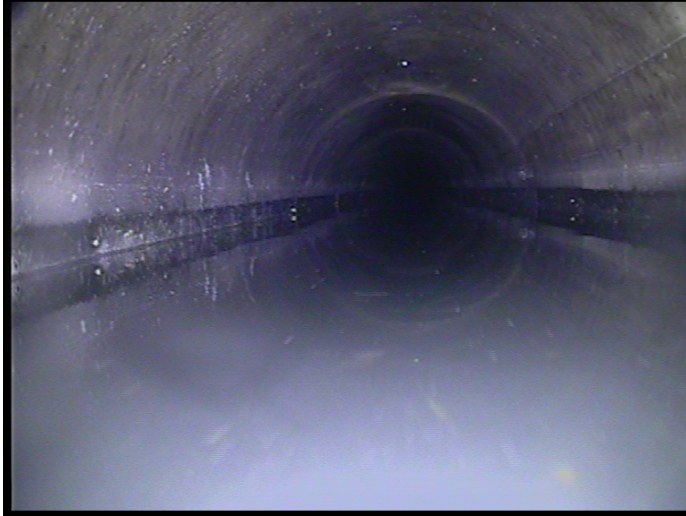
Code: **DSF**
Description: **Deposits Settled Fine**

Distance (ft): **45.9**
Structural Grade: **0**
O&M Grade: **3**
Clock Start/From: **5**
Clock To: **7**
1st Value:
2nd Value:
Value Percent: **20.000**
Continuous Index: **F01**
Within 8" of Joint: **NO**
Remarks:

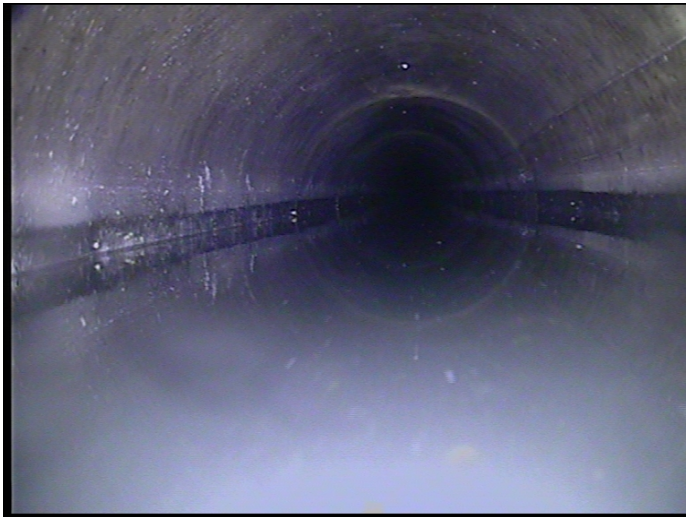
Code: **MSA**
Description: **Abandoned Survey**

Distance (ft): **46.2**
Structural Grade: **0**
O&M Grade: **0**
Clock Start/From:
Clock To:
1st Value:
2nd Value:
Value Percent:
Continuous Index:
Within 8" of Joint: **NO**
Remarks: **sediment**
