Profile/Photo Observation Report

Date:	08/10/2022	Weather:		Coding:	PACP 7.0
Pipe Length (ft):	162.0	Owner:	City of Hobart	Pre Clean:	Heavy Cleaning
P.O.#:	YES502259	Surveyor:	S. Bucklin	PSR:	P-404-001-028
Customer:	City of Hobart	Clean Date:	08/06/2022	Shape:	C

Street:	West Cleveland Avenue	Flow Control:	Not Controlled
City:	Hobart, IN	Year Renewed:	
Location:	Local rural streets with light traffic, t	Tape/Media #:	
Purpose:	Routine Assessment	Dia/Height:	18"
Use:	Sanitary Sewage Pipe	Material:	VCP
Drain Area:		Lining:	Cured-In-Place Pipe

US MH: **M-404-001** DS MH: **M-504-028** Total Length Surveyed (ft): **156.7**

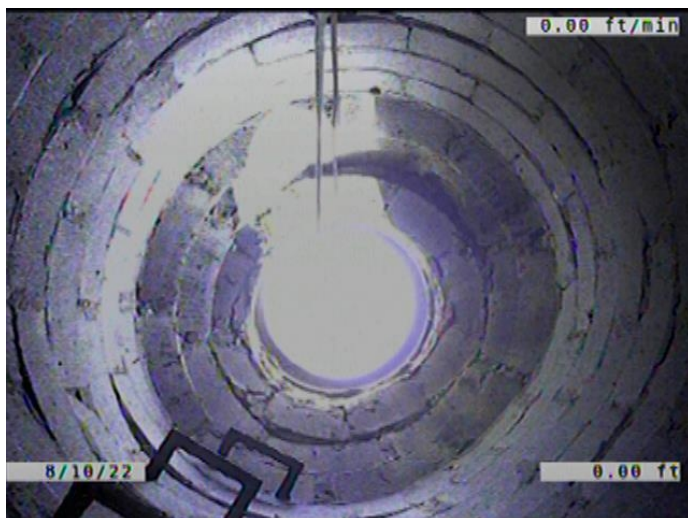
Code: **AMH**
Description: **Manhole**

Distance (ft): **.0**
Structural Grade: **0**
O&M Grade: **0**
Clock Start/From:
Clock To:
1st Value:
2nd Value:
Value Percent:
Continuous Index:
Within 8" of Joint: **NO**
Remarks: **M-404-001**

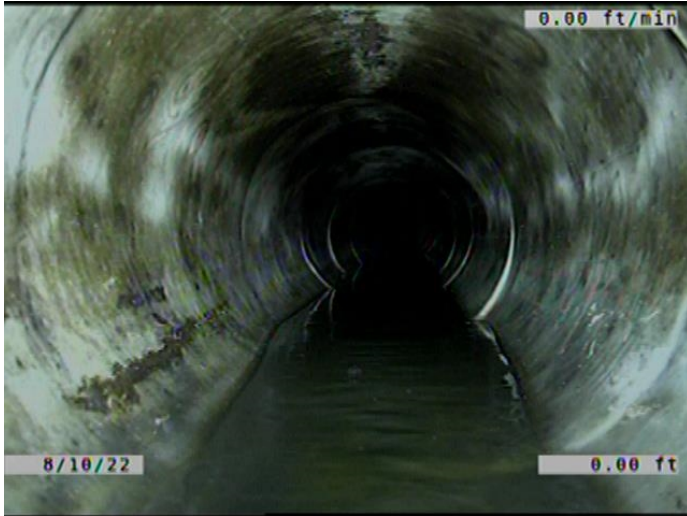
Code:	MWL
Description:	Miscellaneous Water Level
Distance (ft):	.0
Structural Grade:	0
O&M Grade:	0
Clock Start/From:	
Clock To:	
1st Value:	
2nd Value:	
Value Percent:	10.000
Continuous Index:	
Within 8" of Joint:	NO
Remarks:

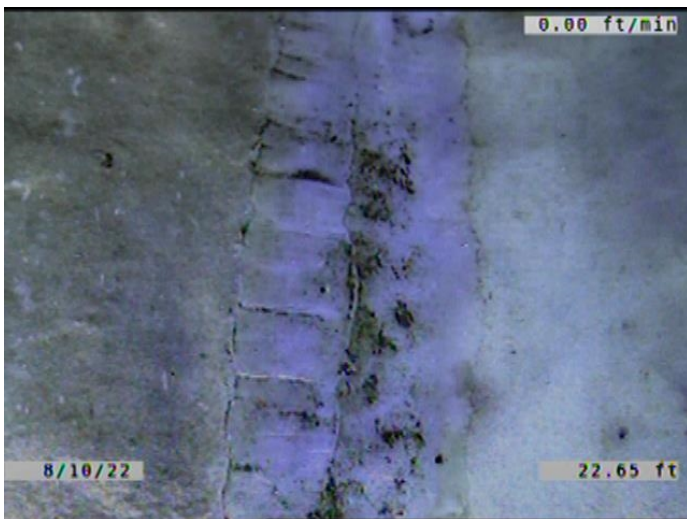
Code:	LFRS
Description:	Lining Feature Resin slug
Distance (ft):	22.7
Structural Grade:	3
O&M Grade:	0
Clock Start/From:	8
Clock To:	
1st Value:	
2nd Value:	
Value Percent:	
Continuous Index:	
Within 8" of Joint:	NO
Remarks:

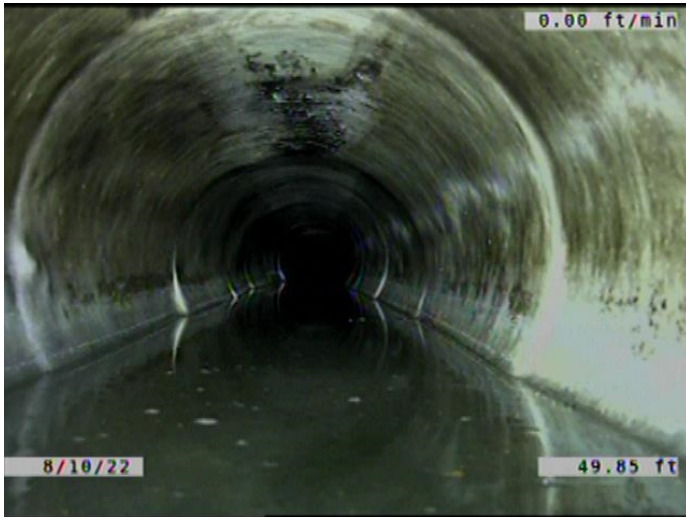
Code:	MWLS
Description:	Miscellaneous Water Level Sag
Distance (ft):	49.9
Structural Grade:	2
O&M Grade:	0
Clock Start/From:	
Clock To:	
1st Value:	
2nd Value:	
Value Percent:	20.000
Continuous Index:	
Within 8" of Joint:	NO
Remarks:

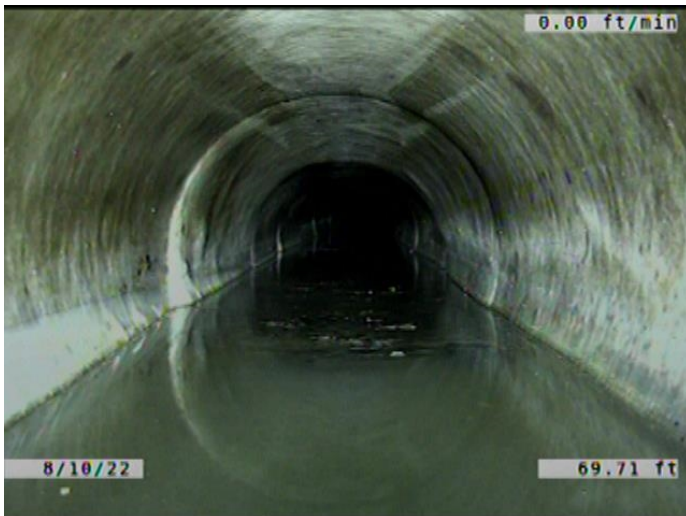
Code:	MWL
Description:	Miscellaneous Water Level
Distance (ft):	69.7
Structural Grade:	0
O&M Grade:	0
Clock Start/From:	
Clock To:	
1st Value:	
2nd Value:	
Value Percent:	30.000
Continuous Index:	
Within 8" of Joint:	NO
Remarks:

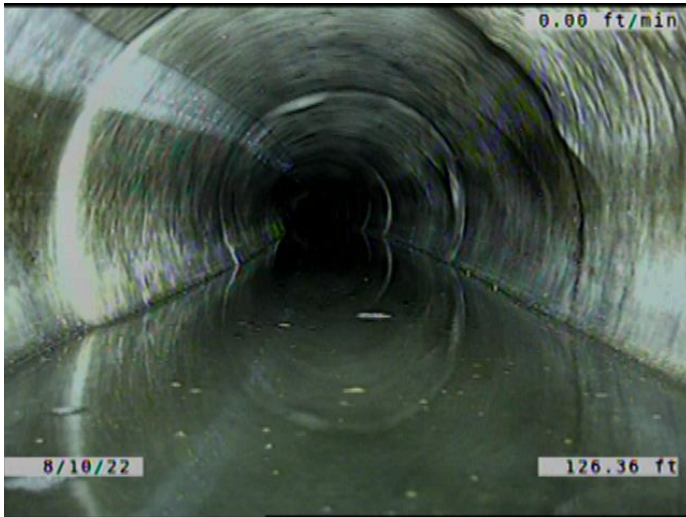
Code: **MWLS**
 Description: **Miscellaneous Water Level Sag**

Distance (ft): **126.4**
 Structural Grade: **2**
 O&M Grade: **0**
 Clock Start/From:
 Clock To:
 1st Value:
 2nd Value:
 Value Percent: **25.000**
 Continuous Index:
 Within 8" of Joint: **NO**
 Remarks:

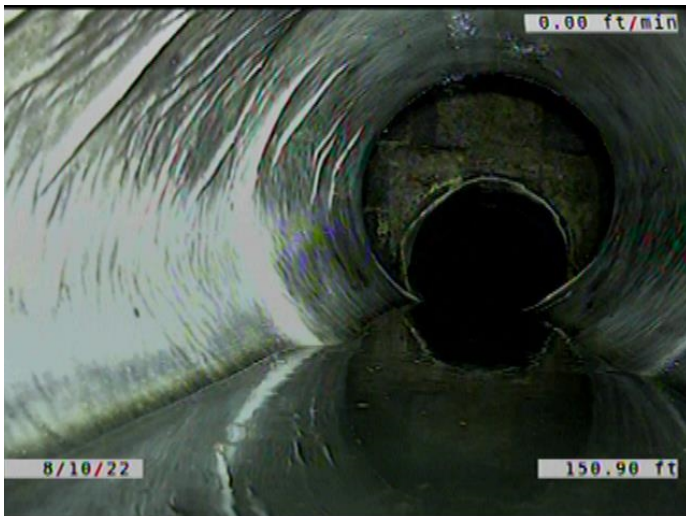
Code: **MWLS**
 Description: **Miscellaneous Water Level Sag**

Distance (ft): **150.9**
 Structural Grade: **2**
 O&M Grade: **0**
 Clock Start/From:
 Clock To:
 1st Value:
 2nd Value:
 Value Percent: **25.000**
 Continuous Index:
 Within 8" of Joint: **NO**
 Remarks:

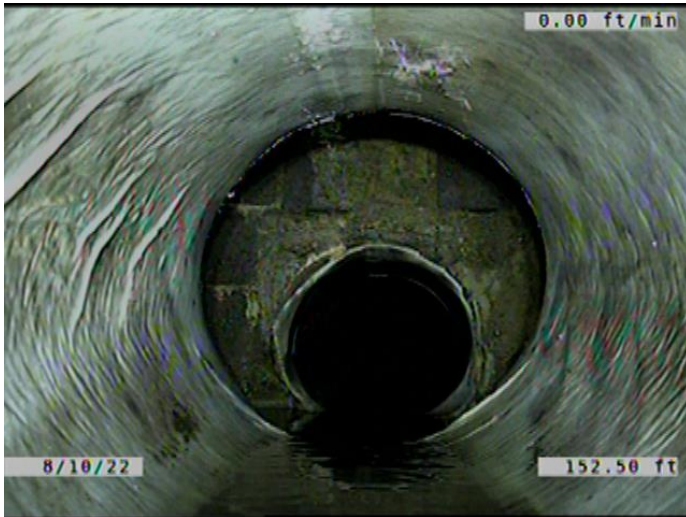
Code: **MWL**
 Description: **Miscellaneous Water Level**

Distance (ft): **152.5**
 Structural Grade: **0**
 O&M Grade: **0**
 Clock Start/From:
 Clock To:
 1st Value:
 2nd Value:
 Value Percent: **5.000**
 Continuous Index:
 Within 8" of Joint: **NO**
 Remarks:

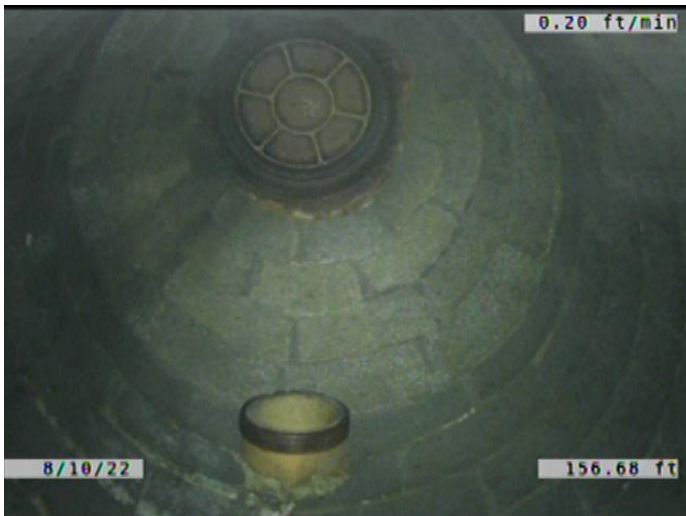
Code: **AMH**
 Description: **Manhole**

Distance (ft): **156.7**
 Structural Grade: **0**
 O&M Grade: **0**
 Clock Start/From:
 Clock To:
 1st Value:
 2nd Value:
 Value Percent:
 Continuous Index:
 Within 8" of Joint: **NO**
 Remarks: **M-504-028**
