Profile/Photo Observation Report

Street:	S WILSON ST & W CLEVELAND AVE	Flow Control:	Not Controlled
City:	Hobart, IN	Year Renewed:	
Location:	Light Highway	Tape/Media #:	
Purpose:	Routine Assessment	Dia/Height:	10"
Use:	Sanitary	Material:	VCP
Drain Area:	NA	Lining:	
Category:	NA		
Comment:	P_C at 33 ft debris . Flow direction wrong		
Location Details:		Direction of Survey:	Upstream
US MH:	M-404-001	DS MH:	M-505-070
		Total Length Surveyed (ft):	34.4

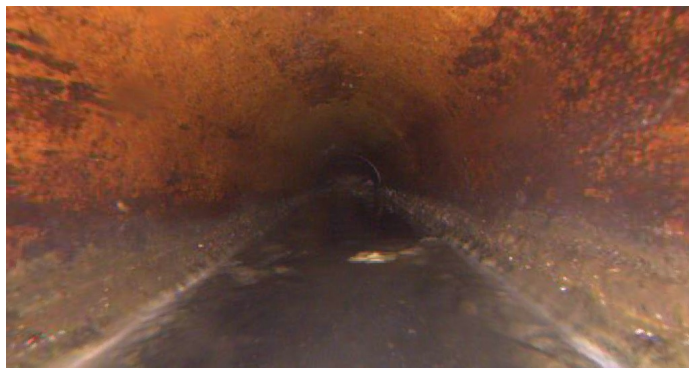
Code: **AMH**
 Description: **Manhole**

Distance (ft): **.0**
 Structural Grade: **0**
 O&M Grade: **0**
 Clock Start/From:
 Clock To:
 1st Value:
 2nd Value:
 Value Percent:
 Continuous Index:
 Within 8" of Joint: **NO**
 Remarks: **M-505-070**

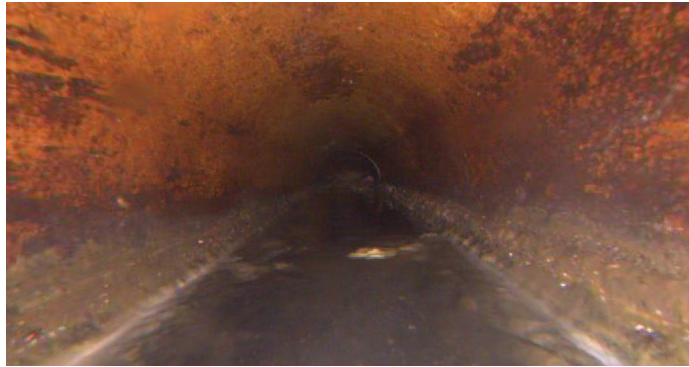
Code: **MWL**
Description: **Water Level**

Distance (ft): **.0**
Structural Grade: **0**
O&M Grade: **0**
Clock Start/From:
Clock To:
1st Value:
2nd Value:
Value Percent: **10.000**
Continuous Index:
Within 8" of Joint: **NO**
Remarks:
