Profile/Photo Observation Report

Street:	FOXCROFT STREET	Flow Control:	Not Controlled
City:	Hobart, IN	Year Renewed:	
Location:	Light Highway	Tape/Media #:	
Purpose:	Routine Assessment	Dia/Height:	10"
Use:	Sanitary	Material:	VCP
Drain Area:	NA	Lining:	
Category:	NA		
Comment:	P_C at 33 ft debris . Flow direction wrong		
Location Details:		Direction of Survey:	Upstream
US MH:	M-404-001	DS MH:	M-505-070
		Total Length Surveyed (ft):	34.4

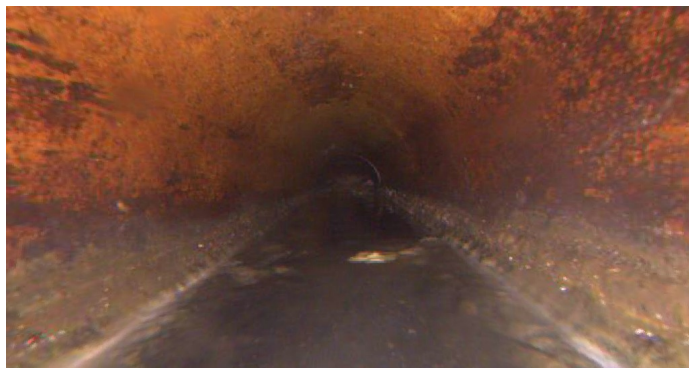
Code: **AMH**
Description: **Manhole**

Distance (ft): **.0**
Structural Grade: **0**
O&M Grade: **0**
Clock Start/From:
Clock To:
1st Value:
2nd Value:
Value Percent:
Continuous Index:
Within 8" of Joint: **NO**
Remarks: **M-505-070**

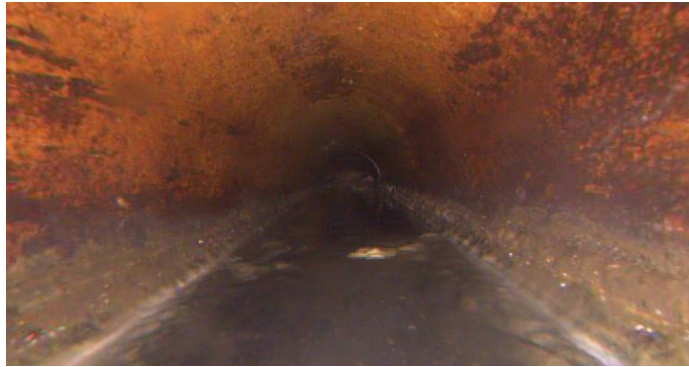
Code: **MWL**
Description: **Water Level**

Distance (ft): **.0**
Structural Grade: **0**
O&M Grade: **0**
Clock Start/From:
Clock To:
1st Value:
2nd Value:
Value Percent: **10.000**
Continuous Index:
Within 8" of Joint: **NO**
Remarks:

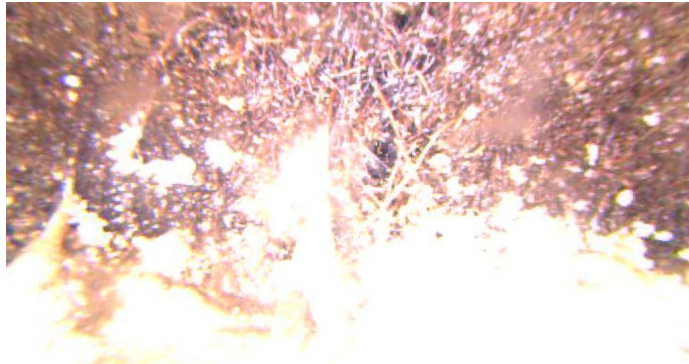
Code: **RMB**
Description: **Roots Medium Barrel**

Distance (ft): **8.8**
Structural Grade: **0**
O&M Grade: **4**
Clock Start/From: **12**
Clock To: **12**
1st Value:
2nd Value:
Value Percent: **40.000**
Continuous Index:
Within 8" of Joint: **NO**
Remarks:

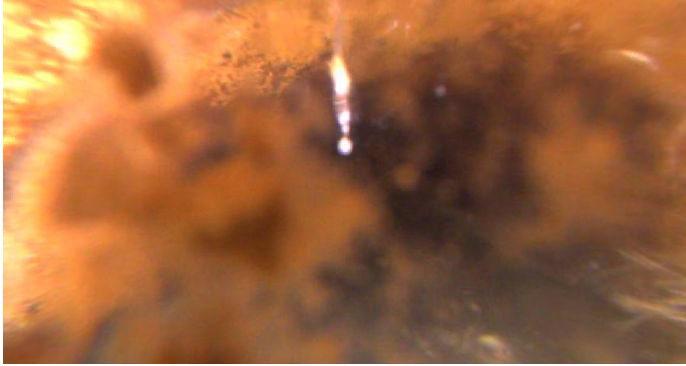
Code: **RFJ**
Description: **Roots Fine Joint**

Distance (ft): **16.7**
Structural Grade: **0**
O&M Grade: **1**
Clock Start/From: **8**
Clock To: **5**
1st Value:
2nd Value:
Value Percent:
Continuous Index:
Within 8" of Joint: **YES**
Remarks:

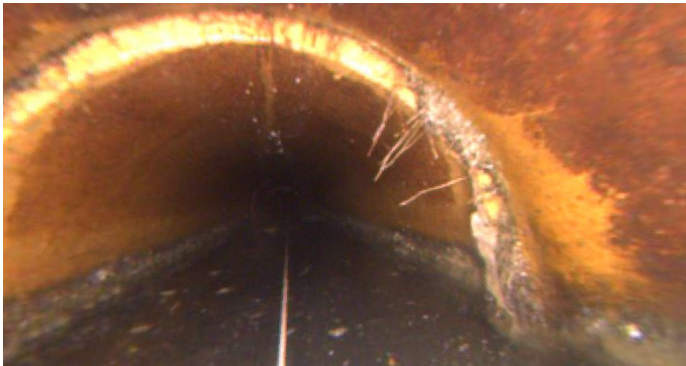
Code: **RFJ**
Description: **Roots Fine Joint**

Distance (ft): **29.1**
Structural Grade: **0**
O&M Grade: **1**
Clock Start/From: **12**
Clock To: **7**
1st Value:
2nd Value:
Value Percent:
Continuous Index:
Within 8" of Joint: **YES**
Remarks:

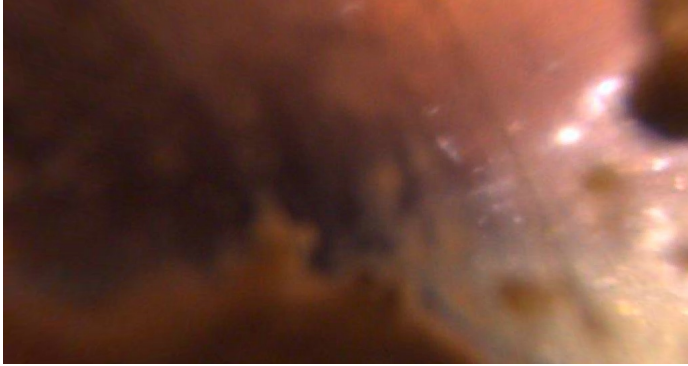
Code:	MSA
Description:	Abandoned Survey
Distance (ft):	34.4
Structural Grade:	0
O&M Grade:	0
Clock Start/From:	
Clock To:	
1st Value:	
2nd Value:	
Value Percent:	
Continuous Index:	
Within 8" of Joint:	NO
Remarks:	Debris
