Profile/Photo Observation Report

Date:	04/27/2018	Weather:		Coding:	PACP 6.0
Pipe Length (ft):		Owner:	City of Hobart	Pre Clean:	Not Known
P.O.#:	122	Surveyor:	M. Pielacha	PSR:	P-404-002-001
Customer:	City of Hobart	Clean Date:		Shape:	C

Street:	West Cleveland Avenue	Flow Control:	Not Controlled
City:	Hobart, IN	Year Renewed:	
Location:	Light Highway	Tape/Media #:	DEP-122
Purpose:	Routine Assessment	Dia/Height:	15"
Use:	Sanitary	Material:	VCP
Drain Area:		Lining:	
Category:	NA		
Comment:	YES501824 Submittal 2		
Location Details:		Direction of Survey:	Downstream
US MH:	M-404-002	DS MH:	M-404-001
		Total Length Surveyed (ft):	161.4

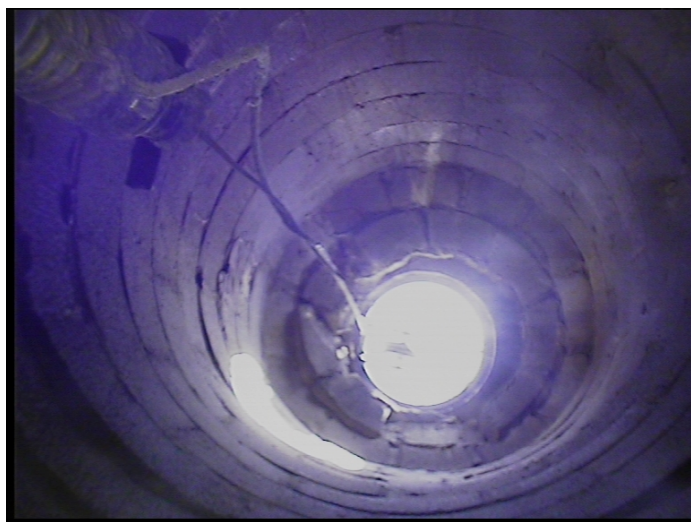
Code: **AMH**
Description: **Manhole**

Distance (ft): **.0**
Structural Grade: **0**
O&M Grade: **0**
Clock Start/From:
Clock To:
1st Value:
2nd Value:
Value Percent:
Continuous Index:
Within 8" of Joint: **NO**
Remarks: **M-404-002**

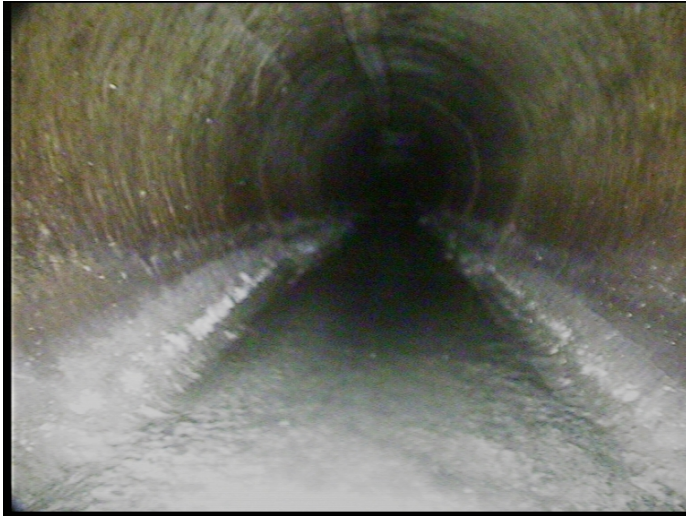
Code: **MWL**
Description: **Water Level**

Distance (ft): **.0**
Structural Grade: **0**
O&M Grade: **0**
Clock Start/From:
Clock To:
1st Value:
2nd Value:
Value Percent: **5.000**
Continuous Index:
Within 8" of Joint: **NO**
Remarks:

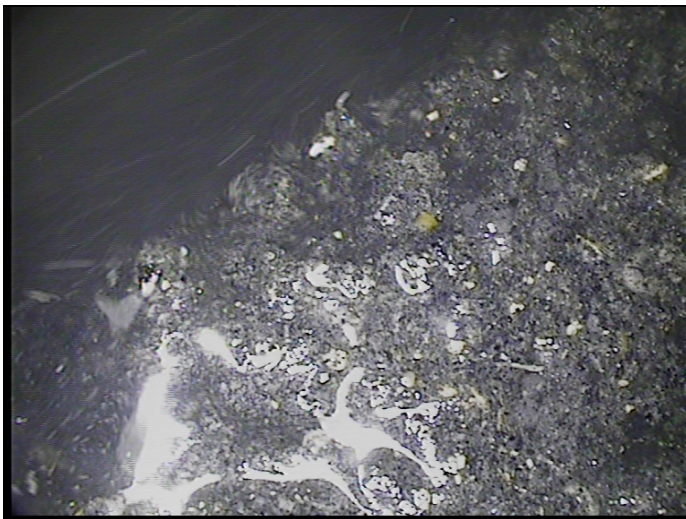
Code: **DSF**
Description: **Deposits Settled Fine**

Distance (ft): **109.8**
Structural Grade: **0**
O&M Grade: **3**
Clock Start/From: **4**
Clock To: **8**
1st Value:
2nd Value:
Value Percent: **15.000**
Continuous Index:
Within 8" of Joint: **NO**
Remarks:

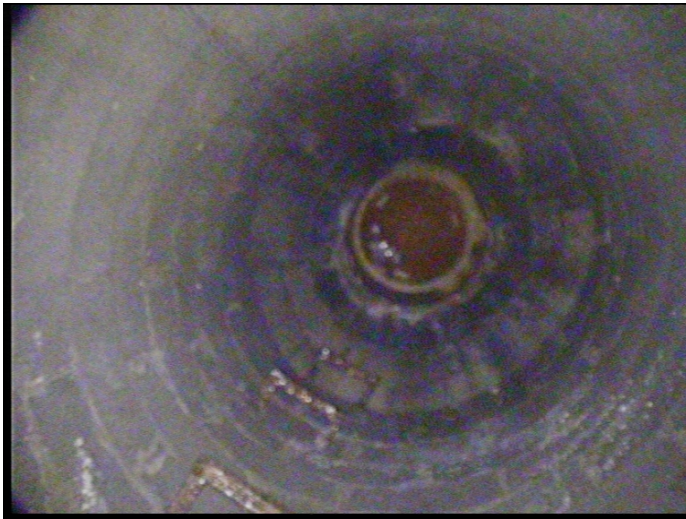
Code:	AMH
Description:	Manhole
Distance (ft):	161.4
Structural Grade:	0
O&M Grade:	0
Clock Start/From:	
Clock To:	
1st Value:	
2nd Value:	
Value Percent:	
Continuous Index:	
Within 8" of Joint:	NO
Remarks:	M-404-001
