Profile/Photo Observation Report

Street:	West Cleveland Avenue	Flow Control:	Not Controlled
City:	Hobart, IN	Year Renewed:	
Location:	Light Highway	Tape/Media #:	123
Purpose:	Routine Assessment	Dia/Height:	15"
Use:	Sanitary	Material:	VCP
Drain Area:		Lining:	
Category:	NA		
Comment:	YES501824 Submittal 2		
Location Details:		Direction of Survey:	Upstream
US MH:	M-404-002.1	DS MH:	M-404-002
		Total Length Surveyed (ft):	161.5

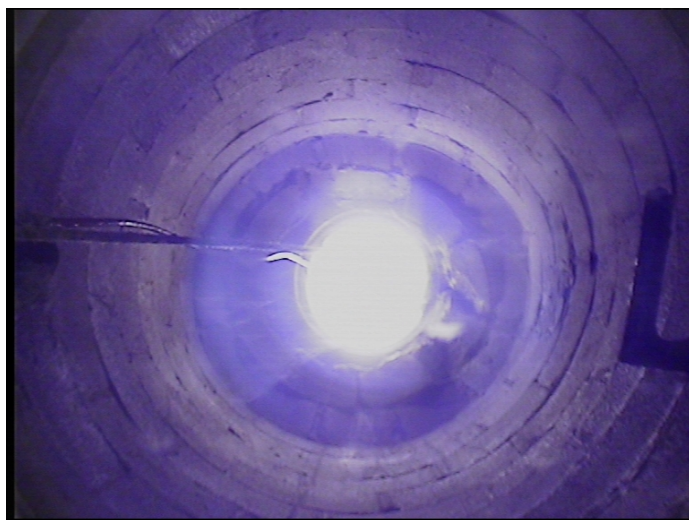
Code: **AMH**
Description: **Manhole**

Distance (ft): **.0**
Structural Grade: **0**
O&M Grade: **0**
Clock Start/From:
Clock To:
1st Value:
2nd Value:
Value Percent:
Continuous Index:
Within 8" of Joint: **NO**
Remarks: **M-404-002**

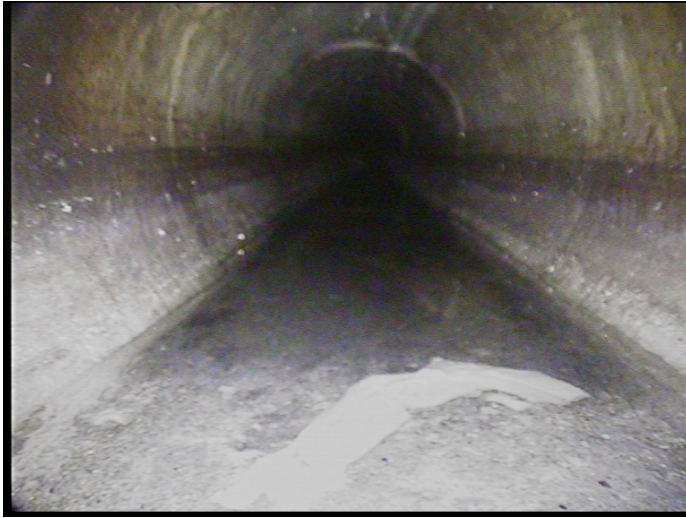
Code: **MWL**
Description: **Water Level**

Distance (ft): **.0**
Structural Grade: **0**
O&M Grade: **0**
Clock Start/From:
Clock To:
1st Value:
2nd Value:
Value Percent: **5.000**
Continuous Index:
Within 8" of Joint: **NO**
Remarks:

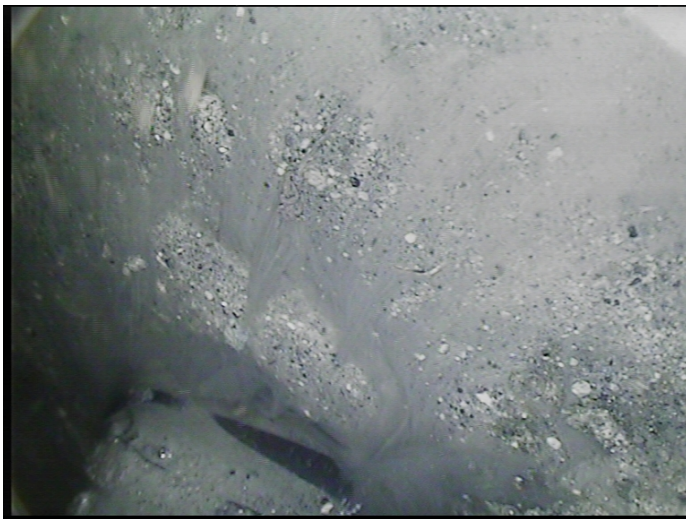
Code: **DSF**
Description: **Deposits Settled Fine**

Distance (ft): **152.6**
Structural Grade: **0**
O&M Grade: **2**
Clock Start/From: **4**
Clock To: **8**
1st Value:
2nd Value:
Value Percent: **10.000**
Continuous Index:
Within 8" of Joint: **NO**
Remarks:

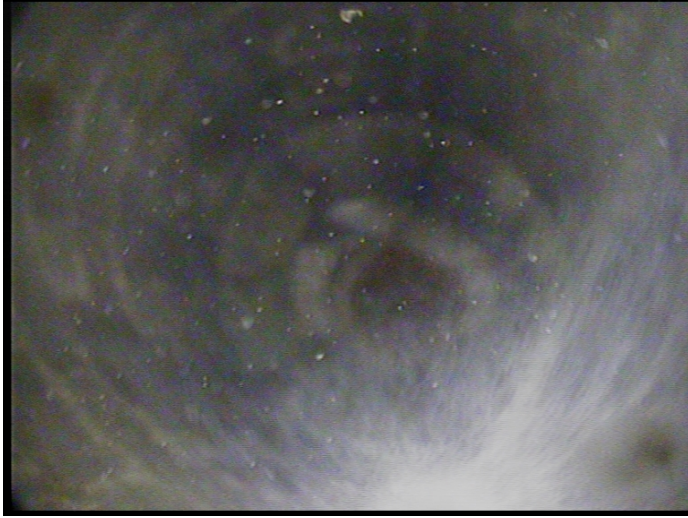
Code:	AMH
Description:	Manhole
Distance (ft):	161.5
Structural Grade:	0
O&M Grade:	0
Clock Start/From:	
Clock To:	
1st Value:	
2nd Value:	
Value Percent:	
Continuous Index:	
Within 8" of Joint:	NO
Remarks:	M-404-002.1
