Profile/Photo Observation Report

Street:	West Cleveland Avenue	Flow Control:	Not Controlled
City:	Hobart, IN	Year Renewed:	
Location:	Local rural streets with light traffic, t	Tape/Media #:	
Purpose:	Routine Assessment	Dia/Height:	15"
Use:	Sanitary Sewage Pipe	Material:	VCP
Drain Area:		Lining:	None
Category:	NA		
Comment:			
Location Details:		Direction of Survey:	Upstream
US MH:	UNK WABASH ST	DS MH:	M-404-002.1
		Total Length Surveyed (ft):	27.7

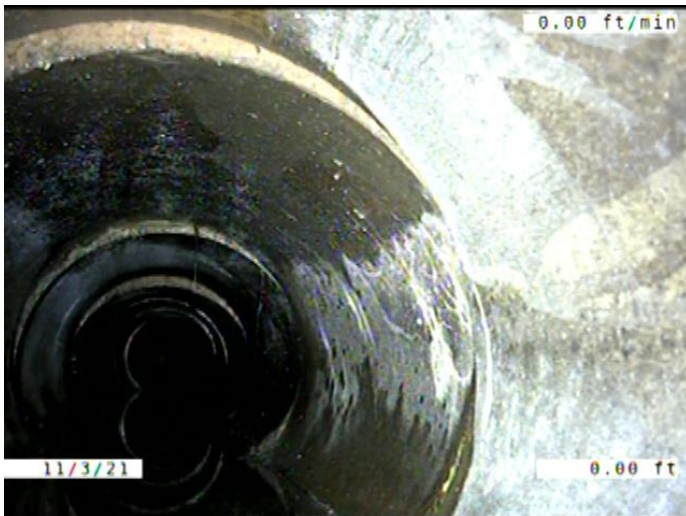
Code: **MWL**
 Description: **Miscellaneous Water Level**

Distance (ft): **.0**
 Structural Grade: **0**
 O&M Grade: **0**
 Clock Start/From:
 Clock To:
 1st Value:
 2nd Value:
 Value Percent: **5.000**
 Continuous Index:
 Within 8" of Joint: **NO**
 Remarks:

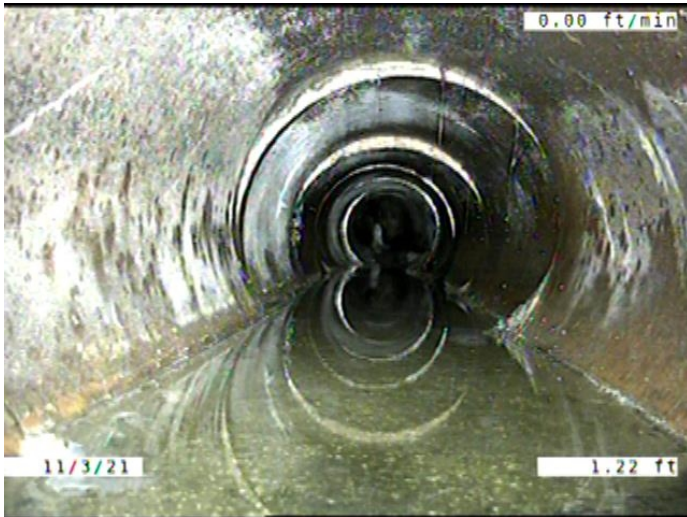
Code: **DSF**
 Description: **Deposits Settled Fine**

Distance (ft): **1.2**
 Structural Grade: **0**
 O&M Grade: **2**
 Clock Start/From: **5**
 Clock To: **7**
 1st Value:
 2nd Value:
 Value Percent: **5.000**
 Continuous Index: **S01**
 Within 8" of Joint: **YES**
 Remarks:

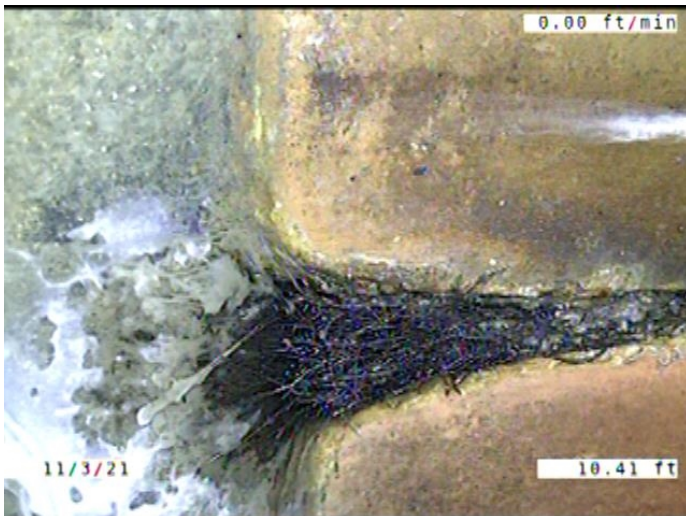
Code: **RFJ**
 Description: **Roots Fine Joint**

Distance (ft): **10.4**
 Structural Grade: **0**
 O&M Grade: **1**
 Clock Start/From: **8**
 Clock To: **10**
 1st Value:
 2nd Value:
 Value Percent:
 Continuous Index:
 Within 8" of Joint: **YES**
 Remarks:
