Profile/Photo Observation Report

Street:	W 43RD PL	Flow Control:	Not Controlled
City:	Hobart, IN	Year Renewed:	
Location:	Light Highway	Tape/Media #:	
Purpose:	Not Known	Dia/Height:	10"
Use:	Sanitary	Material:	VCP
Drain Area:	NA	Lining:	
Category:	NA		
Comment:

Location Details:		Direction of Survey:	Downstream
US MH:	M-404-007	DS MH:	M-404-006
		Total Length Surveyed (ft):	7.4

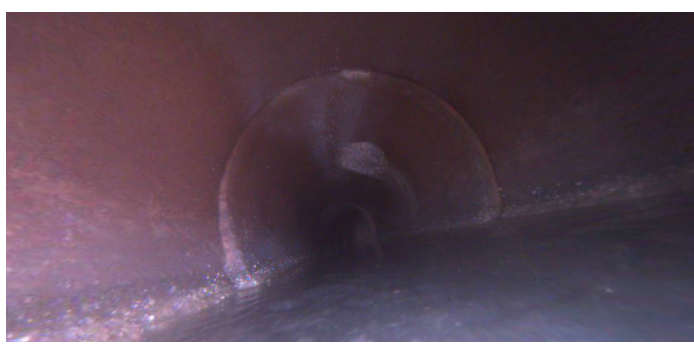
Code: **AMH**
Description: **Manhole**

Distance (ft): **.0**
Structural Grade: **0**
O&M Grade: **0**
Clock Start/From:
Clock To:
1st Value:
2nd Value:
Value Percent:
Continuous Index:
Within 8" of Joint: **NO**
Remarks: **M-404-007**

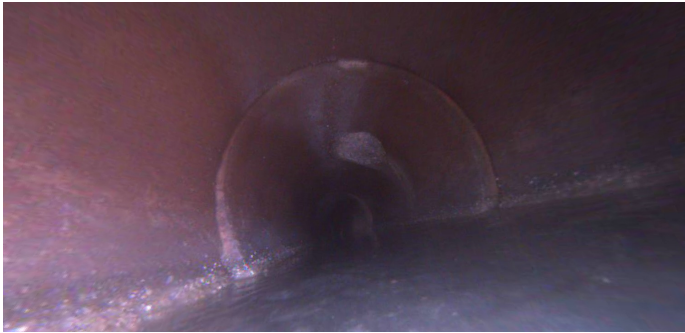
Code:	MWL
Description:	Water Level

Distance (ft):	.0
Structural Grade:	0
O&M Grade:	0
Clock Start/From:	
Clock To:	
1st Value:	
2nd Value:	
Value Percent:	20.000
Continuous Index:	
Within 8" of Joint:	NO
Remarks:

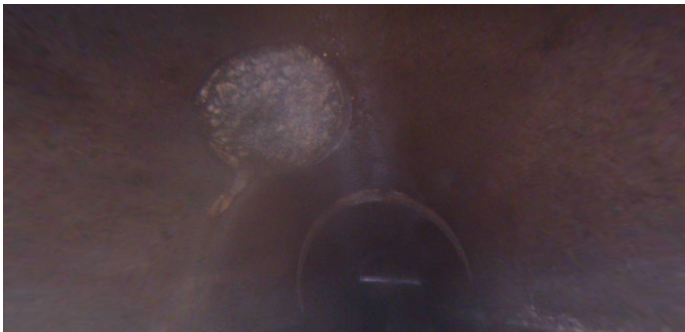
Code:	TFC
Description:	Tap Factory Capped

Distance (ft):	3.4
Structural Grade:	0
O&M Grade:	0
Clock Start/From:	2
Clock To:	
1st Value:	4.000
2nd Value:	
Value Percent:	
Continuous Index:	
Within 8" of Joint:	
Remarks:

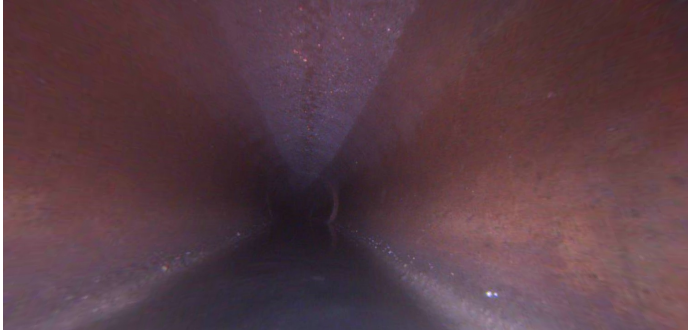
Code:	MSA
Description:	Abandoned Survey
Distance (ft):	7.4
Structural Grade:	0
O&M Grade:	0
Clock Start/From:	
Clock To:	
1st Value:	
2nd Value:	
Value Percent:	
Continuous Index:	
Within 8" of Joint:	NO
Remarks:	unknown
