## Profile/Photo Observation Report

Street:	<b>Summerlin</b>	Flow Control:	<b>Not Controlled</b>
City:	<b>Hobart, IN</b>	Year Renewed:	
Location:	<b>Light Highway</b>	Tape/Media #:	
Purpose:	<b>Not Known</b>	Dia/Height:	<b>10"</b>
Use:	<b>Sanitary</b>	Material:	<b>VCP</b>
Drain Area:	<b>NA</b>	Lining:	
Category:	<b>NA</b>		
Comment:

Location Details:		Direction of Survey:	<b>Downstream</b>
US MH:	<b>M-404-007</b>	DS MH:	<b>M-404-006</b>
		Total Length Surveyed (ft):	<b>7.4</b>

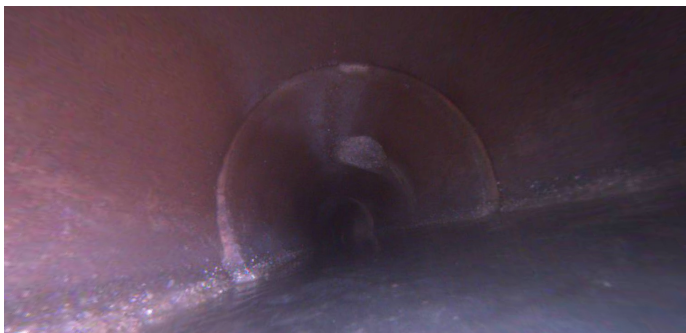
Code: **AMH**  
Description: **Manhole**

Distance (ft): **.0**  
Structural Grade: **0**  
O&M Grade: **0**  
Clock Start/From:  
Clock To:  
1st Value:  
2nd Value:  
Value Percent:  
Continuous Index:  
Within 8" of Joint: **NO**  
Remarks: **M-404-007**

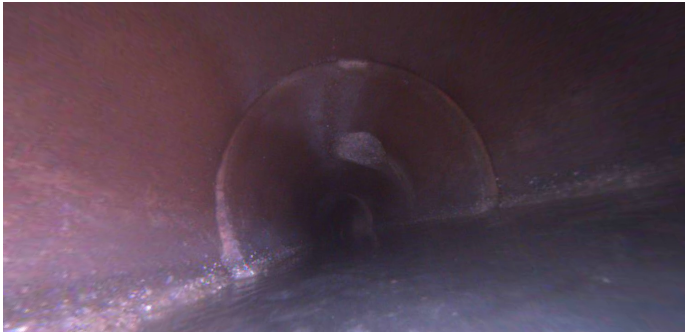
Code:	<b>MWL</b>
Description:	<b>Water Level</b>

Distance (ft):	<b>.0</b>
Structural Grade:	<b>0</b>
O&M Grade:	<b>0</b>
Clock Start/From:	
Clock To:	
1st Value:	
2nd Value:	
Value Percent:	<b>20.000</b>
Continuous Index:	
Within 8" of Joint:	<b>NO</b>
Remarks:

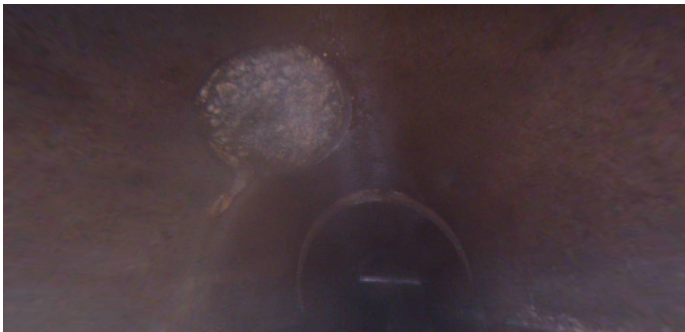
Code:	<b>TFC</b>
Description:	<b>Tap Factory Capped</b>

Distance (ft):	<b>3.4</b>
Structural Grade:	<b>0</b>
O&M Grade:	<b>0</b>
Clock Start/From:	<b>2</b>
Clock To:	
1st Value:	<b>4.000</b>
2nd Value:	
Value Percent:	
Continuous Index:	
Within 8" of Joint:	
Remarks:

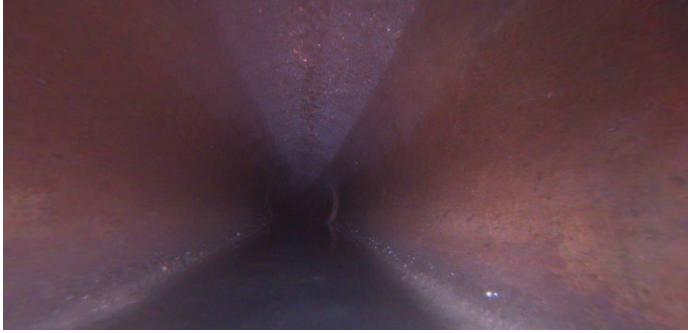
Code:	<b>MSA</b>
Description:	<b>Abandoned Survey</b>
Distance (ft):	<b>7.4</b>
Structural Grade:	<b>0</b>
O&M Grade:	<b>0</b>
Clock Start/From:	
Clock To:	
1st Value:	
2nd Value:	
Value Percent:	
Continuous Index:	
Within 8" of Joint:	<b>NO</b>
Remarks:	<b>unknown</b>
