Profile/Photo Observation Report

Street:	W 43RD PL	Flow Control:	Not Controlled
City:	Hobart, IN	Year Renewed:	
Location:	Light Highway	Tape/Media #:	
Purpose:	Not Known	Dia/Height:	10"
Use:	Sanitary	Material:	VCP
Drain Area:	NA	Lining:	
Category:	NA		
Comment:

Location Details:		Direction of Survey:	Upstream
US MH:	M-404-007	DS MH:	M-404-006
		Total Length Surveyed (ft):	20.3

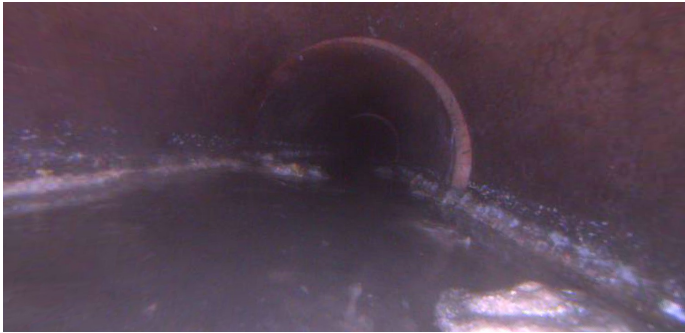
Code:	MWL
Description:	Water Level

Distance (ft):	.0
Structural Grade:	0
O&M Grade:	0
Clock Start/From:	
Clock To:	
1st Value:	
2nd Value:	
Value Percent:	30.000
Continuous Index:	
Within 8" of Joint:	NO
Remarks:

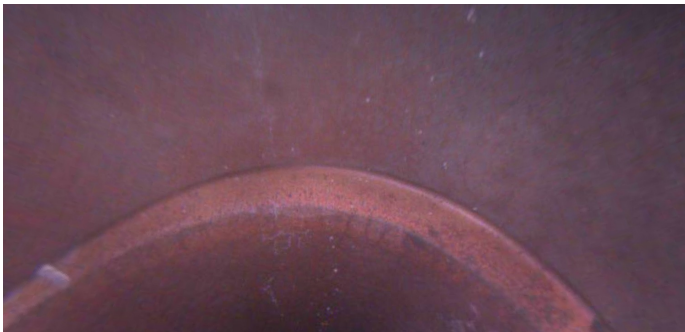
Code:	CL
Description:	Crack Longitudinal

Distance (ft):	4.9
Structural Grade:	2
O&M Grade:	0
Clock Start/From:	12
Clock To:	
1st Value:	
2nd Value:	
Value Percent:	
Continuous Index:	
Within 8" of Joint:	YES
Remarks:

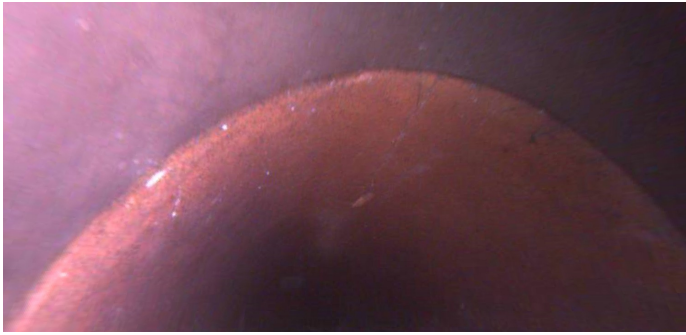
Code: **FL**
Description: **Fracture Longitudinal**

Distance (ft): **8.1**
Structural Grade: **3**
O&M Grade: **0**
Clock Start/From: **12**
Clock To:
1st Value:
2nd Value:
Value Percent:
Continuous Index:
Within 8" of Joint: **YES**
Remarks:

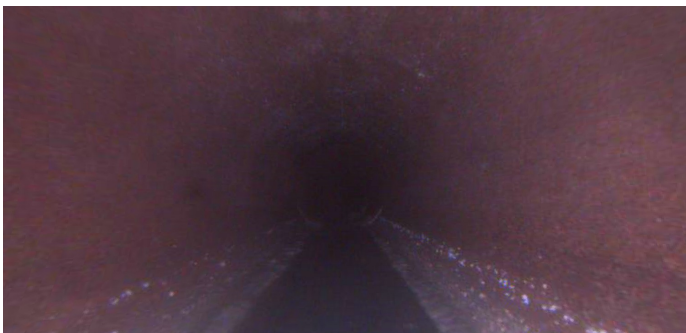
Code: **MSA**
Description: **Abandoned Survey**

Distance (ft): **20.3**
Structural Grade: **0**
O&M Grade: **0**
Clock Start/From:
Clock To:
1st Value:
2nd Value:
Value Percent:
Continuous Index:
Within 8" of Joint: **NO**
Remarks: **UNKNOWN**
