Profile/Photo Observation Report

Date:	04/20/2018	Weather:		Coding:	PACP 6.0
Pipe Length (ft):	12.6	Owner:	NA	Pre Clean:	Not Known
P.O.#:		Surveyor:	Jen Costello	PSR:	P-404-009-008
Customer:		Clean Date:	01/01/1900	Shape:	C

Street:	ALLEY BETWEEN N WABASH ST & N	Flow Control:	Not Controlled
City:	Hobart, IN	Year Renewed:	
Location:	Light Highway	Tape/Media #:	
Purpose:	Not Known	Dia/Height:	10"
Use:	Sanitary	Material:	PVC
Drain Area:	NA	Lining:	
Category:	NA		
Comment:

Location Details:		Direction of Survey:	Downstream
US MH:	M-404-009	DS MH:	M-404-008
		Total Length Surveyed (ft):	11.3

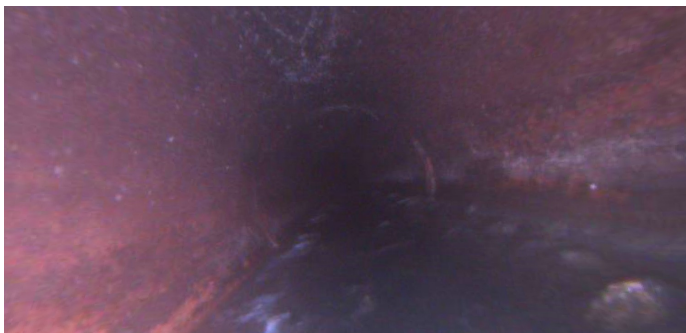
Code: **AMH**
Description: **Manhole**

Distance (ft): **.0**
Structural Grade: **0**
O&M Grade: **0**
Clock Start/From:
Clock To:
1st Value:
2nd Value:
Value Percent:
Continuous Index:
Within 8" of Joint: **NO**
Remarks: **M-404-009**

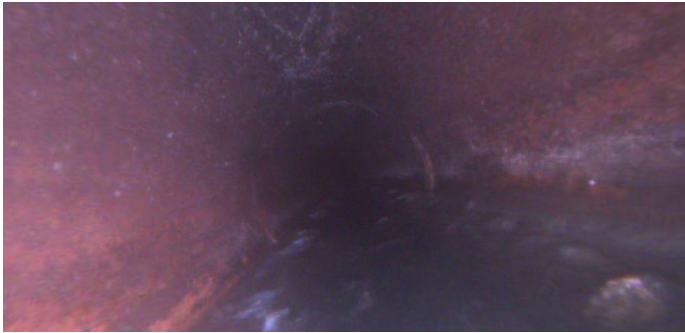
Code:	MWL
Description:	Water Level

Distance (ft):	.0
Structural Grade:	0
O&M Grade:	0
Clock Start/From:	
Clock To:	
1st Value:	
2nd Value:	
Value Percent:	10.000
Continuous Index:	
Within 8" of Joint:	NO
Remarks:

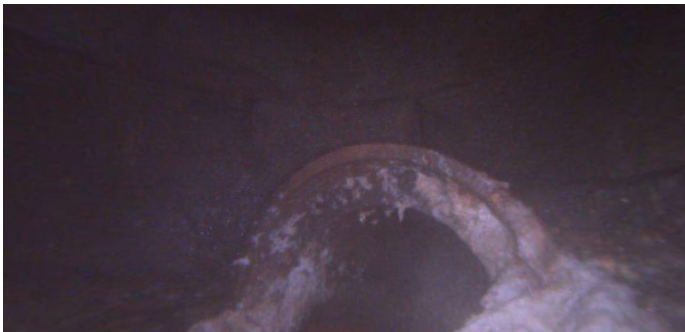
Code:	AMH
Description:	Manhole

Distance (ft):	11.3
Structural Grade:	0
O&M Grade:	0
Clock Start/From:	
Clock To:	
1st Value:	
2nd Value:	
Value Percent:	
Continuous Index:	
Within 8" of Joint:	NO
Remarks:	M-404-008
