Profile/Photo Observation Report

Street:	Summerlin	Flow Control:	Not Controlled
City:	Hobart, IN	Year Renewed:	
Location:	Light Highway	Tape/Media #:	
Purpose:	Not Known	Dia/Height:	10"
Use:	Sanitary	Material:	PVC
Drain Area:	NA	Lining:	
Category:	NA		
Comment:

Location Details:		Direction of Survey:	Downstream
US MH:	M-404-009	DS MH:	M-404-008
		Total Length Surveyed (ft):	11.3

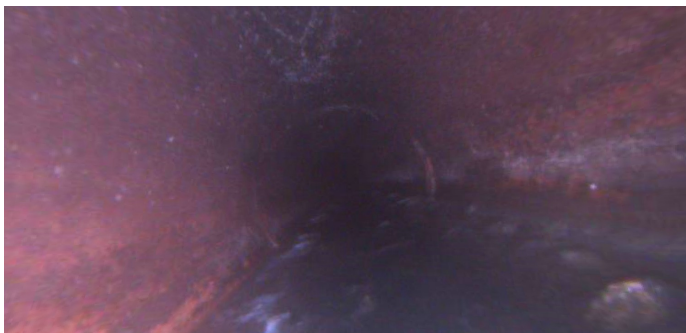
Code: **AMH**
Description: **Manhole**

Distance (ft): **.0**
Structural Grade: **0**
O&M Grade: **0**
Clock Start/From:
Clock To:
1st Value:
2nd Value:
Value Percent:
Continuous Index:
Within 8" of Joint: **NO**
Remarks: **M-404-009**

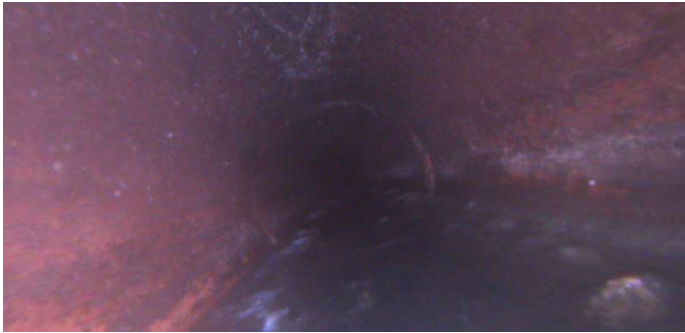
Code:	MWL
Description:	Water Level

Distance (ft):	.0
Structural Grade:	0
O&M Grade:	0
Clock Start/From:	
Clock To:	
1st Value:	
2nd Value:	
Value Percent:	10.000
Continuous Index:	
Within 8" of Joint:	NO
Remarks:

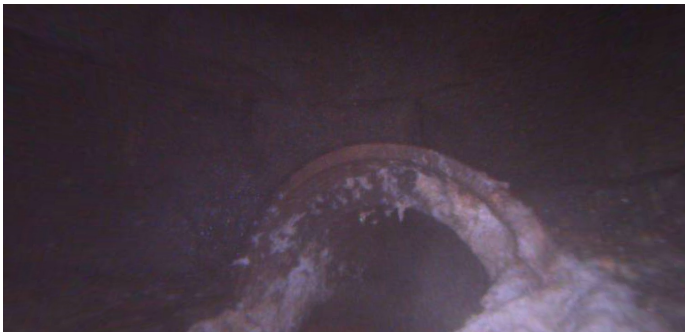
Code:	AMH
Description:	Manhole

Distance (ft):	11.3
Structural Grade:	0
O&M Grade:	0
Clock Start/From:	
Clock To:	
1st Value:	
2nd Value:	
Value Percent:	
Continuous Index:	
Within 8" of Joint:	NO
Remarks:	M-404-008
