Profile/Photo Observation Report

Street:	N WABASH ST	Flow Control:	Not Controlled
City:	Hobart, IN	Year Renewed:	
Location:	Light Highway	Tape/Media #:	
Purpose:	Not Known	Dia/Height:	8"
Use:	Sanitary	Material:	VCP
Drain Area:	NA	Lining:	
Category:	NA		
Comment:			
Location Details:		Direction of Survey:	Upstream
US MH:	M-404-010	DS MH:	M-404-009
		Total Length Surveyed (ft):	30.0

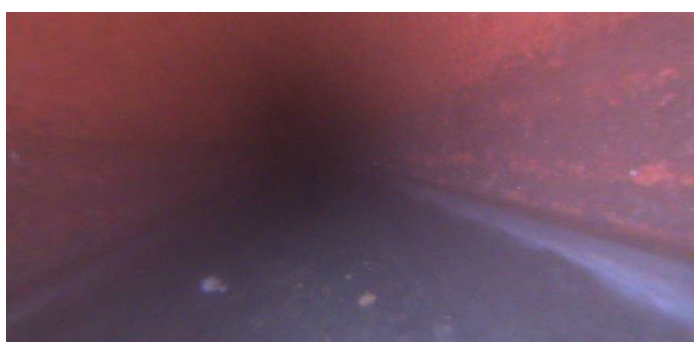
Code: **AMH**
Description: **Manhole**

Distance (ft): **.0**
Structural Grade: **0**
O&M Grade: **0**
Clock Start/From:
Clock To:
1st Value:
2nd Value:
Value Percent:
Continuous Index:
Within 8" of Joint: **NO**
Remarks: **M-404-010**

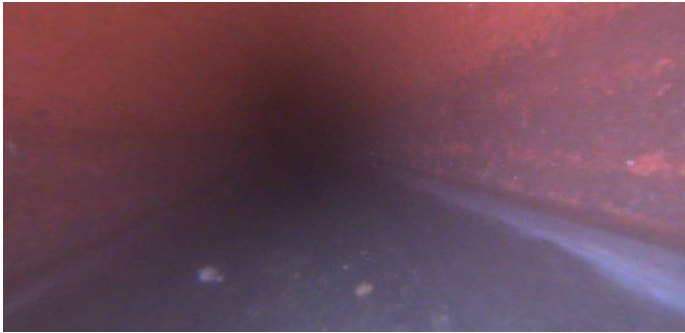
Code:	MWL
Description:	Water Level

Distance (ft):	.0
Structural Grade:	0
O&M Grade:	0
Clock Start/From:	
Clock To:	
1st Value:	
2nd Value:	
Value Percent:	10.000
Continuous Index:	
Within 8" of Joint:	NO
Remarks:

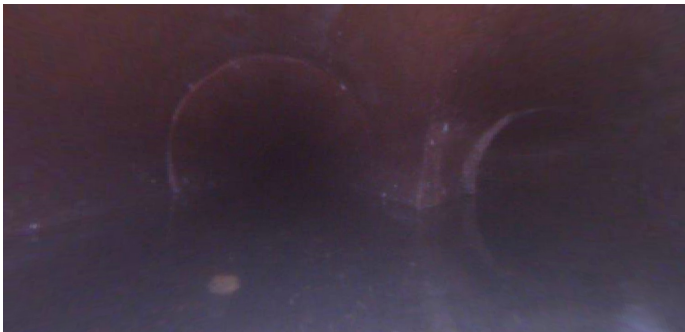
Code:	TF
Description:	Tap Factory

Distance (ft):	9.9
Structural Grade:	0
O&M Grade:	0
Clock Start/From:	3
Clock To:	
1st Value:	4.000
2nd Value:	
Value Percent:	
Continuous Index:	
Within 8" of Joint:	YES
Remarks:

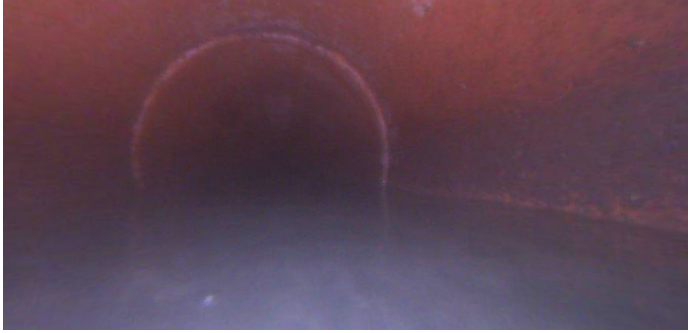
Code:	MSA
Description:	Abandoned Survey
Distance (ft):	30.0
Structural Grade:	0
O&M Grade:	0
Clock Start/From:	
Clock To:	
1st Value:	
2nd Value:	
Value Percent:	
Continuous Index:	
Within 8" of Joint:	NO
Remarks:	no blockage
