Profile/Photo Observation Report

Date:	10/24/2021	Weather:		Coding:	PACP 7.0
Pipe Length (ft):	159.8	Owner:	City of Hobart	Pre Clean:	Heavy Cleaning
P.O.#:	YES502259	Surveyor:	S. Bucklin	PSR:	P-404-010-009
Customer:	City of Hobart	Clean Date:	10/22/2021	Shape:	C

Location Details:		Direction of Survey:	Downstream
US MH:	M-404-010	DS MH:	M-404-009
		Total Length Surveyed (ft):	159.8

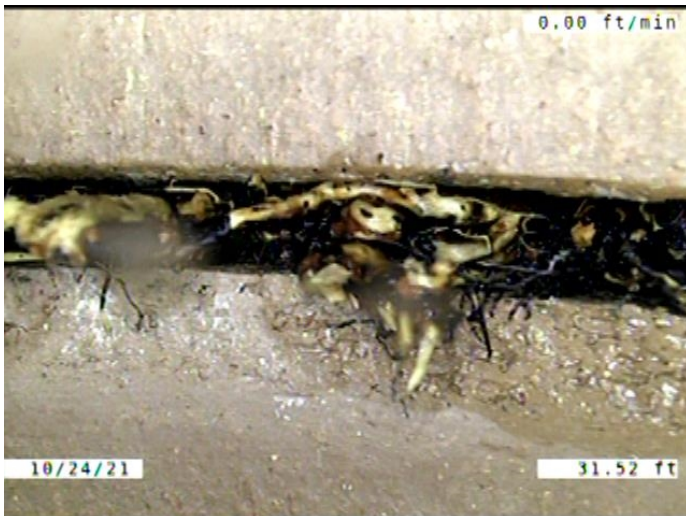
Code:	RFJ
Description:	Roots Fine Joint
Distance (ft):	31.5
Structural Grade:	0
O&M Grade:	1
Clock Start/From:	9
Clock To:	3
1st Value:	
2nd Value:	
Value Percent:	
Continuous Index:	
Within 8" of Joint:	YES
Remarks:
