Profile/Photo Observation Report

Date:	10/24/2021	Weather:		Coding:	PACP 7.0
Pipe Length (ft):	159.8	Owner:	City of Hobart	Pre Clean:	Heavy Cleaning
P.O.#:	YES502259	Surveyor:	S. Bucklin	PSR:	P-404-010-009
Customer:	City of Hobart	Clean Date:	10/22/2021	Shape:	C

Street:	North Wabash Street	Flow Control:	Not Controlled
City:	Hobart, IN	Year Renewed:	
Location:	Local rural streets with light traffic, t	Tape/Media #:	
Purpose:	Routine Assessment	Dia/Height:	8"
Use:	Sanitary Sewage Pipe	Material:	VCP
Drain Area:		Lining:	None
Category:	NA		
Comment:			
Location Details:		Direction of Survey:	Downstream
US MH:	M-404-010	DS MH:	M-404-009
		Total Length Surveyed (ft):	159.8

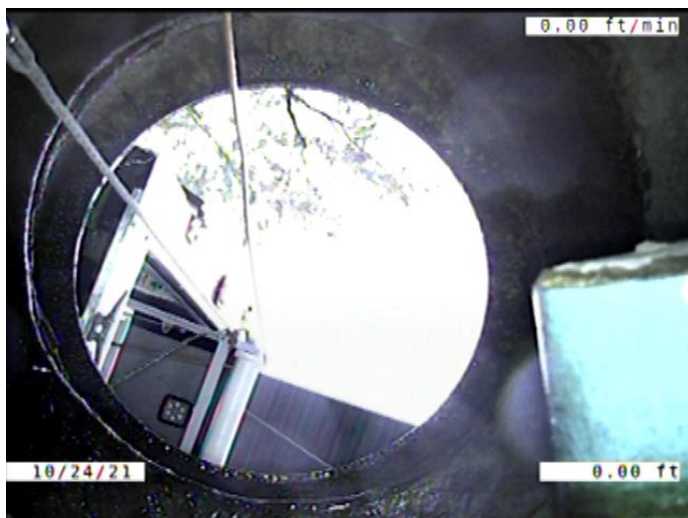
Code: **AMH**
 Description: **Manhole**

Distance (ft): **.0**
 Structural Grade: **0**
 O&M Grade: **0**
 Clock Start/From:
 Clock To:
 1st Value:
 2nd Value:
 Value Percent:
 Continuous Index:
 Within 8" of Joint: **NO**
 Remarks: **M-404-010**

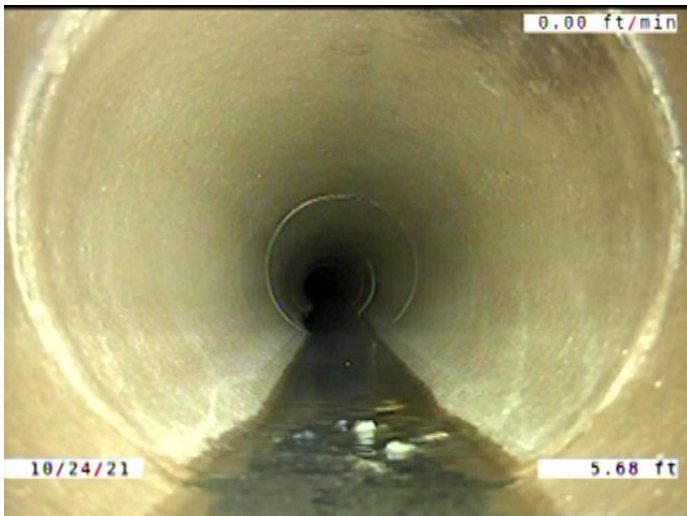
Code: **DSF**
 Description: **Deposits Settled Fine**

Distance (ft): **5.7**
 Structural Grade: **0**
 O&M Grade: **2**
 Clock Start/From: **5**
 Clock To: **7**
 1st Value:
 2nd Value:
 Value Percent: **5.000**
 Continuous Index: **S01**
 Within 8" of Joint: **YES**
 Remarks:

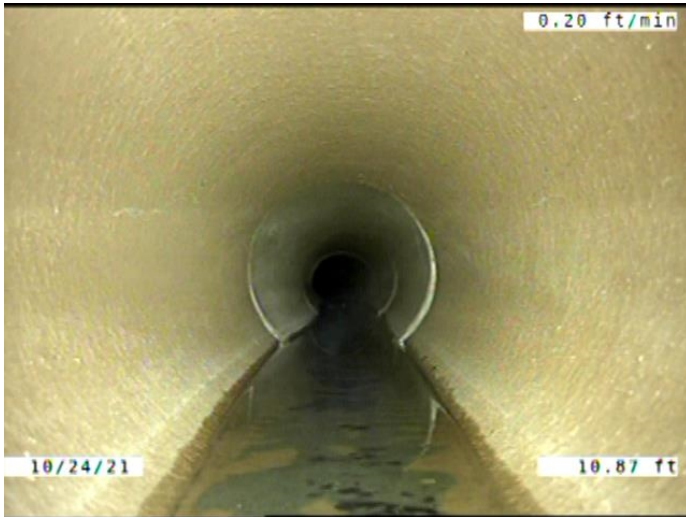
Code: **MWLS**
Description: **Miscellaneous Water Level Sag**

Distance (ft): **10.9**
Structural Grade: **2**
O&M Grade: **0**
Clock Start/From:
Clock To:
1st Value:
2nd Value:
Value Percent: **5.000**
Continuous Index: **S02**
Within 8" of Joint: **NO**
Remarks:

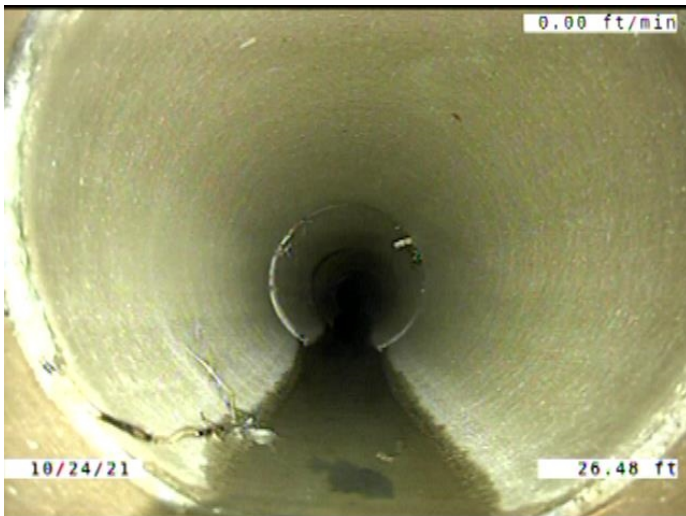
Code: **MWLS**
Description: **Miscellaneous Water Level Sag**

Distance (ft): **26.5**
Structural Grade: **2**
O&M Grade: **0**
Clock Start/From:
Clock To:
1st Value:
2nd Value:
Value Percent: **5.000**
Continuous Index: **F02**
Within 8" of Joint: **NO**
Remarks:

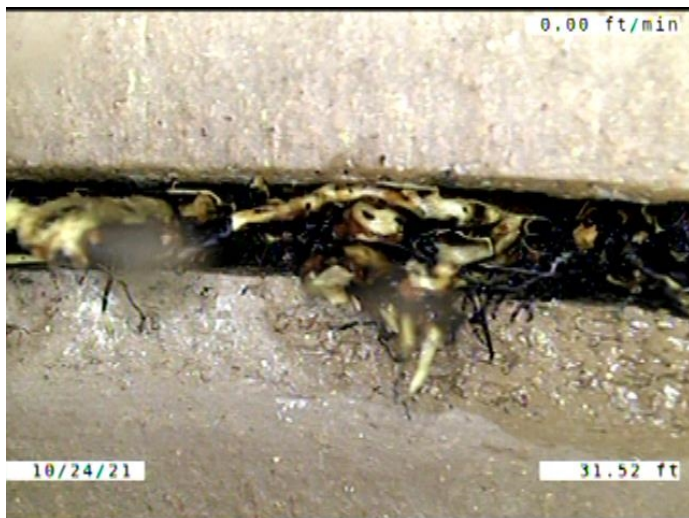
Code: **RFJ**
 Description: **Roots Fine Joint**

Distance (ft): **31.5**
 Structural Grade: **0**
 O&M Grade: **1**
 Clock Start/From: **9**
 Clock To: **3**
 1st Value:
 2nd Value:
 Value Percent:
 Continuous Index:
 Within 8" of Joint: **YES**
 Remarks:

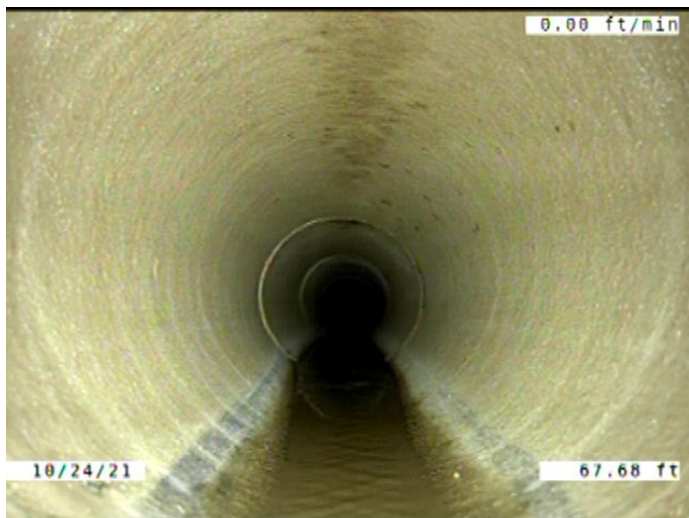
Code: **MWLS**
 Description: **Miscellaneous Water Level Sag**

Distance (ft): **67.7**
 Structural Grade: **2**
 O&M Grade: **0**
 Clock Start/From:
 Clock To:
 1st Value:
 2nd Value:
 Value Percent: **5.000**
 Continuous Index: **F03**
 Within 8" of Joint: **NO**
 Remarks:

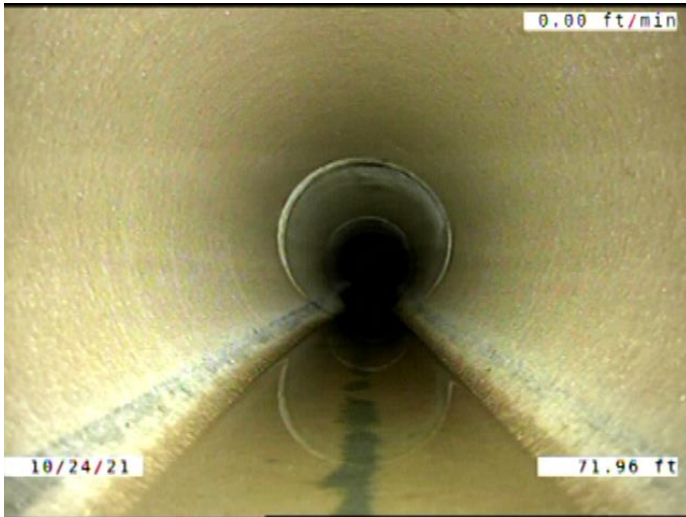
Code: **MWLS**
Description: **Miscellaneous Water Level Sag**

Distance (ft): **72.0**
Structural Grade: **2**
O&M Grade: **0**
Clock Start/From:
Clock To:
1st Value:
2nd Value:
Value Percent: **5.000**
Continuous Index: **S04**
Within 8" of Joint: **NO**
Remarks:

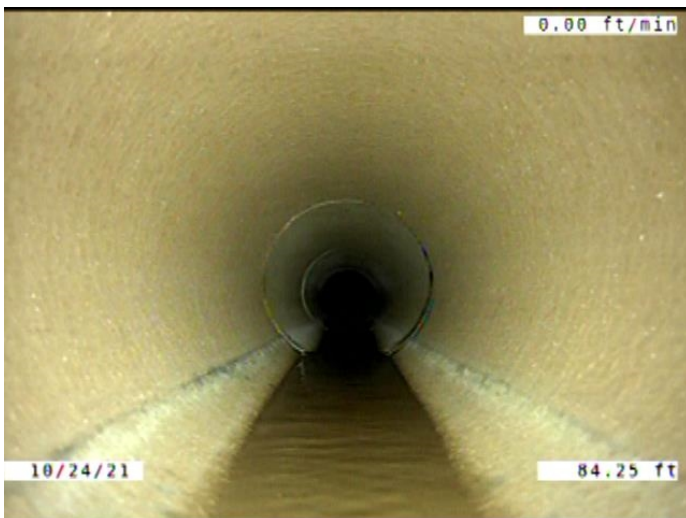
Code: **MWLS**
Description: **Miscellaneous Water Level Sag**

Distance (ft): **84.3**
Structural Grade: **2**
O&M Grade: **0**
Clock Start/From:
Clock To:
1st Value:
2nd Value:
Value Percent: **5.000**
Continuous Index: **F04**
Within 8" of Joint: **NO**
Remarks:

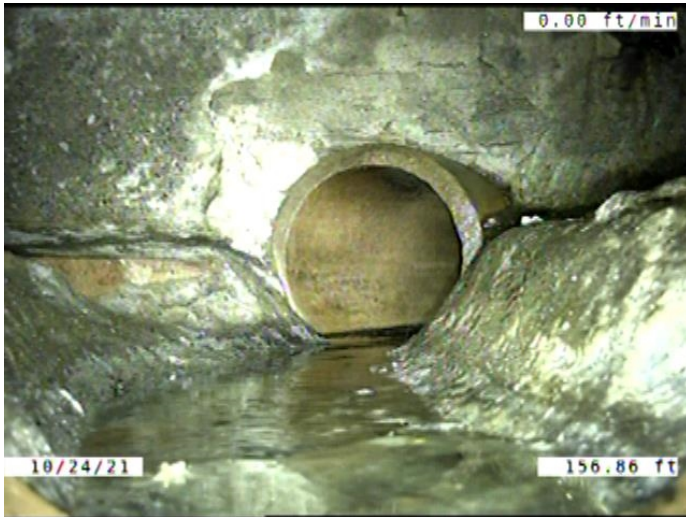
Code: **DSF**
 Description: **Deposits Settled Fine**

Distance (ft): **156.9**
 Structural Grade: **0**
 O&M Grade: **2**
 Clock Start/From: **5**
 Clock To: **7**
 1st Value:
 2nd Value:
 Value Percent: **5.000**
 Continuous Index: **F01**
 Within 8" of Joint: **YES**
 Remarks:
