Profile/Photo Observation Report

Date:	10/23/2021	Weather:		Coding:	PACP 7.0
Pipe Length (ft):	88.8	Owner:	City of Hobart	Pre Clean:	Heavy Cleaning
P.O.#:	YES502259	Surveyor:	S. Bucklin	PSR:	P-404-011-010
Customer:	City of Hobart	Clean Date:	10/22/2021	Shape:	C

Street:	North Wabash Street	Flow Control:	Not Controlled
City:	Hobart, IN	Year Renewed:	
Location:	Local rural streets with light traffic, t	Tape/Media #:	
Purpose:	Routine Assessment	Dia/Height:	8"
Use:	Sanitary Sewage Pipe	Material:	VCP
Drain Area:		Lining:	None
Category:	NA		
Comment:			
Location Details:		Direction of Survey:	Upstream
US MH:	M-404-011	DS MH:	M-404-010
		Total Length Surveyed (ft):	88.8

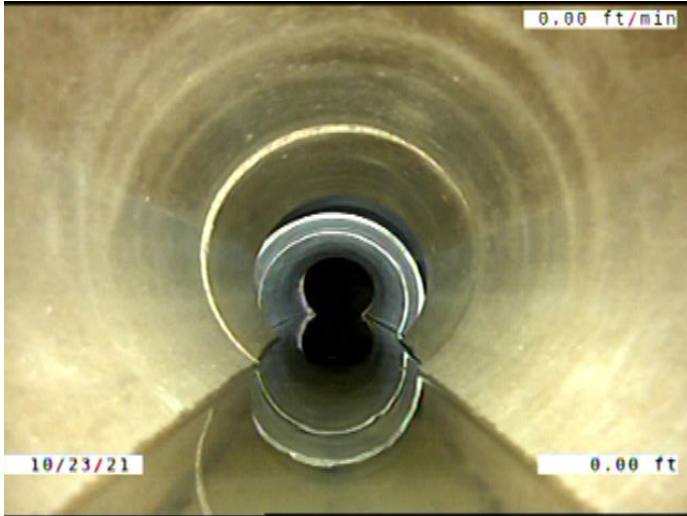
Code: **MWL**
Description: **Miscellaneous Water Level**

Distance (ft): **.0**
Structural Grade: **0**
O&M Grade: **0**
Clock Start/From:
Clock To:
1st Value:
2nd Value:
Value Percent: **5.000**
Continuous Index:
Within 8" of Joint: **NO**
Remarks:

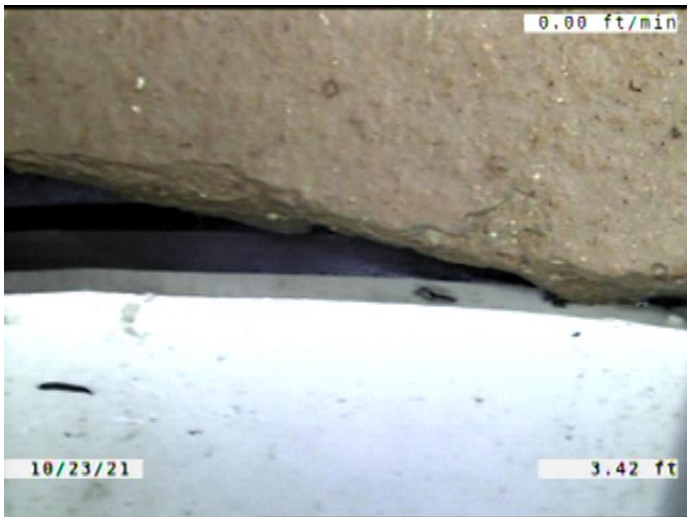
Code: **MMC**
Description: **Miscellaneous Material Change**

Distance (ft): **3.4**
Structural Grade: **0**
O&M Grade: **0**
Clock Start/From:
Clock To:
1st Value:
2nd Value:
Value Percent:
Continuous Index:
Within 8" of Joint: **NO**
Remarks: **VCP TO PVC**

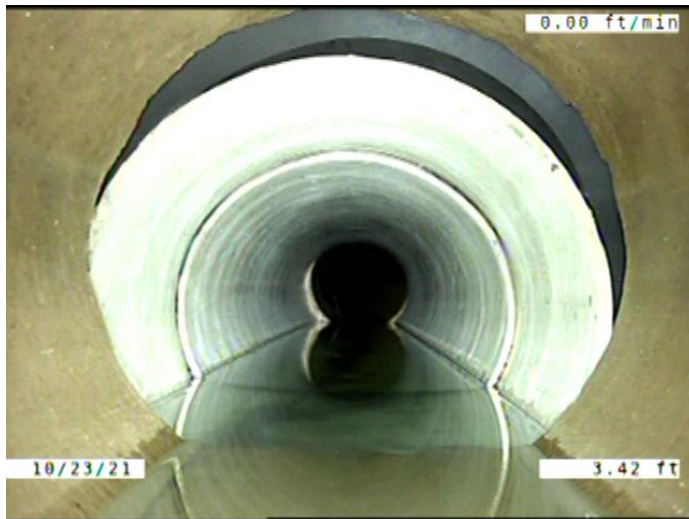
Code: **JOL**
 Description: **Joint Offset Large**

Distance (ft): **3.4**
 Structural Grade: **4**
 O&M Grade: **0**
 Clock Start/From:
 Clock To:
 1st Value: **1.000**
 2nd Value:
 Value Percent:
 Continuous Index:
 Within 8" of Joint: **NO**
 Remarks:

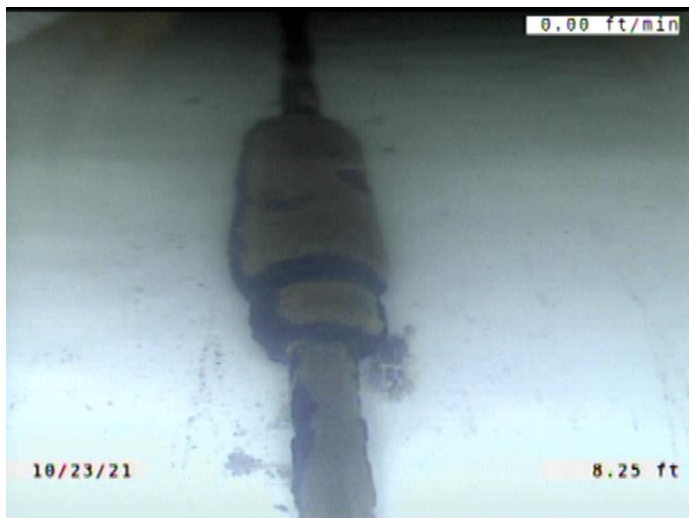
Code: **OBZ**
 Description: **Obstruction Other**

Distance (ft): **8.2**
 Structural Grade: **0**
 O&M Grade: **2**
 Clock Start/From: **5**
 Clock To: **7**
 1st Value:
 2nd Value:
 Value Percent: **5.000**
 Continuous Index:
 Within 8" of Joint: **YES**
 Remarks: **LOOKS TO BE A SEWER RODDER.**

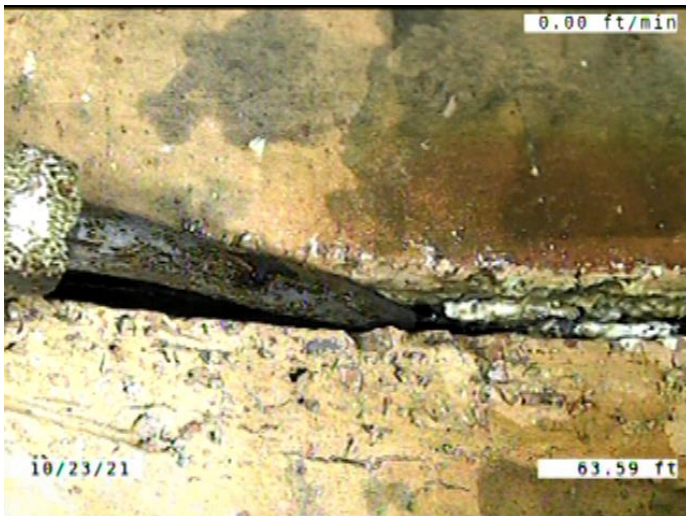
Code: **IWJ**
 Description: **Infiltration Weeper Joint**

Distance (ft): **63.6**
 Structural Grade: **0**
 O&M Grade: **2**
 Clock Start/From: **3**
 Clock To:
 1st Value:
 2nd Value:
 Value Percent:
 Continuous Index:
 Within 8" of Joint: **YES**
 Remarks:

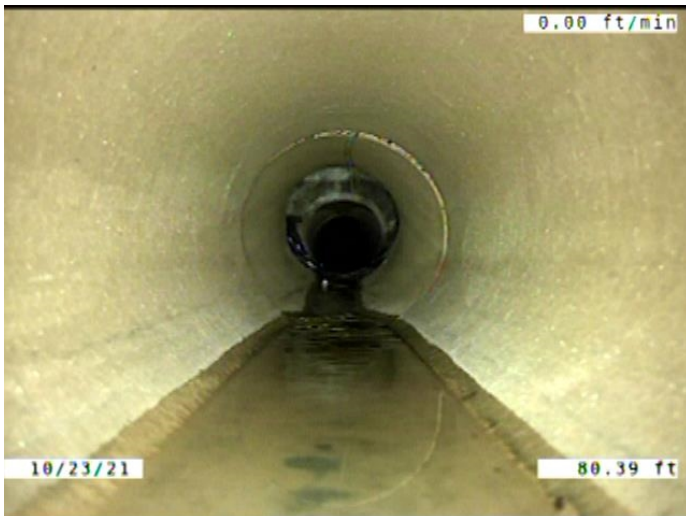
Code: **MWLS**
 Description: **Miscellaneous Water Level Sag**

Distance (ft): **80.4**
 Structural Grade: **2**
 O&M Grade: **0**
 Clock Start/From:
 Clock To:
 1st Value:
 2nd Value:
 Value Percent: **5.000**
 Continuous Index:
 Within 8" of Joint: **NO**
 Remarks:
