Profile/Photo Observation Report

Date:	04/08/2018	Weather:		Coding:	PACP 6.0
Pipe Length (ft):		Owner:	City of Hobart	Pre Clean:	No Pre-Cleaning
P.O.#:	19-2	Surveyor:	M. Pielacha	PSR:	M-404-014-M-404-013
Customer:	City of Hobart	Clean Date:		Shape:	C

Street:	Old Ridge Road	Flow Control:	Not Controlled
City:	Hobart, IN	Year Renewed:	
Location:	Light Highway	Tape/Media #:	DEP 19
Purpose:	Routine Assessment	Dia/Height:	18"
Use:	Sanitary	Material:	VCP
Drain Area:		Lining:

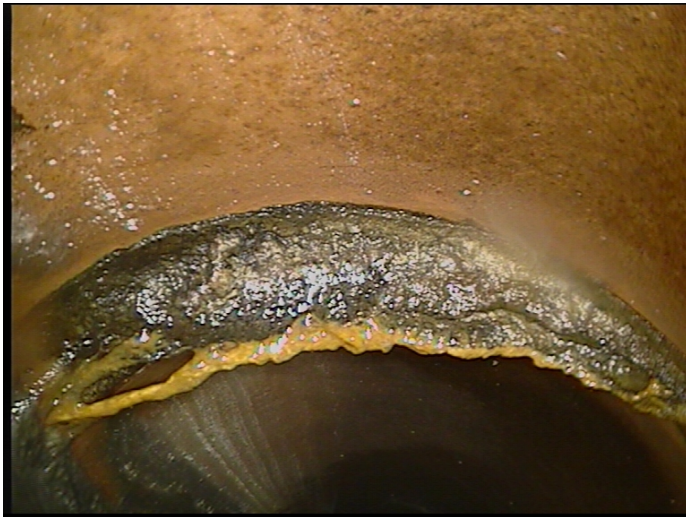
Code: **DAE**
Description: **Deposits Attached Encrustation**

Distance (ft): **163.6**
Structural Grade: **0**
O&M Grade: **2**
Clock Start/From: **7**
Clock To: **11**
1st Value:
2nd Value:
Value Percent: **5.000**
Continuous Index:
Within 8" of Joint: **YES**
Remarks:

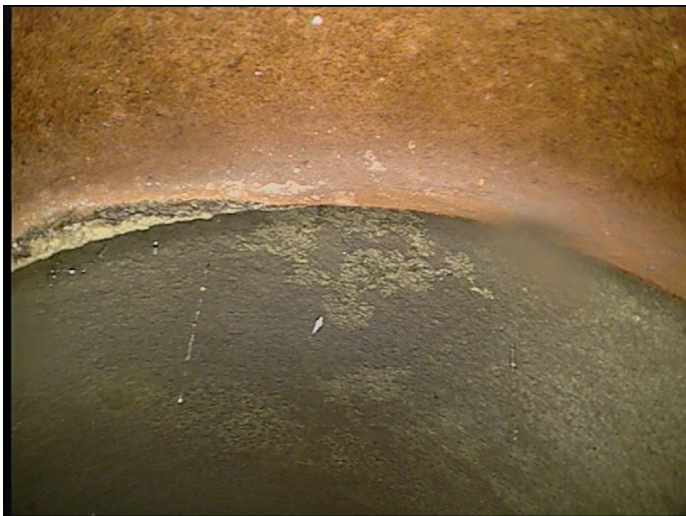
Code: **DAE**
Description: **Deposits Attached Encrustation**

Distance (ft): **273.9**
Structural Grade: **0**
O&M Grade: **2**
Clock Start/From: **7**
Clock To: **11**
1st Value:
2nd Value:
Value Percent: **5.000**
Continuous Index:
Within 8" of Joint: **YES**
Remarks:
