Profile/Photo Observation Report

Date:	09/01/2021	Weather:		Coding:	PACP 7.0
Pipe Length (ft):	295.8	Owner:	City of Hobart	Pre Clean:	Light Cleaning
P.O.#:	YES502259	Surveyor:	S. Bucklin	PSR:	P-404-017-016
Customer:	City of Hobart	Clean Date:	08/29/2021	Shape:	C

Location Details:		Direction of Survey:	Downstream
US MH:	M-404-016	DS MH:	M-404-017
		Total Length Surveyed (ft):	295.8

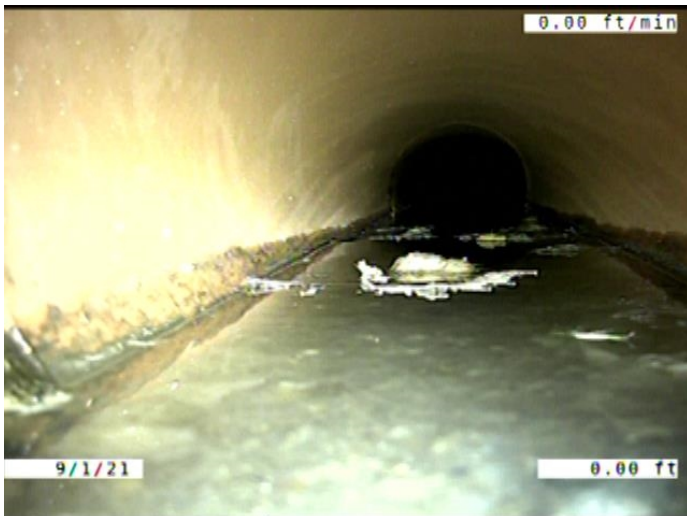
Code: **MWL**
 Description: **Miscellaneous Water Level**

Distance (ft): **.0**
 Structural Grade: **0**
 O&M Grade: **0**
 Clock Start/From:
 Clock To:
 1st Value:
 2nd Value:
 Value Percent: **10.000**
 Continuous Index:
 Within 8" of Joint: **NO**
 Remarks:

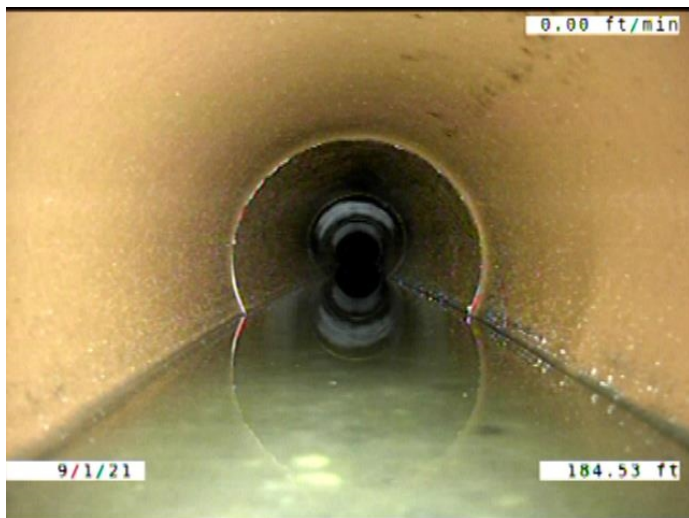
Code: **MWLS**
 Description: **Miscellaneous Water Level Sag**

Distance (ft): **184.5**
 Structural Grade: **2**
 O&M Grade: **0**
 Clock Start/From:
 Clock To:
 1st Value:
 2nd Value:
 Value Percent: **5.000**
 Continuous Index:
 Within 8" of Joint: **NO**
 Remarks:

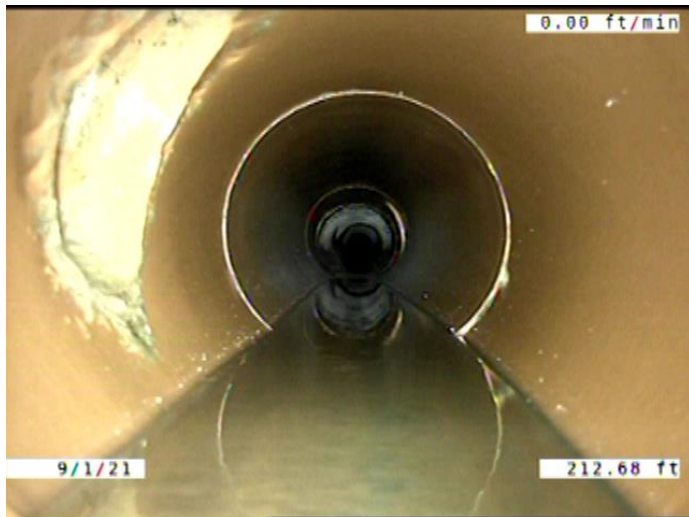
Code: **MWLS**
 Description: **Miscellaneous Water Level Sag**

Distance (ft): **212.7**
 Structural Grade: **2**
 O&M Grade: **0**
 Clock Start/From:
 Clock To:
 1st Value:
 2nd Value:
 Value Percent: **5.000**
 Continuous Index:
 Within 8" of Joint: **NO**
 Remarks:

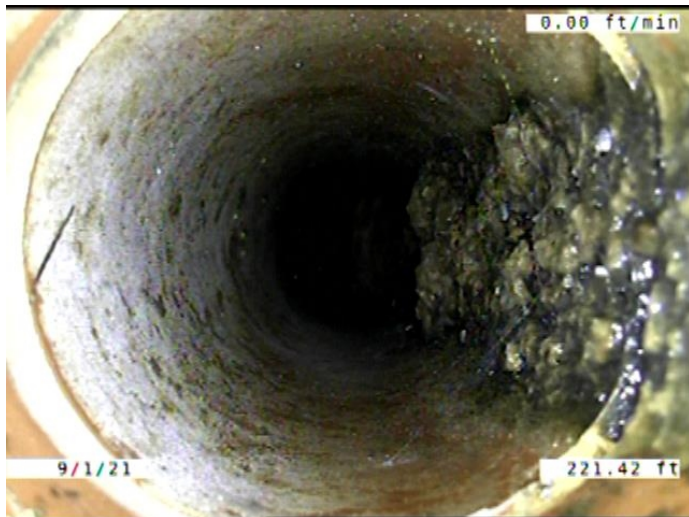
Code: **TF**
Description: **Tap Factory**

Distance (ft): **221.4**
Structural Grade: **0**
O&M Grade: **0**
Clock Start/From: **2**
Clock To:
1st Value: **6.000**
2nd Value:
Value Percent:
Continuous Index:
Within 8" of Joint: **YES**
Remarks:
