Profile/Photo Observation Report

Date:	09/01/2021	Weather:		Coding:	PACP 7.0
Pipe Length (ft):	295.8	Owner:	City of Hobart	Pre Clean:	Light Cleaning
P.O.#:	YES502259	Surveyor:	S. Bucklin	PSR:	P-404-017-016
Customer:	City of Hobart	Clean Date:	08/29/2021	Shape:	C

Street:	North Wabash Street	Flow Control:	Not Controlled
City:	Hobart, IN	Year Renewed:	
Location:	Yard	Tape/Media #:	
Purpose:	Routine Assessment	Dia/Height:	10"
Use:	Sanitary Sewage Pipe	Material:	VCP
Drain Area:		Lining:	
Category:	NA		
Comment:			
Location Details:		Direction of Survey:	Downstream
US MH:	M-404-016	DS MH:	M-404-017
		Total Length Surveyed (ft):	295.8

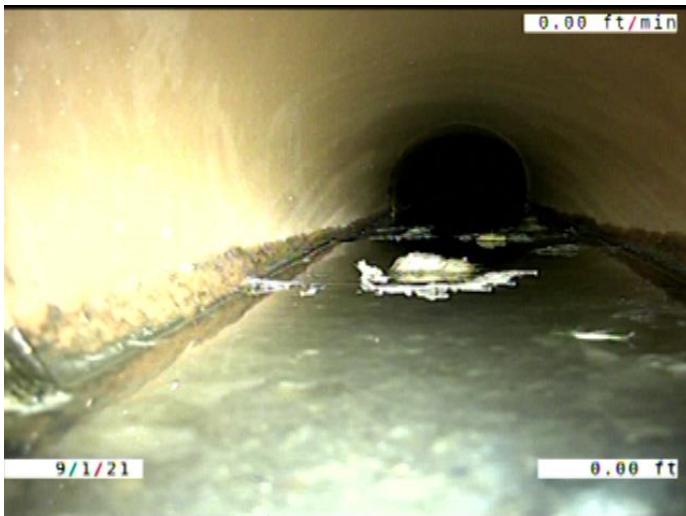
Code: **MWL**
 Description: **Miscellaneous Water Level**

Distance (ft): **.0**
 Structural Grade: **0**
 O&M Grade: **0**
 Clock Start/From:
 Clock To:
 1st Value:
 2nd Value:
 Value Percent: **10.000**
 Continuous Index:
 Within 8" of Joint: **NO**
 Remarks:

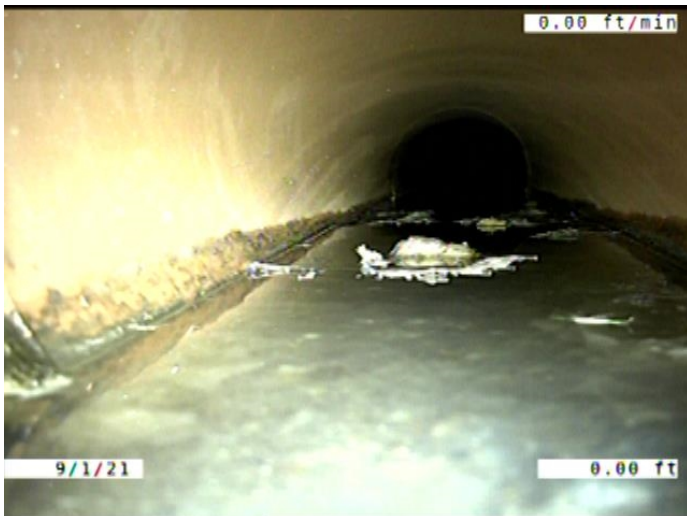
Code: **DSF**
 Description: **Deposits Settled Fine**

Distance (ft): **.0**
 Structural Grade: **0**
 O&M Grade: **2**
 Clock Start/From: **5**
 Clock To: **7**
 1st Value:
 2nd Value:
 Value Percent: **5.000**
 Continuous Index: **S02**
 Within 8" of Joint: **YES**
 Remarks:

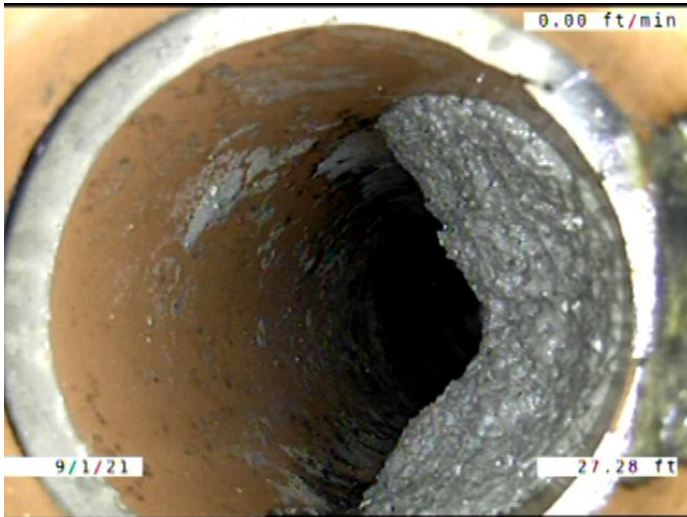
Code: **TF**
 Description: **Tap Factory**

Distance (ft): **27.3**
 Structural Grade: **0**
 O&M Grade: **0**
 Clock Start/From: **2**
 Clock To:
 1st Value: **4.000**
 2nd Value:
 Value Percent:
 Continuous Index:
 Within 8" of Joint: **YES**
 Remarks:

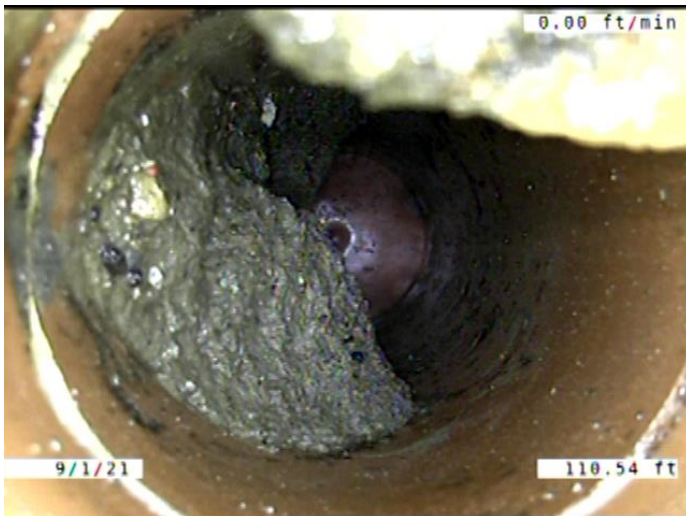
Code: **TFC**
 Description: **Tap Factory Capped**

Distance (ft): **110.5**
 Structural Grade: **0**
 O&M Grade: **0**
 Clock Start/From: **9**
 Clock To:
 1st Value: **4.000**
 2nd Value:
 Value Percent:
 Continuous Index:
 Within 8" of Joint: **YES**
 Remarks: **ENCrustATION JUST INSIDE THE TAP CONNECTION**

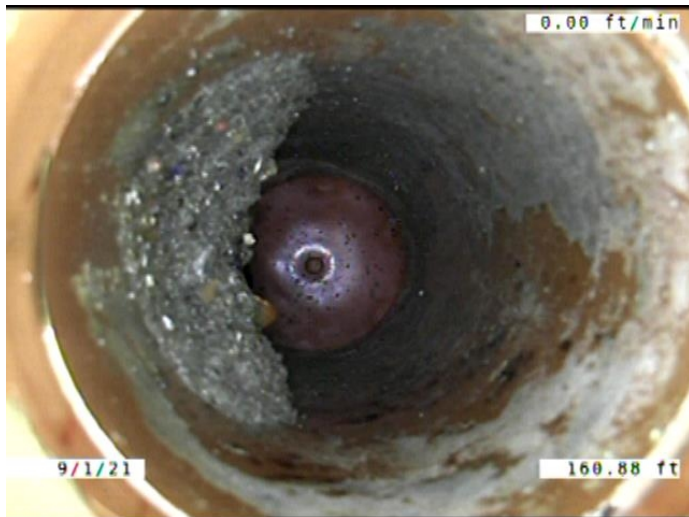
Code: **TFC**
 Description: **Tap Factory Capped**

Distance (ft): **160.9**
 Structural Grade: **0**
 O&M Grade: **0**
 Clock Start/From: **10**
 Clock To:
 1st Value: **6.000**
 2nd Value:
 Value Percent:
 Continuous Index:
 Within 8" of Joint: **YES**
 Remarks:

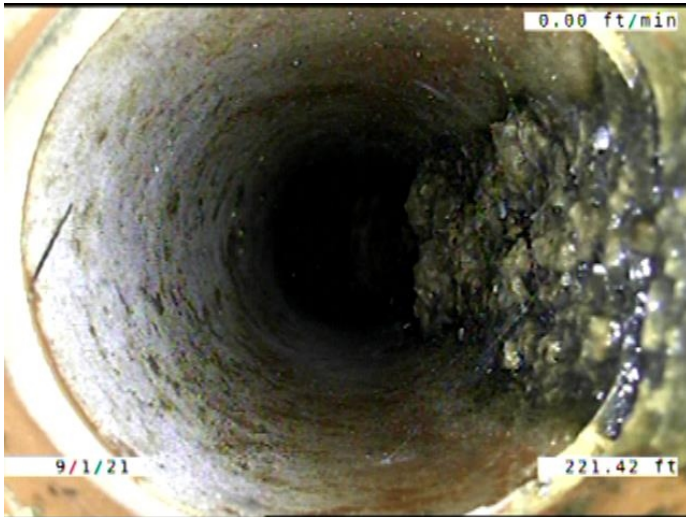
Code: **TF**
Description: **Tap Factory**

Distance (ft): **221.4**
Structural Grade: **0**
O&M Grade: **0**
Clock Start/From: **2**
Clock To:
1st Value: **6.000**
2nd Value:
Value Percent:
Continuous Index:
Within 8" of Joint: **YES**
Remarks:

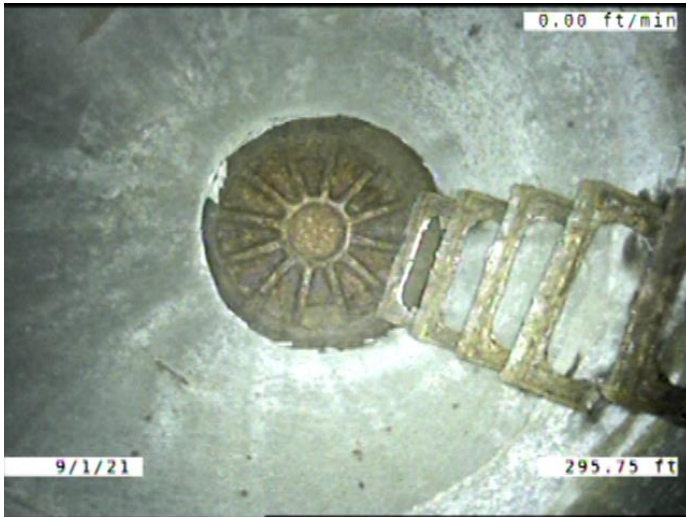
Code:	AMH
Description:	Manhole
Distance (ft):	295.8
Structural Grade:	0
O&M Grade:	0
Clock Start/From:	
Clock To:	
1st Value:	
2nd Value:	
Value Percent:	
Continuous Index:	
Within 8" of Joint:	NO
Remarks:	M-404-017
