# Profile/Photo Observation Report

Street:	<b>ALLEY BETWEEN N WABASH ST &amp; N</b>	Flow Control:	<b>Not Controlled</b>
City:	<b>Hobart, IN</b>	Year Renewed:	
Location:	<b>Light Highway</b>	Tape/Media #:	
Purpose:	<b>Not Known</b>	Dia/Height:	<b>10"</b>
Use:	<b>Sanitary</b>	Material:	<b>VCP</b>
Drain Area:	<b>NA</b>	Lining:	
Category:	<b>NA</b>		
Comment:			
Location Details:		Direction of Survey:	<b>Downstream</b>
US MH:	<b>M-404-020</b>	DS MH:	<b>M-404-021</b>
		Total Length Surveyed (ft):	<b>19.0</b>

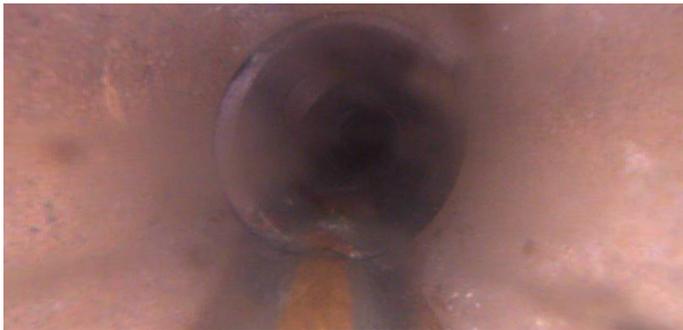
Code: **AMH**  
Description: **Manhole**

Distance (ft): **.0**  
Structural Grade: **0**  
O&M Grade: **0**  
Clock Start/From:  
Clock To:  
1st Value:  
2nd Value:  
Value Percent:  
Continuous Index:  
Within 8" of Joint: **NO**  
Remarks: **M-404-020**

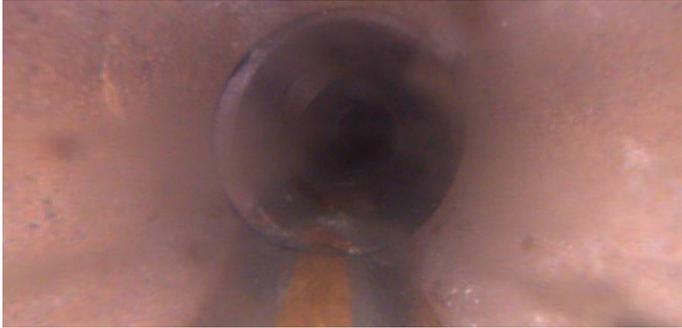
Code: **MWL**  
Description: **Water Level**

Distance (ft): **.0**  
Structural Grade: **0**  
O&M Grade: **0**  
Clock Start/From:  
Clock To:  
1st Value:  
2nd Value:  
Value Percent: **5.000**  
Continuous Index:  
Within 8" of Joint: **NO**  
Remarks:

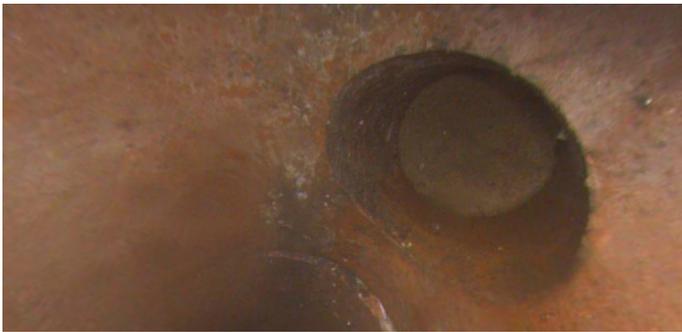
Code: **TFC**  
Description: **Tap Factory Capped**

Distance (ft): **5.9**  
Structural Grade: **0**  
O&M Grade: **0**  
Clock Start/From: **10**  
Clock To:  
1st Value: **4.000**  
2nd Value:  
Value Percent:  
Continuous Index:  
Within 8" of Joint:  
Remarks:

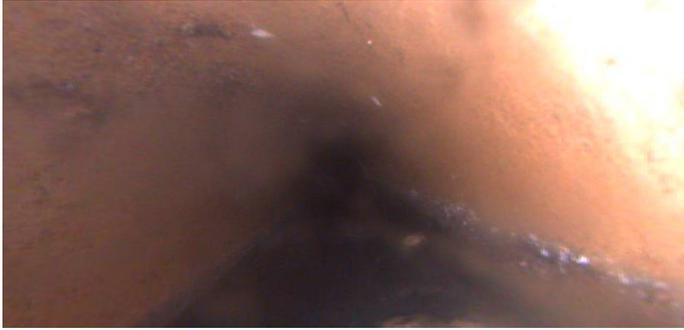
Code:	<b>MSA</b>
Description:	<b>Abandoned Survey</b>
Distance (ft):	<b>19.0</b>
Structural Grade:	<b>0</b>
O&M Grade:	<b>0</b>
Clock Start/From:	
Clock To:	
1st Value:	
2nd Value:	
Value Percent:	
Continuous Index:	
Within 8" of Joint:	<b>NO</b>
Remarks:	<b>camera stopped</b>
