Profile/Photo Observation Report

Date:	04/16/2018	Weather:		Coding:	PACP 6.0
Pipe Length (ft):	184.7	Owner:	NA	Pre Clean:	Not Known
P.O.#:		Surveyor:	Selasie Honu	PSR:	P-404-020-021
Customer:		Clean Date:	01/01/1900	Shape:	C

Location Details:		Direction of Survey:	Downstream
US MH:	M-404-020	DS MH:	M-404-021
		Total Length Surveyed (ft):	19.0

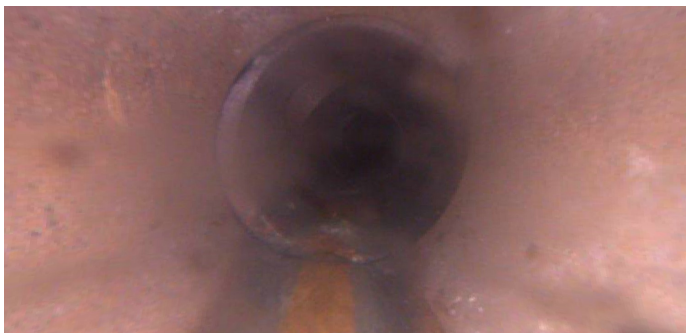
Code: **AMH**
Description: **Manhole**

Distance (ft): **.0**
Structural Grade: **0**
O&M Grade: **0**
Clock Start/From:
Clock To:
1st Value:
2nd Value:
Value Percent:
Continuous Index:
Within 8" of Joint: **NO**
Remarks: **M-404-020**

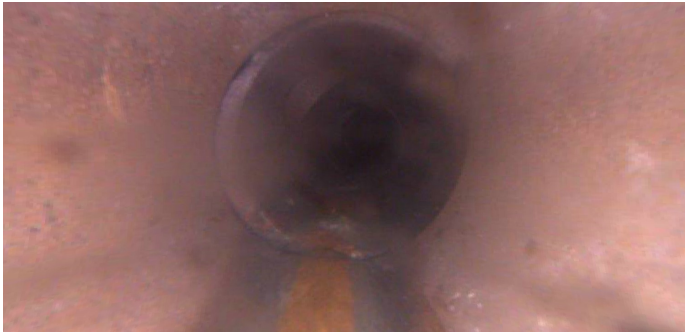
Code:	MWL
Description:	Water Level

Distance (ft):	.0
Structural Grade:	0
O&M Grade:	0
Clock Start/From:	
Clock To:	
1st Value:	
2nd Value:	
Value Percent:	5.000
Continuous Index:	
Within 8" of Joint:	NO
Remarks:

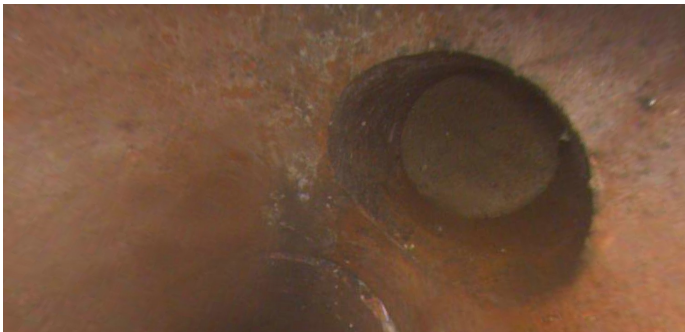
Code:	TFC
Description:	Tap Factory Capped

Distance (ft):	5.9
Structural Grade:	0
O&M Grade:	0
Clock Start/From:	10
Clock To:	
1st Value:	4.000
2nd Value:	
Value Percent:	
Continuous Index:	
Within 8" of Joint:	
Remarks:

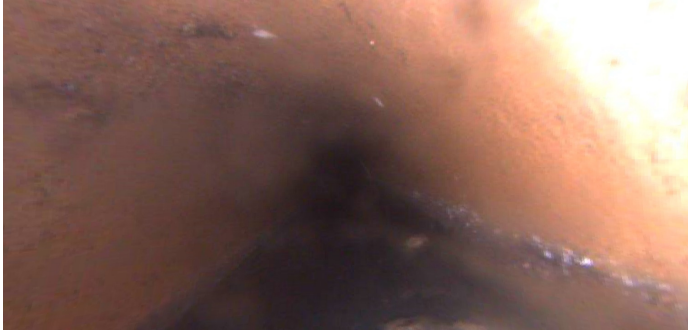
Code:	MSA
Description:	Abandoned Survey
Distance (ft):	19.0
Structural Grade:	0
O&M Grade:	0
Clock Start/From:	
Clock To:	
1st Value:	
2nd Value:	
Value Percent:	
Continuous Index:	
Within 8" of Joint:	NO
Remarks:	camera stopped
