Profile/Photo Observation Report

Date:	04/16/2018	Weather:		Coding:	PACP 6.0
Pipe Length (ft):	184.6	Owner:	NA	Pre Clean:	Not Known
P.O.#:		Surveyor:	Selasie Honu	PSR:	P-404-021-022
Customer:		Clean Date:	01/01/1900	Shape:	C

Street:	ALLEY BETWEEN N WABASH ST & N	Flow Control:	Not Controlled
City:	Hobart, IN	Year Renewed:	
Location:	Light Highway	Tape/Media #:	
Purpose:	Not Known	Dia/Height:	10"
Use:	Sanitary	Material:	VCP
Drain Area:	NA	Lining:	
Category:	NA		
Comment:

Location Details:		Direction of Survey:	Downstream
US MH:	M-404-021	DS MH:	M-404-022
		Total Length Surveyed (ft):	194.6

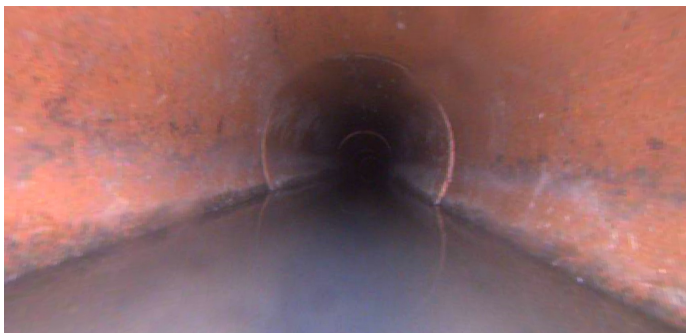
Code: **AMH**
Description: **Manhole**

Distance (ft): **.0**
Structural Grade: **0**
O&M Grade: **0**
Clock Start/From:
Clock To:
1st Value:
2nd Value:
Value Percent:
Continuous Index:
Within 8" of Joint: **NO**
Remarks: **M-404-021**

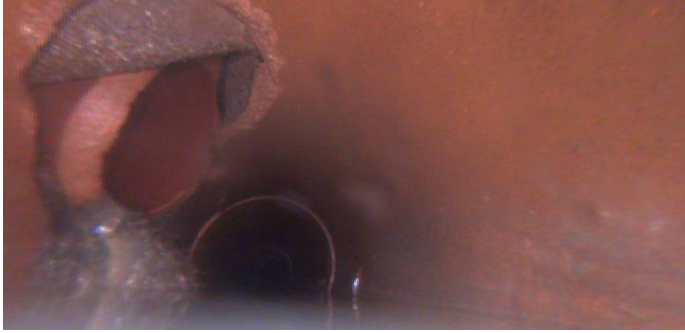
Code: **RML**
Description: **Roots Medium Lateral**

Distance (ft): **38.5**
Structural Grade: **0**
O&M Grade: **3**
Clock Start/From: **7**
Clock To: **9**
1st Value:
2nd Value:
Value Percent: **10.000**
Continuous Index:
Within 8" of Joint: **NO**
Remarks:

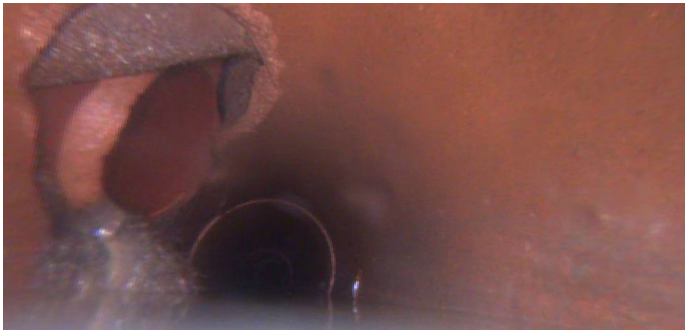
Code: **TBI**
Description: **Tap Break-in Intruding**

Distance (ft): **38.5**
Structural Grade: **0**
O&M Grade: **2**
Clock Start/From: **10**
Clock To:
1st Value: **4.000**
2nd Value: **1.000**
Value Percent:
Continuous Index:
Within 8" of Joint:
Remarks:

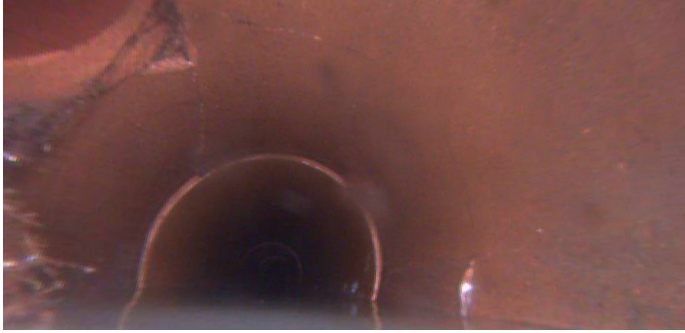
Code: **FM**
Description: **Fracture Multiple**

Distance (ft): **39.3**
Structural Grade: **4**
O&M Grade: **0**
Clock Start/From: **10**
Clock To: **4**
1st Value:
2nd Value:
Value Percent:
Continuous Index:
Within 8" of Joint: **YES**
Remarks:

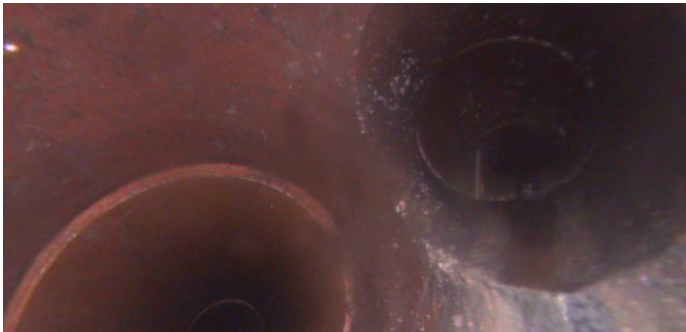
Code: **TF**
Description: **Tap Factory**

Distance (ft): **92.2**
Structural Grade: **0**
O&M Grade: **0**
Clock Start/From: **2**
Clock To:
1st Value: **4.000**
2nd Value:
Value Percent:
Continuous Index:
Within 8" of Joint:
Remarks:

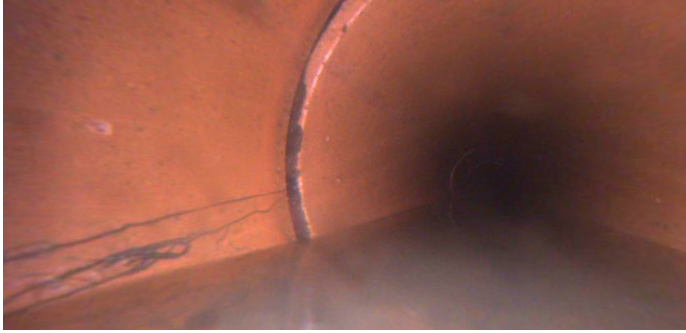
Code: **RFJ**
Description: **Roots Fine Joint**

Distance (ft): **112.0**
Structural Grade: **0**
O&M Grade: **1**
Clock Start/From: **8**
Clock To:
1st Value:
2nd Value:
Value Percent:
Continuous Index:
Within 8" of Joint: **YES**
Remarks:

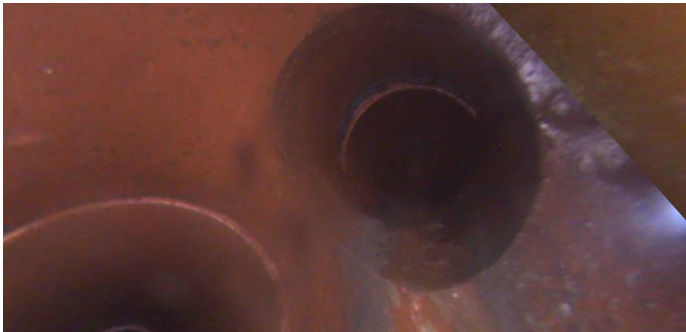
Code: **TF**
Description: **Tap Factory**

Distance (ft): **133.0**
Structural Grade: **0**
O&M Grade: **0**
Clock Start/From: **2**
Clock To:
1st Value: **4.000**
2nd Value:
Value Percent:
Continuous Index:
Within 8" of Joint:
Remarks:

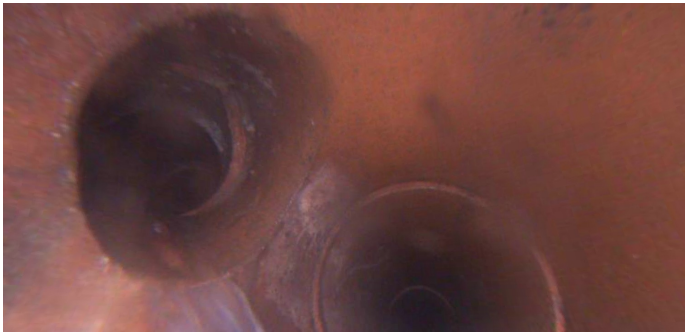
Code: **TFA**
Description: **Tap Factory Active**

Distance (ft): **164.2**
Structural Grade: **0**
O&M Grade: **0**
Clock Start/From: **10**
Clock To:
1st Value: **4.000**
2nd Value:
Value Percent:
Continuous Index:
Within 8" of Joint:
Remarks:

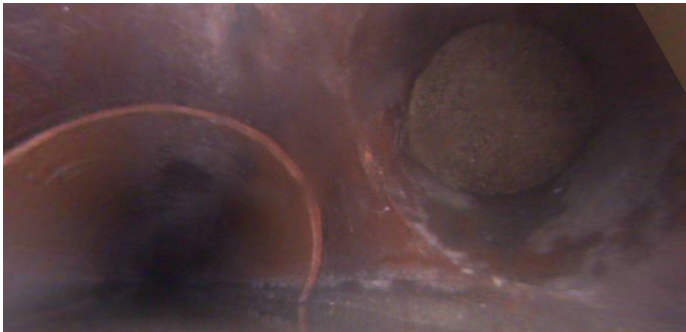
Code: **TFC**
Description: **Tap Factory Capped**

Distance (ft): **186.0**
Structural Grade: **0**
O&M Grade: **0**
Clock Start/From: **2**
Clock To:
1st Value: **4.000**
2nd Value:
Value Percent:
Continuous Index:
Within 8" of Joint:
Remarks:
