## Profile/Photo Observation Report

Street:	<b>Summerlin</b>	Flow Control:	<b>Not Controlled</b>
City:	<b>Hobart, IN</b>	Year Renewed:	
Location:	<b>Light Highway</b>	Tape/Media #:	
Purpose:	<b>Not Known</b>	Dia/Height:	<b>10"</b>
Use:	<b>Sanitary</b>	Material:	<b>VCP</b>
Drain Area:	<b>NA</b>	Lining:	
Category:	<b>NA</b>		
Comment:

Location Details:		Direction of Survey:	<b>Downstream</b>
US MH:	<b>M-404-021</b>	DS MH:	<b>M-404-022</b>
		Total Length Surveyed (ft):	<b>194.6</b>

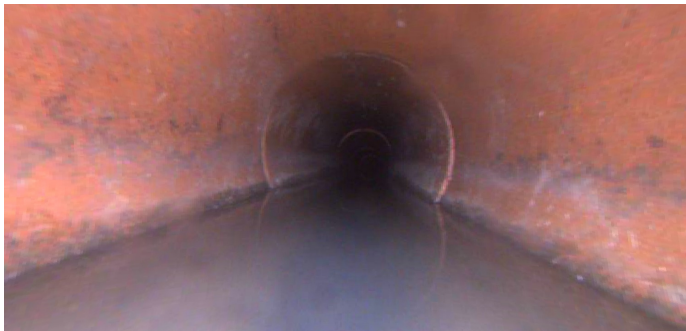
Code: **AMH**  
Description: **Manhole**

Distance (ft): **.0**  
Structural Grade: **0**  
O&M Grade: **0**  
Clock Start/From:  
Clock To:  
1st Value:  
2nd Value:  
Value Percent:  
Continuous Index:  
Within 8" of Joint: **NO**  
Remarks: **M-404-021**

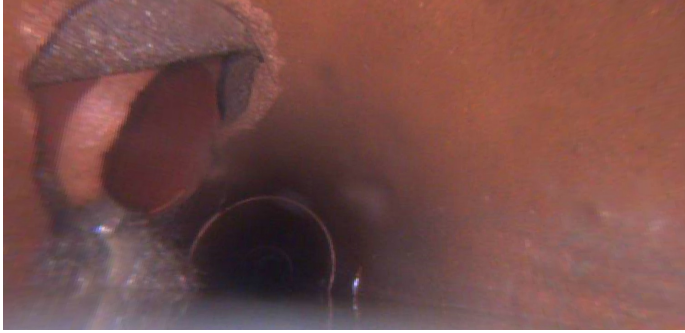
Code: **RML**  
Description: **Roots Medium Lateral**

Distance (ft): **38.5**  
Structural Grade: **0**  
O&M Grade: **3**  
Clock Start/From: **7**  
Clock To: **9**  
1st Value:  
2nd Value:  
Value Percent: **10.000**  
Continuous Index:  
Within 8" of Joint: **NO**  
Remarks:

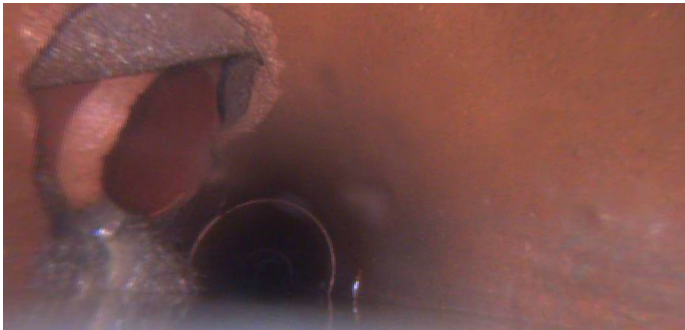
Code: **TBI**  
Description: **Tap Break-in Intruding**

Distance (ft): **38.5**  
Structural Grade: **0**  
O&M Grade: **2**  
Clock Start/From: **10**  
Clock To:  
1st Value: **4.000**  
2nd Value: **1.000**  
Value Percent:  
Continuous Index:  
Within 8" of Joint:  
Remarks:

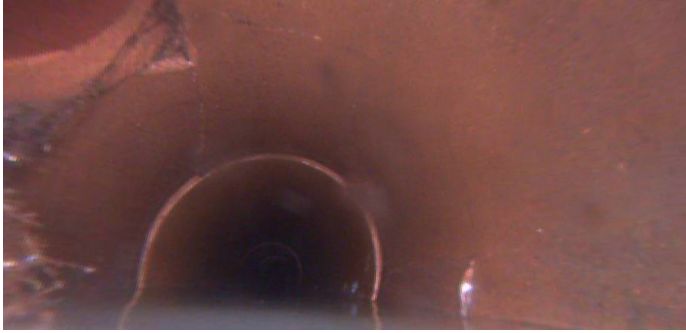
Code: **FM**  
Description: **Fracture Multiple**

Distance (ft): **39.3**  
Structural Grade: **4**  
O&M Grade: **0**  
Clock Start/From: **10**  
Clock To: **4**  
1st Value:  
2nd Value:  
Value Percent:  
Continuous Index:  
Within 8" of Joint: **YES**  
Remarks:

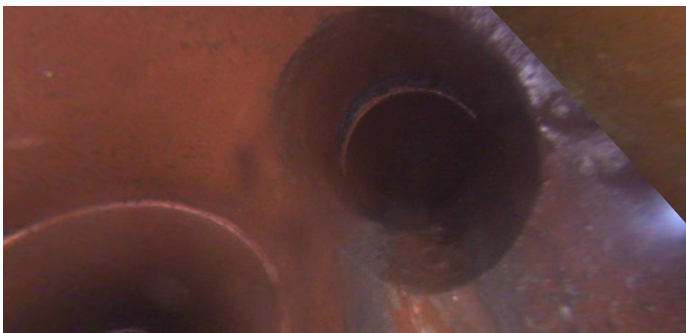
Code: **TF**  
Description: **Tap Factory**

Distance (ft): **133.0**  
Structural Grade: **0**  
O&M Grade: **0**  
Clock Start/From: **2**  
Clock To:  
1st Value: **4.000**  
2nd Value:  
Value Percent:  
Continuous Index:  
Within 8" of Joint:  
Remarks:

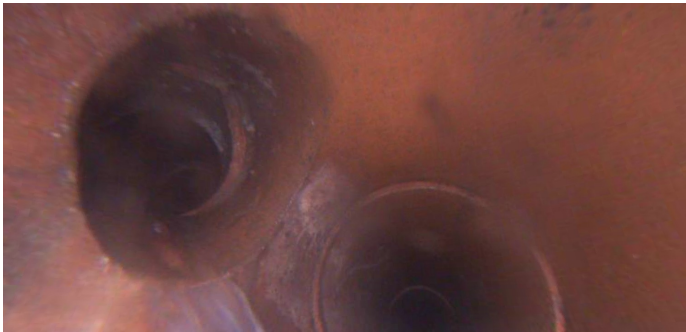
Code: **TFA**  
Description: **Tap Factory Active**

Distance (ft): **164.2**  
Structural Grade: **0**  
O&M Grade: **0**  
Clock Start/From: **10**  
Clock To:  
1st Value: **4.000**  
2nd Value:  
Value Percent:  
Continuous Index:  
Within 8" of Joint:  
Remarks:

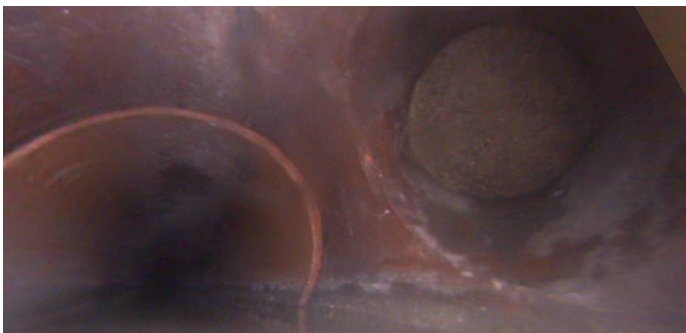
Code: **TFC**  
Description: **Tap Factory Capped**

Distance (ft): **186.0**  
Structural Grade: **0**  
O&M Grade: **0**  
Clock Start/From: **2**  
Clock To:  
1st Value: **4.000**  
2nd Value:  
Value Percent:  
Continuous Index:  
Within 8" of Joint:  
Remarks:
