Profile/Photo Observation Report

Street:	ALLEY BETWEEN N WABASH ST & N	Flow Control:	Not Controlled
City:	Hobart, IN	Year Renewed:	
Location:	Light Highway	Tape/Media #:	
Purpose:	Not Known	Dia/Height:	10"
Use:	Sanitary	Material:	CP
Drain Area:	NA	Lining:	
Category:	NA		
Comment:

Location Details:		Direction of Survey:	Upstream
US MH:	M-404-022	DS MH:	M-404-023
		Total Length Surveyed (ft):	5.9

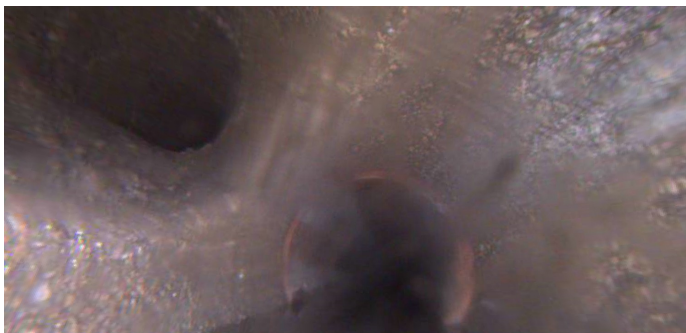
Code: **TF**
Description: **Tap Factory**

Distance (ft): **.0**
Structural Grade: **0**
O&M Grade: **0**
Clock Start/From: **10**
Clock To:
1st Value: **4.000**
2nd Value:
Value Percent:
Continuous Index:
Within 8" of Joint:
Remarks:

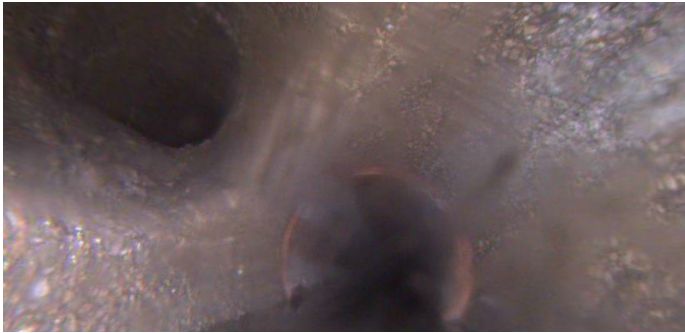
Code:	SAP
Description:	Surface Aggregate Projecting

Distance (ft):	.0
Structural Grade:	3
O&M Grade:	0
Clock Start/From:	8
Clock To:	4
1st Value:	
2nd Value:	
Value Percent:	
Continuous Index:	
Within 8" of Joint:	
Remarks:

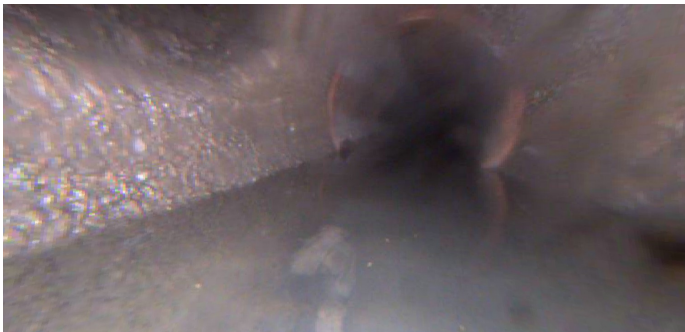
Code:	AMH
Description:	Manhole

Distance (ft):	.0
Structural Grade:	0
O&M Grade:	0
Clock Start/From:	
Clock To:	
1st Value:	
2nd Value:	
Value Percent:	
Continuous Index:	
Within 8" of Joint:	NO
Remarks:	M-404-022

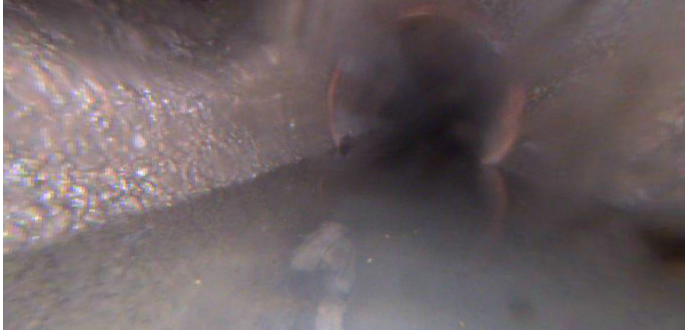
Code: **MWL**
Description: **Water Level**

Distance (ft): **.0**
Structural Grade: **0**
O&M Grade: **0**
Clock Start/From:
Clock To:
1st Value:
2nd Value:
Value Percent: **5.000**
Continuous Index:
Within 8" of Joint: **NO**
Remarks:

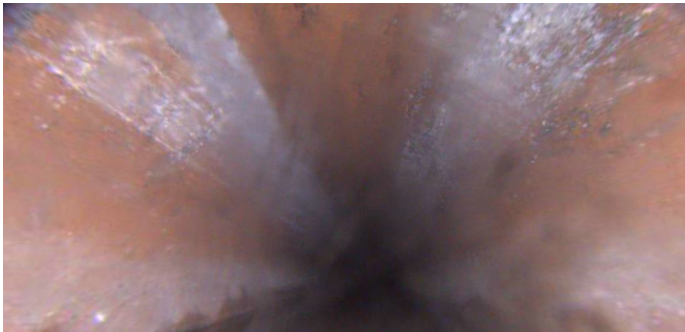
Code: **MMC**
Description: **Material Change**

Distance (ft): **2.5**
Structural Grade: **0**
O&M Grade: **0**
Clock Start/From:
Clock To:
1st Value:
2nd Value:
Value Percent:
Continuous Index:
Within 8" of Joint: **NO**
Remarks: **vcp**

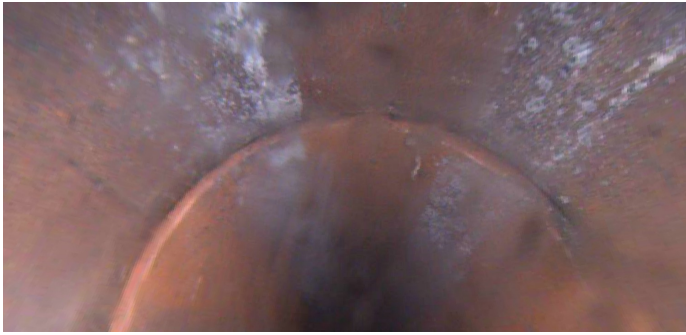
Code: **RFJ**
Description: **Roots Fine Joint**

Distance (ft): **5.4**
Structural Grade: **0**
O&M Grade: **1**
Clock Start/From: **12**
Clock To:
1st Value:
2nd Value:
Value Percent:
Continuous Index:
Within 8" of Joint: **YES**
Remarks:

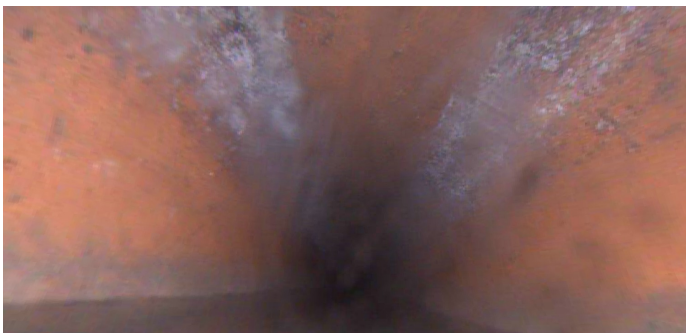
Code: **MSA**
Description: **Abandoned Survey**

Distance (ft): **5.9**
Structural Grade: **0**
O&M Grade: **0**
Clock Start/From:
Clock To:
1st Value:
2nd Value:
Value Percent:
Continuous Index:
Within 8" of Joint: **NO**
Remarks: **camera stopped**
