Profile/Photo Observation Report

Street:	W 41ST AVE & N WILSON ST	Flow Control:	Not Controlled
City:	Hobart, IN	Year Renewed:	
Location:	Other	Tape/Media #:	
Purpose:	Not Known	Dia/Height:	12"
Use:	Sanitary	Material:	VCP
Drain Area:	NA	Lining:	
Category:	NA		
Comment:

Location Details:		Direction of Survey:	Downstream
US MH:	M-404-024	DS MH:	M-504-128
		Total Length Surveyed (ft):	5.9

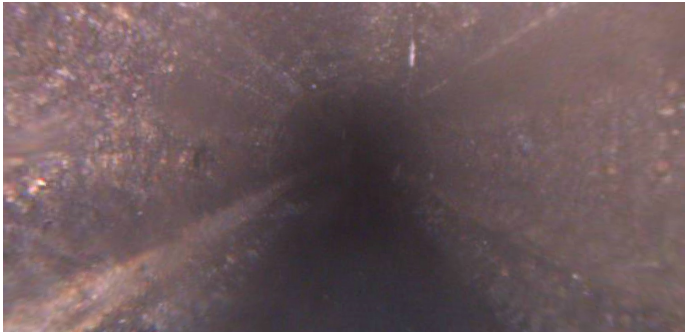
Code:	MWL
Description:	Water Level

Distance (ft):	.0
Structural Grade:	0
O&M Grade:	0
Clock Start/From:	
Clock To:	
1st Value:	
2nd Value:	
Value Percent:	5.000
Continuous Index:	
Within 8" of Joint:	NO
Remarks:

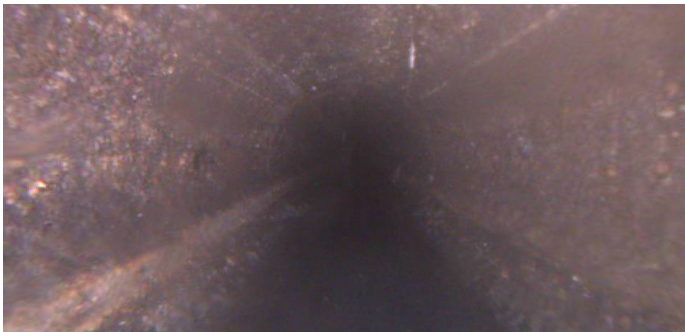
Code:	DAGS
Description:	Deposits Attached Grease

Distance (ft):	.0
Structural Grade:	0
O&M Grade:	2
Clock Start/From:	8
Clock To:	4
1st Value:	
2nd Value:	
Value Percent:	5.000
Continuous Index:	S01
Within 8" of Joint:	NO
Remarks:

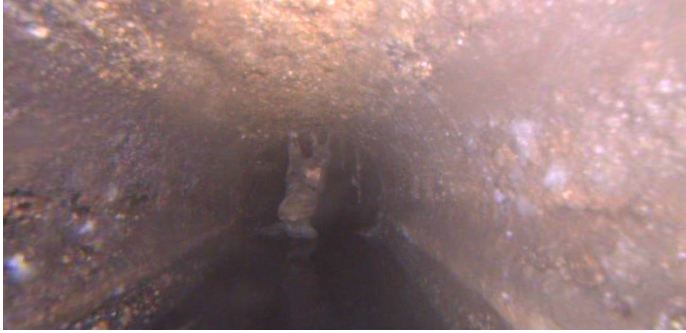
Code: **DAGS**
Description: **Deposits Attached Grease**

Distance (ft): **5.9**
Structural Grade: **0**
O&M Grade: **2**
Clock Start/From: **8**
Clock To: **4**
1st Value:
2nd Value:
Value Percent: **5.000**
Continuous Index: **F01**
Within 8" of Joint: **NO**
Remarks:

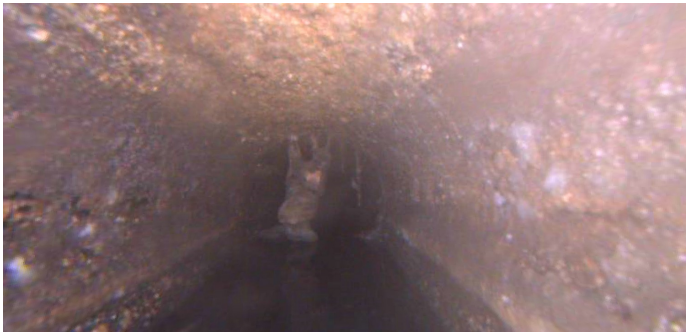
Code: **MSA**
Description: **Abandoned Survey**

Distance (ft): **5.9**
Structural Grade: **0**
O&M Grade: **0**
Clock Start/From:
Clock To:
1st Value:
2nd Value:
Value Percent:
Continuous Index:
Within 8" of Joint: **NO**
Remarks: **debris**
