## Profile/Photo Observation Report

Street:	<b>W 40th ave</b>	Flow Control:	<b>Not Controlled</b>
City:	<b>Hobart, IN</b>	Year Renewed:	
Location:	<b>Other</b>	Tape/Media #:	
Purpose:	<b>Not Known</b>	Dia/Height:	<b>12"</b>
Use:	<b>Sanitary</b>	Material:	<b>VCP</b>
Drain Area:	<b>NA</b>	Lining:	
Category:	<b>NA</b>		
Comment:

Location Details:		Direction of Survey:	<b>Downstream</b>
US MH:	<b>M-404-024</b>	DS MH:	<b>M-504-128</b>
		Total Length Surveyed (ft):	<b>5.9</b>

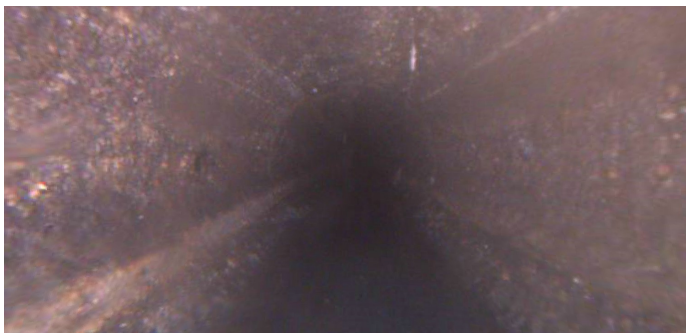
Code: **AMH**  
Description: **Manhole**

Distance (ft): **.0**  
Structural Grade: **0**  
O&M Grade: **0**  
Clock Start/From:  
Clock To:  
1st Value:  
2nd Value:  
Value Percent:  
Continuous Index:  
Within 8" of Joint: **NO**  
Remarks: **M-404-024**

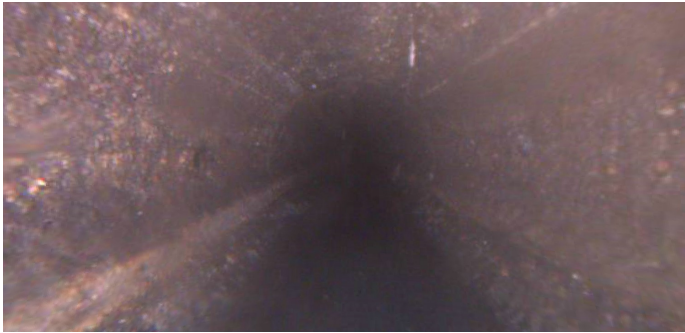
Code:	<b>MWL</b>
Description:	<b>Water Level</b>

Distance (ft):	<b>.0</b>
Structural Grade:	<b>0</b>
O&M Grade:	<b>0</b>
Clock Start/From:	
Clock To:	
1st Value:	
2nd Value:	
Value Percent:	<b>5.000</b>
Continuous Index:	
Within 8" of Joint:	<b>NO</b>
Remarks:

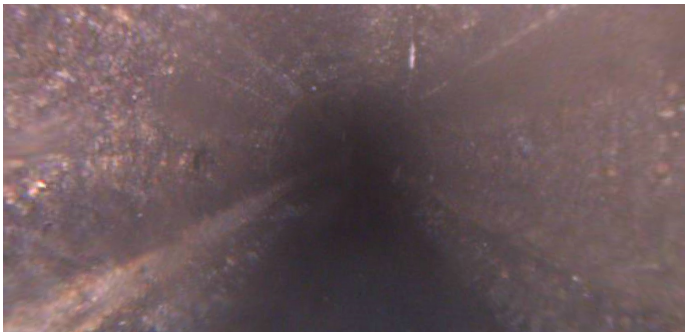
Code:	<b>DAGS</b>
Description:	<b>Deposits Attached Grease</b>

Distance (ft):	<b>.0</b>
Structural Grade:	<b>0</b>
O&M Grade:	<b>2</b>
Clock Start/From:	<b>8</b>
Clock To:	<b>4</b>
1st Value:	
2nd Value:	
Value Percent:	<b>5.000</b>
Continuous Index:	<b>S01</b>
Within 8" of Joint:	<b>NO</b>
Remarks:

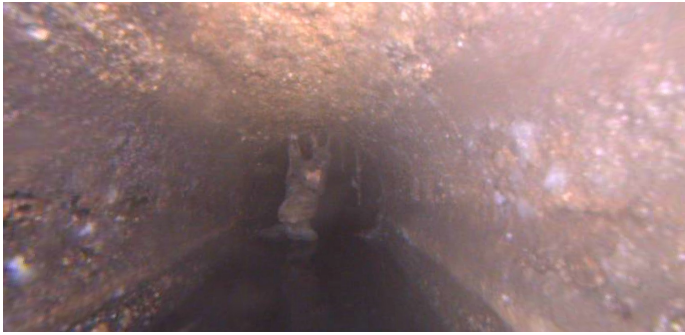
Code: **DAGS**  
Description: **Deposits Attached Grease**

Distance (ft): **5.9**  
Structural Grade: **0**  
O&M Grade: **2**  
Clock Start/From: **8**  
Clock To: **4**  
1st Value:  
2nd Value:  
Value Percent: **5.000**  
Continuous Index: **F01**  
Within 8" of Joint: **NO**  
Remarks:

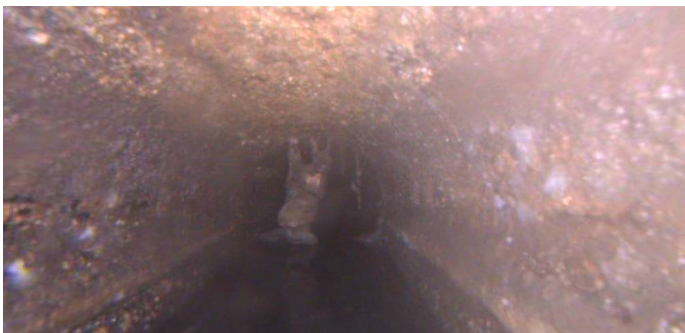
Code: **MSA**  
Description: **Abandoned Survey**

Distance (ft): **5.9**  
Structural Grade: **0**  
O&M Grade: **0**  
Clock Start/From:  
Clock To:  
1st Value:  
2nd Value:  
Value Percent:  
Continuous Index:  
Within 8" of Joint: **NO**  
Remarks: **debris**
